Quick Report on Damage to Buildings by the Tornado on May 6, 2012 in Tsukuba City, Ibaraki Prefecture, JAPAN

National Institute for Land and Infrastructure Management (NILIM)
Ministry of Land, Infrastructure, Transport and Tourism, Japan

Building Research Institute (BRI)
Incorporated Administrative Agency, Japan

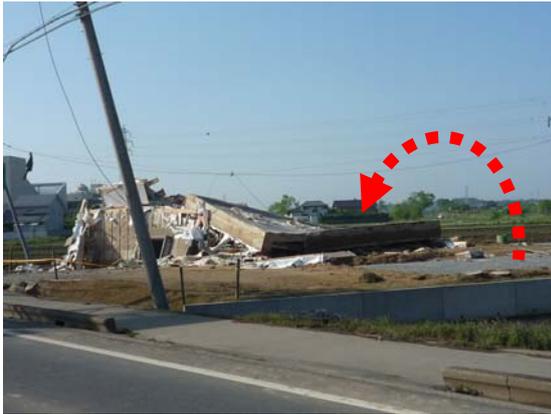
A wooden structure A (Photos 1, 2) completely turned over with mat foundation from ground.

Photo 1 Wood House A

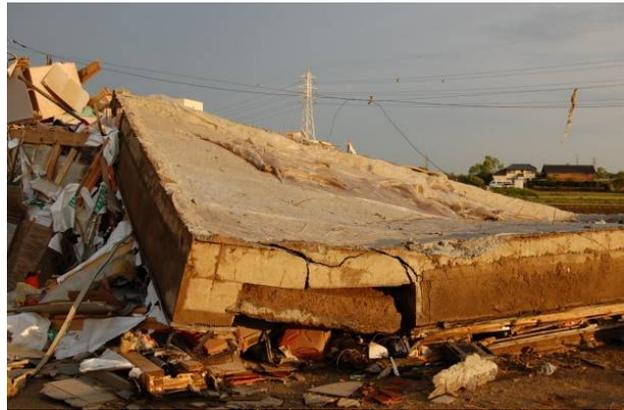
Photo 2 Turned mat foundation of Wood House B

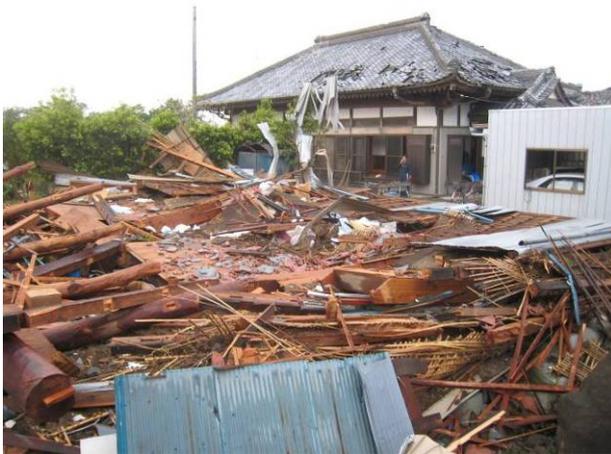
Though the details of the collapsed structure cannot be grasped, wood construction B (this side, Photo 3) and C (Photo 4) completely collapsed because tornado-induced wind force was estimated to surpass the lateral shear strength of these structures.

Photo 3 Wood construction B (this side, collapsed one)

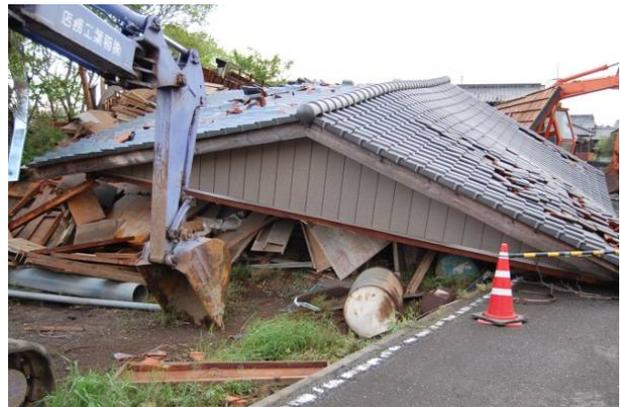
Photo 4 Wood construction C

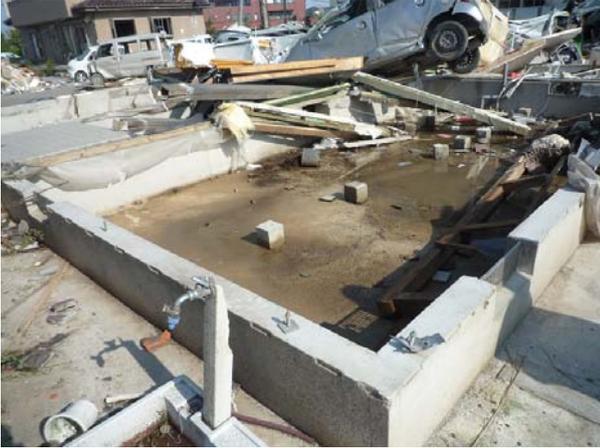
Whole wood construction without foundation (of wood houses D and E) were scattered. In the case of wood house D (Photo 5), the foundation remained (Photo 6) but most of wood construction were scattered. And, in the case of wood house E (Photo 7), sills, joists, and a part of floor board were remained.

Photo 5 Wood House D

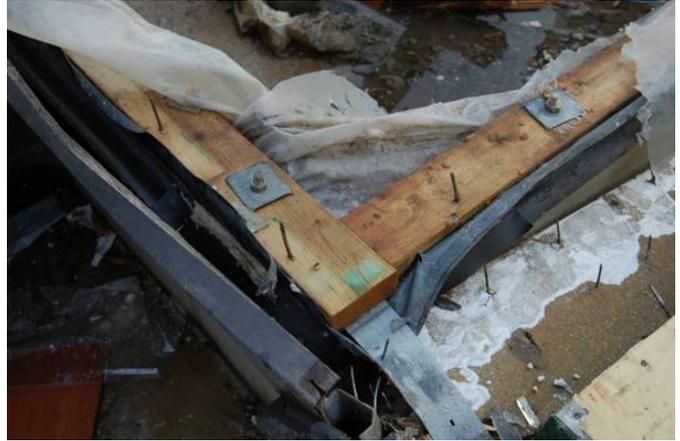
Photo 6 Remaining foundation of Wood House D

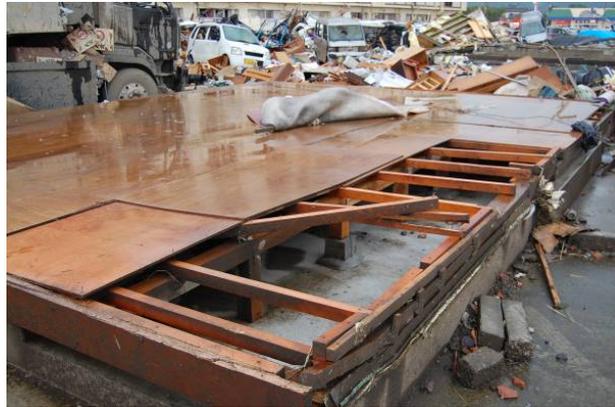
Photo 7 Wood House E

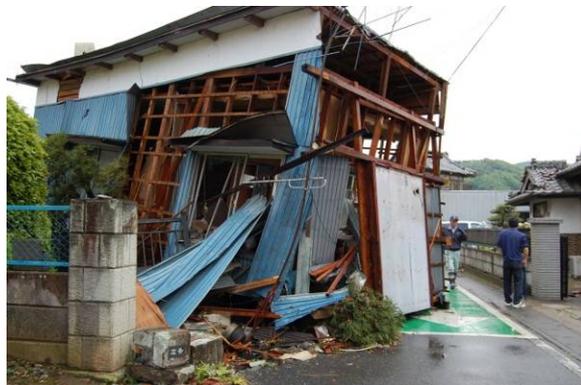
A case of horizontal movement of wood house to the road was observed (Wood House F, Photo 8). Anchor bolts or connection of columns and foundation might be failed by the strong horizontal force of tornado.

Photo 8 Wood House F which moved horizontally

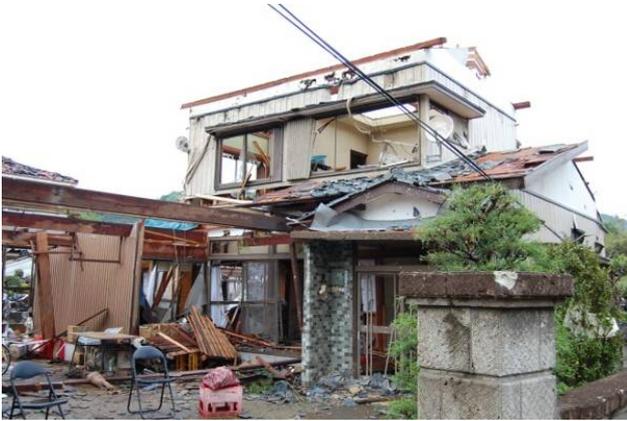
Many cases of damage on roof systems were observed. The damage cases are shown in Photo 9 of a gable roof (comparatively old house), Photo 10 of a gable roof (comparatively new house), Photo 11 of a hipped roof and Photo 12 of a shed roof, respectively.

Photo 9 Wood House G whose gable roof was scattered.

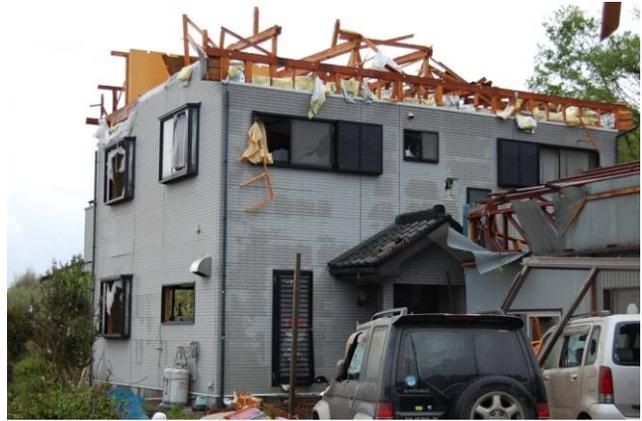
Photo 10 Wood House H whose gable roof was scattered.

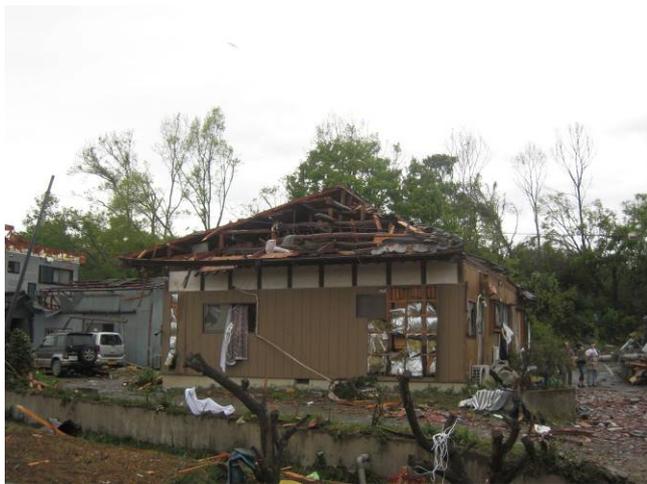
Photo 11 Wood House I whose hipped roof was scattered

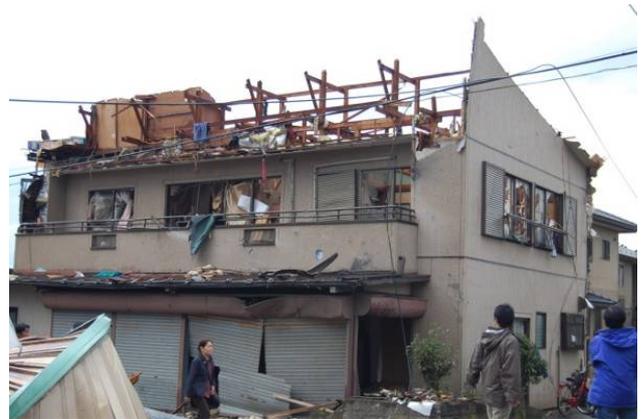
Photo 12 Wood House J whose shed roof was scattered

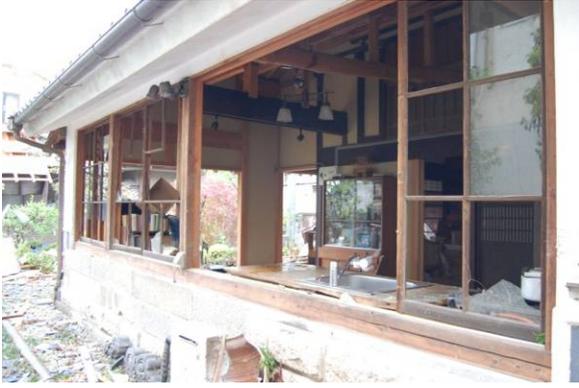
Photo 13 Wooden Building K

The damage from out-of-plane wind pressure (Photos 13 and 14) caused failure of whole openings of outside in many cases, while partial damage of openings was seen in the case of collision of flying debris.

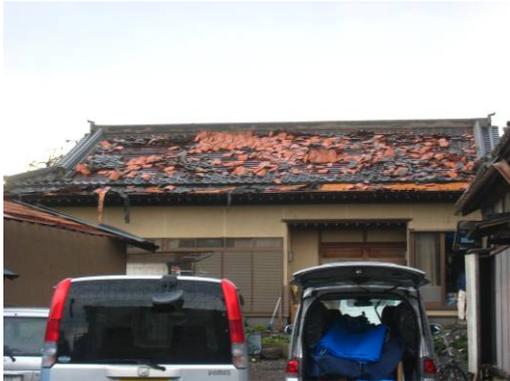
Photo 15 Wooden Building M

Substantial damage to roofing materials was observed (Photo 15). In addition, metal roofing materials were confirmed to have been scattered to considerable distances.

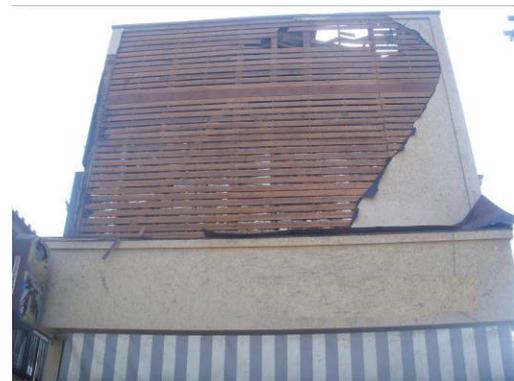
Photo 16 Wooden Building N

On the other hand, falling down of exterior materials was observed in exterior walls with mortar. In some cases, the wood laths of mortar wall were confirmed to be deteriorated. It is claimed that the mortared exterior walls will not collapse except the cases of structural shear deformation or out-of-plane forces, this cited failure is not determined to occur because of the reason of them.

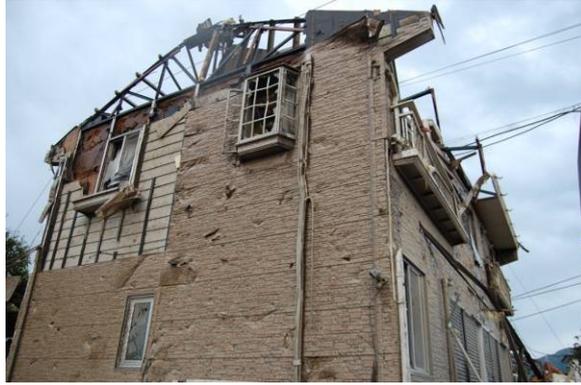
Photo17 Steel Framed Building A

The collapse and scattering of roof trusses with damage of exterior materials and windows were observed in a light-gauge steel framed house.

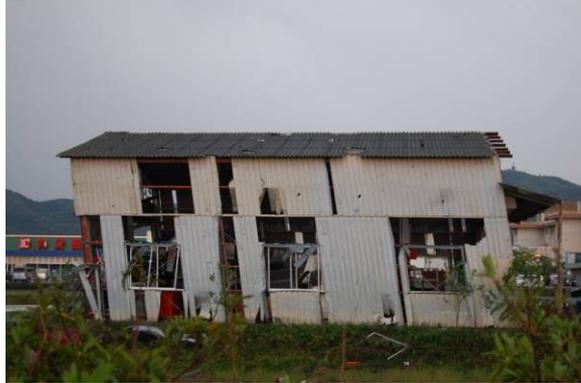
Photo 18 Steel Framed Building B

Residual deformation of structural frame was observed in a warehouse building.

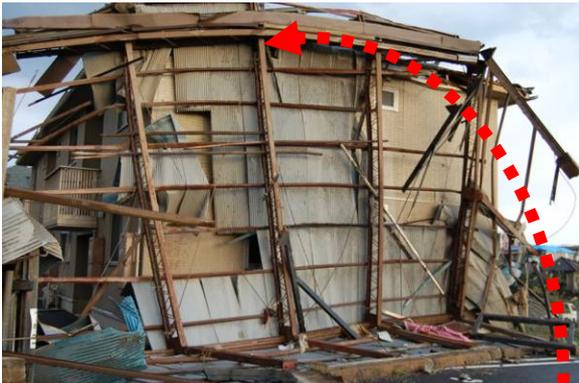
Photo 19 Steel Framed Building C

A steel framed building used as a garage fell down and turned sideways.

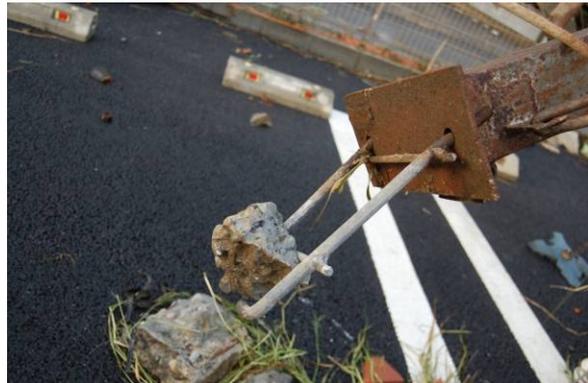
Photo 20 Pull out of column base shown in Photo 19

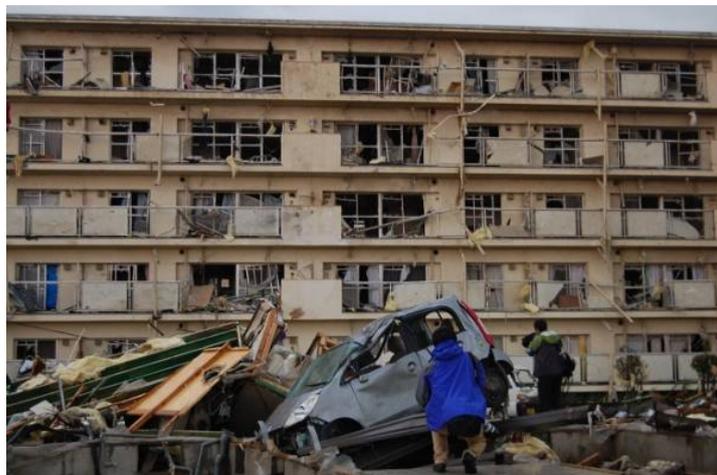
Window glass, frames, handrails of verandah etc. of a five-story multifamily housing were

significantly damaged on the south side. Similar damage was observed on the north side although the openings were small.

Photo 21 South side of a public multifamily housing

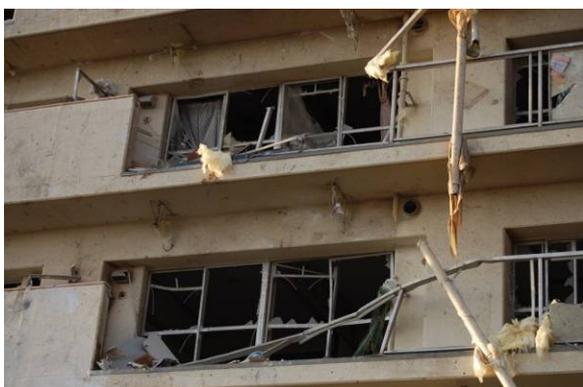
Photo 22 Windows and handrails 1

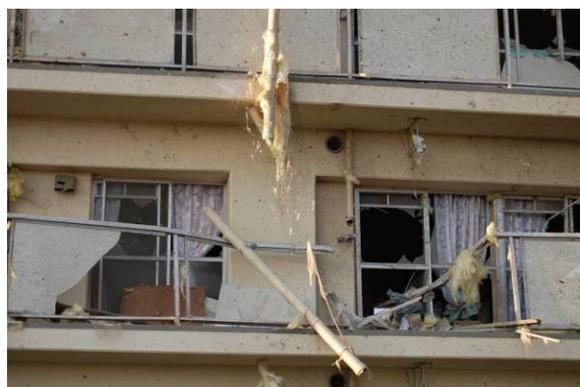
Photo 23 Windows and handrails 2

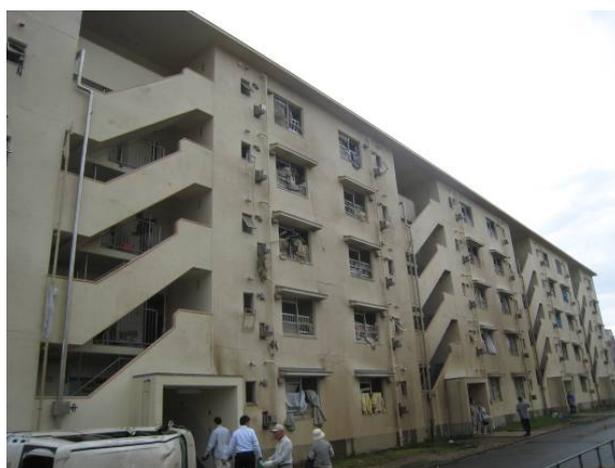
Photo 24 North side of a public multifamily housing

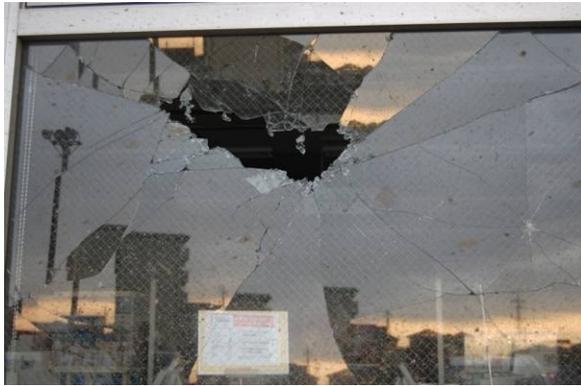
Photos 25 and 26 show traces of collision at an entrance of a shopping center, Photos 27 and 28 show the collision of flying roof/roofing materials and Photo 29 shows a flying roofing material hung at electric cables.

Photo 25 Evidence of collision to window

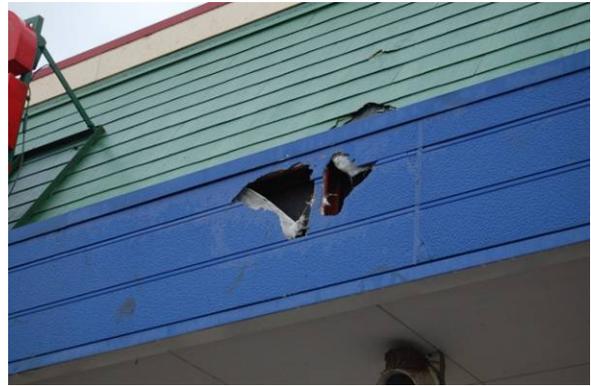
Photo 26 Evidence of collision to exterior material

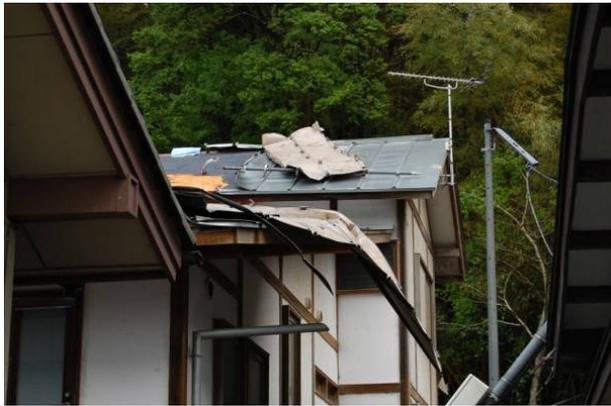
Photo 27 Scattered long steel roofing materials

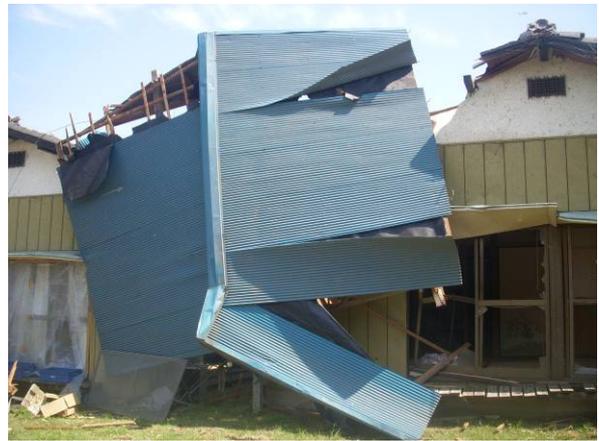
Photo 28 Collision of flying roof frame

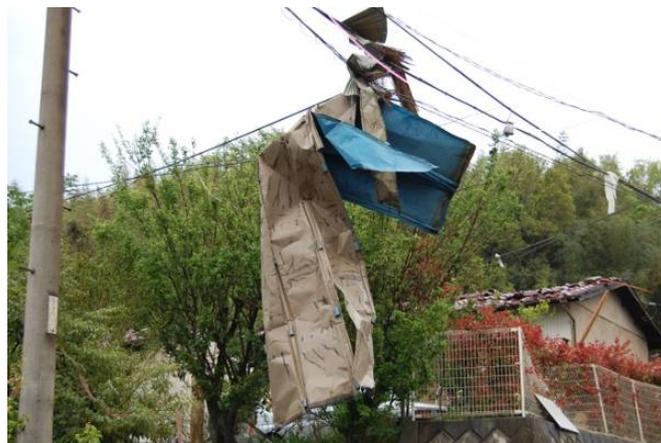
Photo 29 Roofing materials hung at electric cables

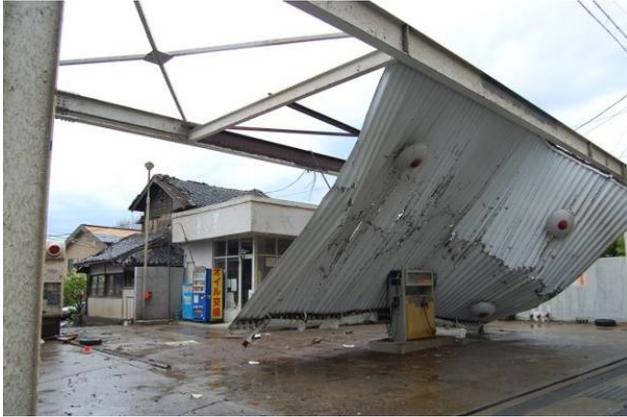
The followings are of additional cases to the previously introduced ones within sections 4.4. Photos 30 and 31 show collapse of a roof at gas station and heavy deformation of roofing materials at a bicycle station, Photo 32 shows collapsed stone fence, Photos 33 and 34 show broken electricity poles, Photo 35 indicates broken trees and Photos 36 and 37 indicate rolling cars etc. Photo 33 shows continuous broken electricity poles or inclined ones while Photo 34 shows the situation of broken electricity pole affecting a neighboring house. Turnover of not only light vehicles but also heavier vehicles and a truck was observed. (Photo 37)

Photo 30 Collapse of a gas station roof

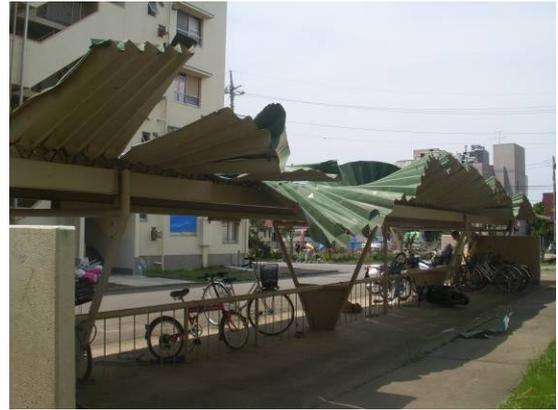
Photo 31 Heavy deformation of roof of a bicycle park

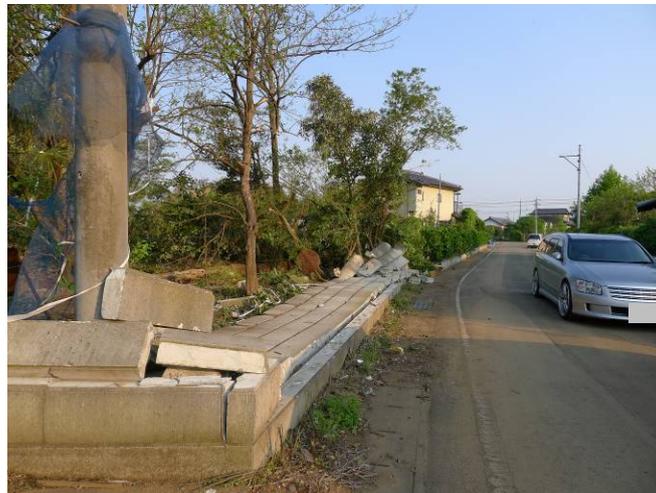
Photo 32 Collapse of stone fence

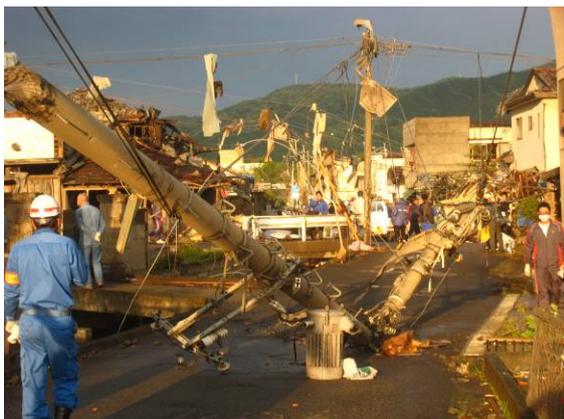
Photo 33 Broken / inclined electricity poles 1

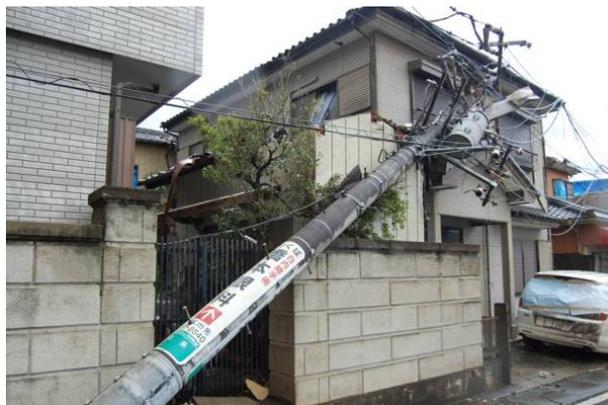
Photo 34 Broken / inclined electricity poles 2

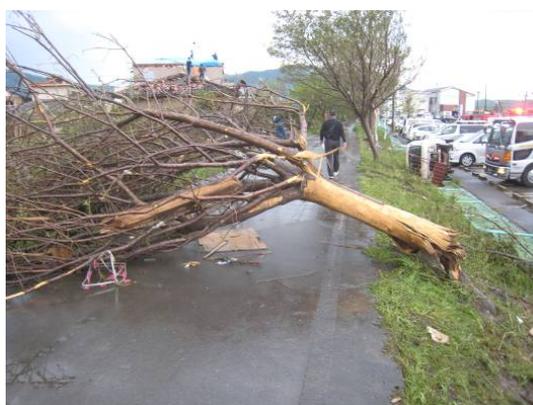
Photo 35 Broken tree

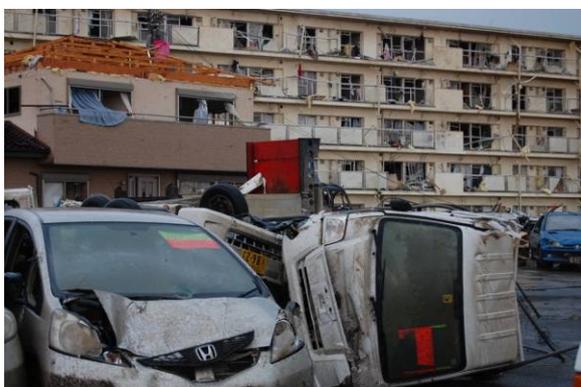
Photo 36 Overturned cars

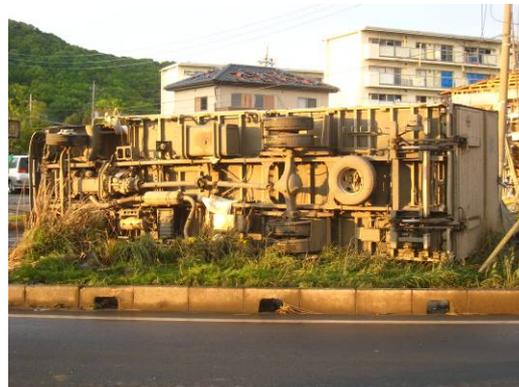
Photo 37 Rolling truck

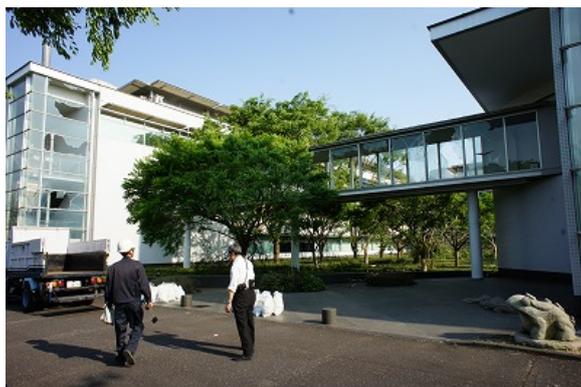
Window breakages were observed at exteriors and within roofed passages of reinforced concrete

or steel framed buildings.

Photo 38 Broken window of a roofed passage

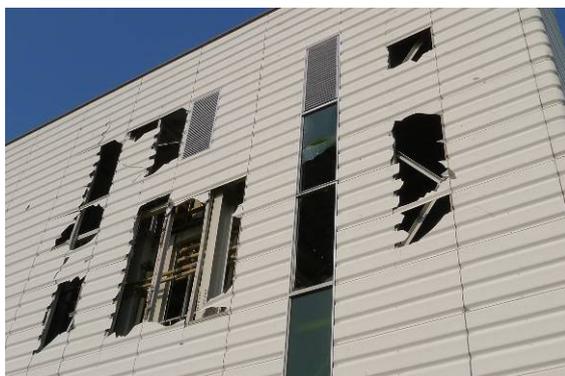
Damage to exterior materials and eave soffits was confirmed in steel framed buildings.

Photo 39 Breakage of exterior and windows

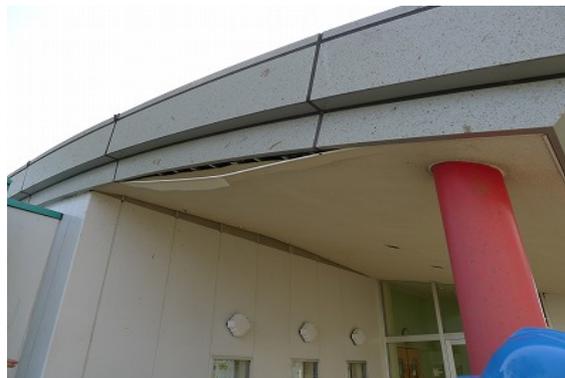
Photo 40 Breakage of eave soffits

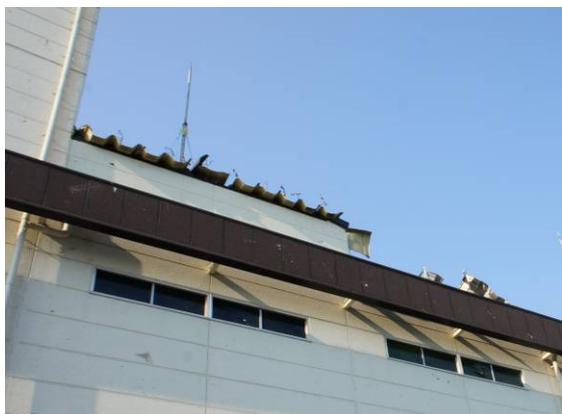
Damage to roofing materials of steel framed buildings was confirmed. Some roofing materials were scattered far to the next factory on the other side of the street more than several dozen meters.

Photo 41 Damage of roofing materials

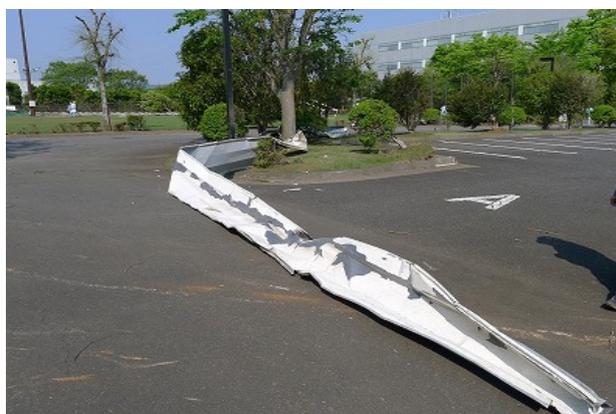
Photo 42 Scattered roofing materials

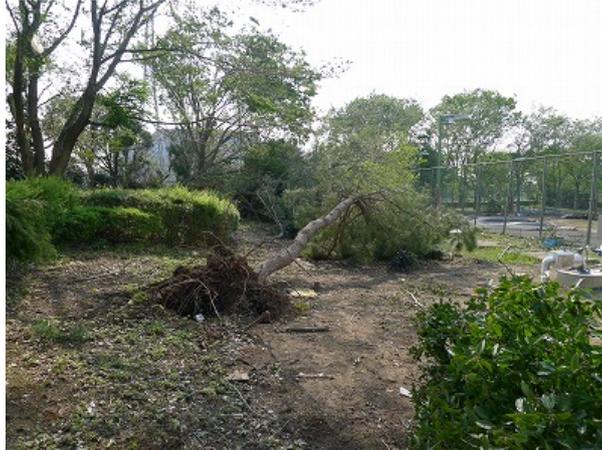
Some cases of broken trees and fallen trees pulled up by the roots were confirmed.

Photo 43 Fallen tree that was pulled up by the root
