Building damage by the 2011 off the Pacific coast of Tohoku earthquake and coping activities by NILIM and BRI collaborated with the administration

Isao Nishiyama¹, Izuru Okawa², Hiroshi Fukuyama³ and Yasuo Okuda³

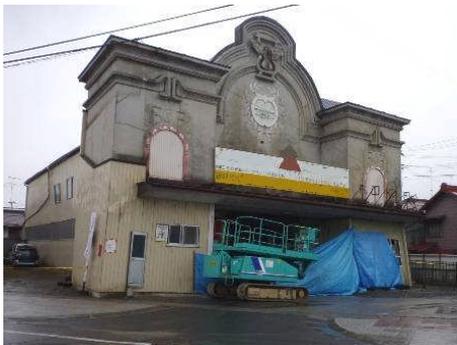
Great residual deformation was observed in the longitudinal direction in the large-scale wood building used to be a movie theater then renovated to a factory (Photo 3.3)

Photo 3.3 Large-scale Wood Building renovated to a Factory

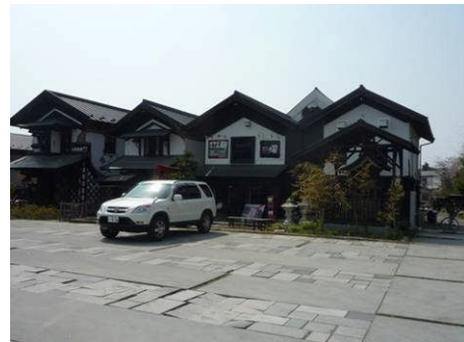
Photo 3.4 Warehouse with Mud Walls damaged Heavily or Slightly

Every warehouse with the mud walls renovated as store or gallery (Photo 3.4) were damaged heavily or slightly. There was the one whose roof system with roof tiles collapsed and fell down, as shown in Photo 3.5. There was the house for combined residential and commercial use (=store

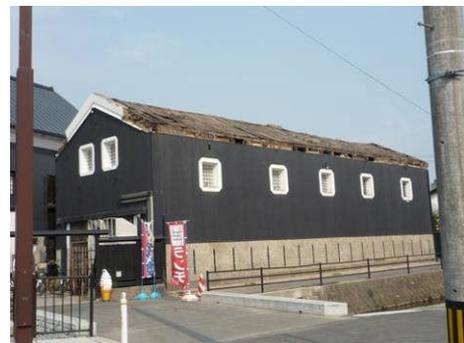
Photo 3.5 Warehouse with Mud Walls whose Roof System with Roof Tiles fell down

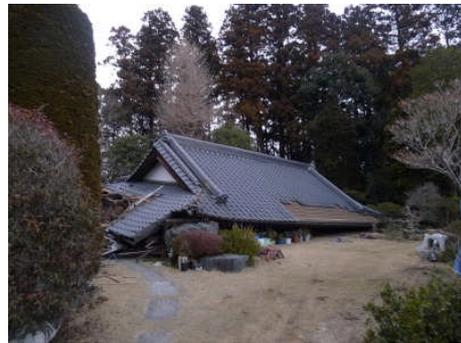
There were a lot of damaged fence made by the Ohyaishi stone. The collapsed farm type house was observed (Photos 3.16, 3.17).

Photo 3.16 Collapsed Wood House

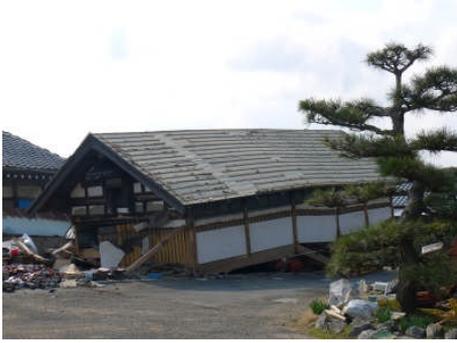
There were a lot of collapsed (Photo 3.18) or heavily damaged barns. The damaged house with shop was observed (Photo 3.19). The two story wood house with mortar finish collapsed at the urban area (Photo 3.20).

Photo 3.18 Collapsed Barn

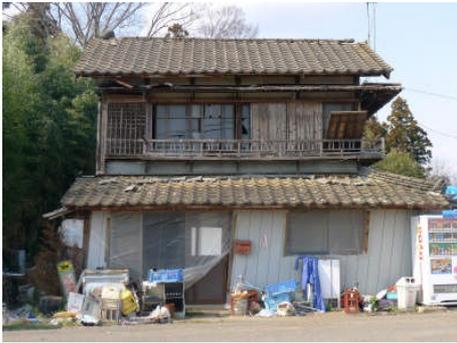
Photo 3.19 Damaged House with Shop

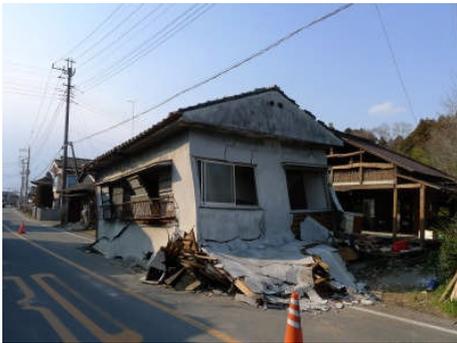
Photo 3.20 Collapsed House

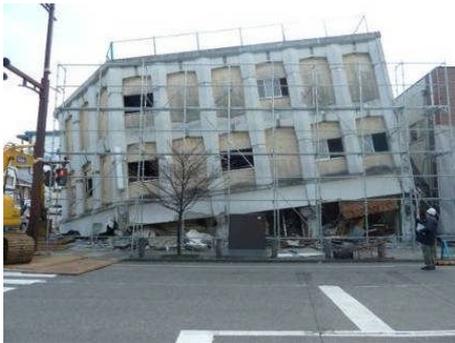
The 3-story RC building which was at the intersection in Sukagawa City, having a few walls on the facade on the first story and many walls on the back of the first story and the second story and higher, was severely damaged on the first story. The corner columns faced the intersection were significantly destroyed. The loss of axial load carrying capacity of the first-story columns caused the drop of the second and higher stories (Photos 3.21 and 3.22).

Photo 3.21 First-story Collapsed Building

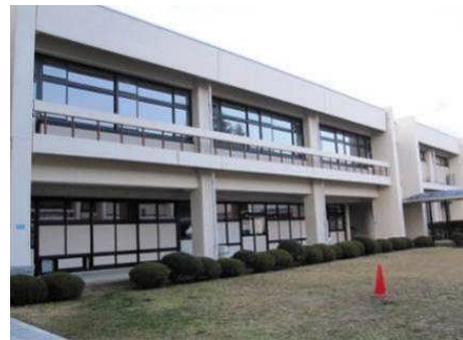
The shear failure occurred on the first-story columns in the two-story RC building in Aoba Ward, Sendai City (Photos 3.24 and 3.25). Some columns of the building were intact after the main shock on March 11, but aftershocks caused shear failure to some of them, as shown on the right of Photo 3.25. It was confirmed that the aftershocks accelerated the damage level of this building.

Photo 3.24 Appearance of Damaged Building

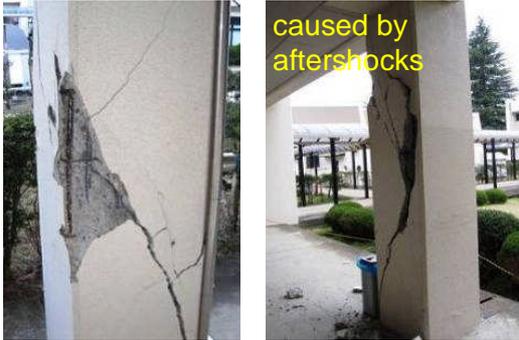
Photo 3.25 Shear Cracks on First-story Columns

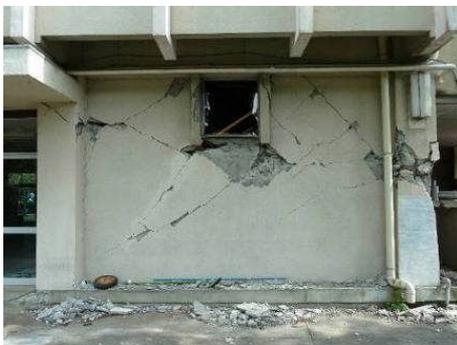
Photo 3.27 Shear Failure of Wall with Opening

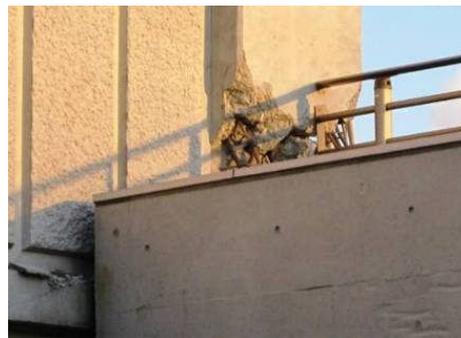
Photo 3.29 Crushing at the Bottom of Column on the Multi-story Shear Wall

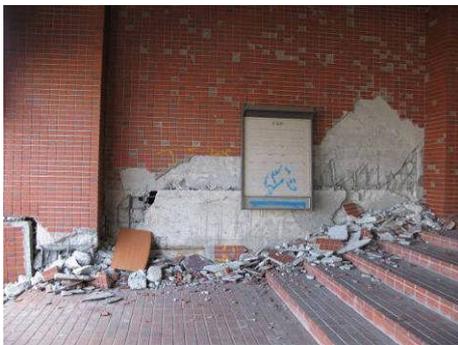
This type of damage was observed not only in buildings designed under the previous seismic design code but also in some buildings done under the current seismic design code.

Photo 3.30 Damage on the Bottom of SRC Column and Shear Wall

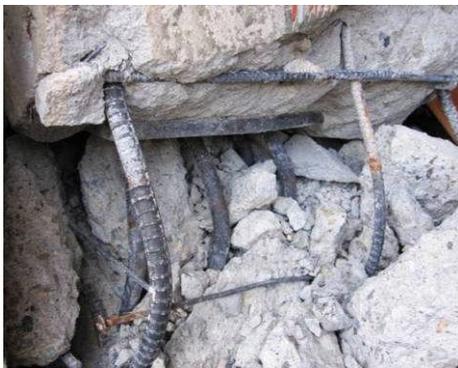
Photo 3.31 Close-up View of the Bottom of SRC Column

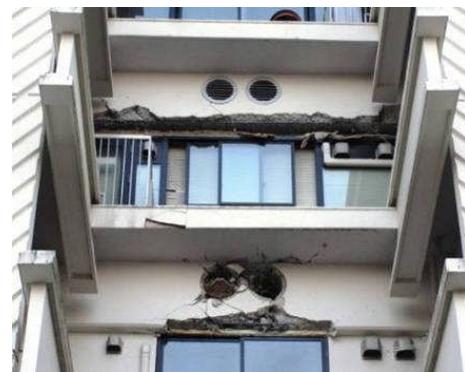
Photo 3.33 Damage on Boundary Beam with Opening

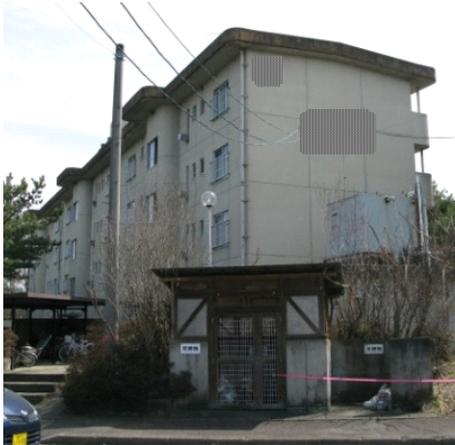
Photo 3.34 shows a residential building that sank and leaned in the longitudinal direction in Shirakawa City. The balcony, of which height above ground level was about 77cm, went down to ground surface in the gable side, as shown in Photo 3.35. Significant settlement was observed too on foot walk in surrounding area.

Photo 3.34 Appearance of Sank and Leaned Building

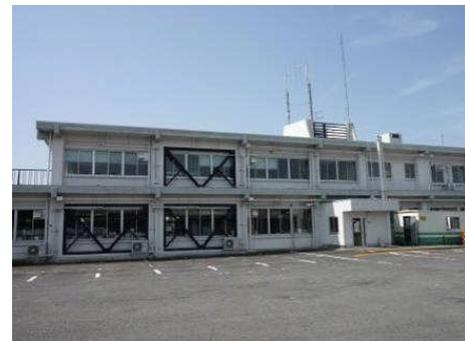
Photo 3.37 Appearance of Damaged Building

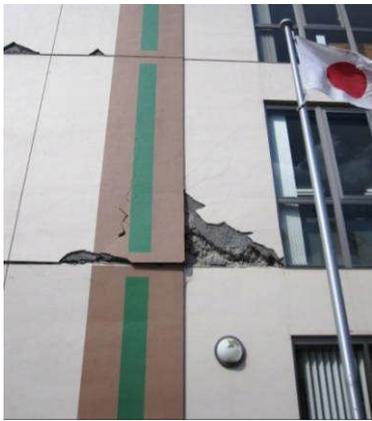
The separation of cover concrete at the bottom of wing wall was observed on the 5-story RC building constructed in 2007 in Sukagawa City (Photo 3.39). In here, we classified this as the damage of nonstructural elements, because the wing wall is generally designed as the nonstructural element, which is not expected to resist the external force.

Photo 3.39 Separation of Concrete of Wing Wall

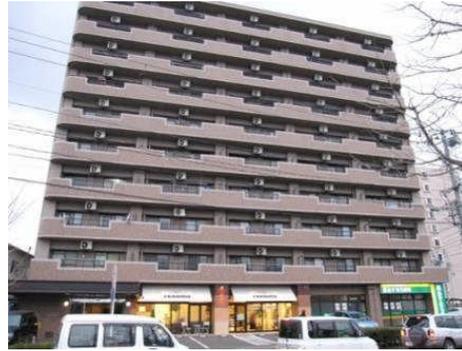
The cases where shear cracks occurred on the nonstructural walls around the front door or on the mullion wall on the balcony were relatively often observed in urban residential buildings, regardless of the seismic design codes applied to.

Photo 3.40 Appearance of Damaged Building

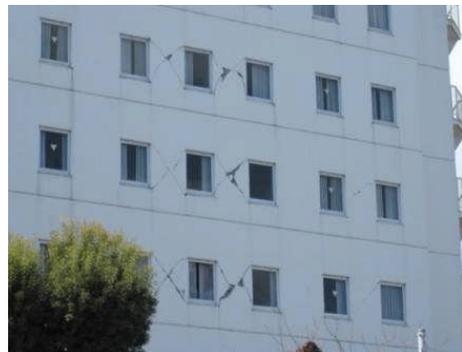
Photo 3.42 Shear Crack on Nonstructural Wall

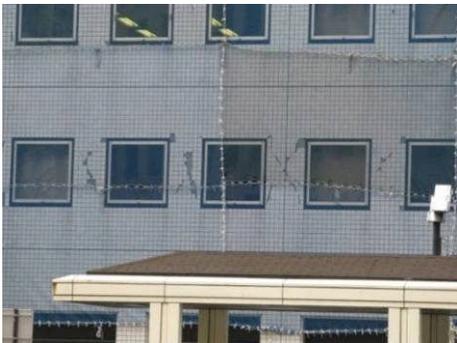
Photo 3.44 Damage of Tile on Exterior Wall

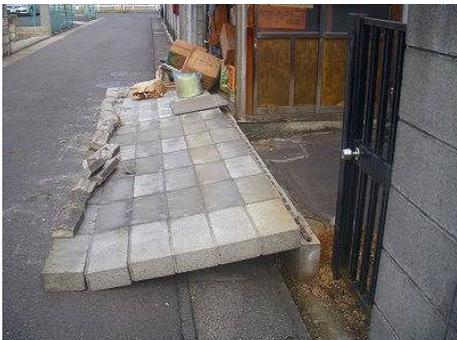
The collapse of concrete block wall and stone masonry wall are well known as earthquake damage caused by strong seismic motion. The damage of those was often observed in the field investigation, as shown in Photos 3.45 and 3.46.

Photo 3.45 Collapse of Concrete Block Wall

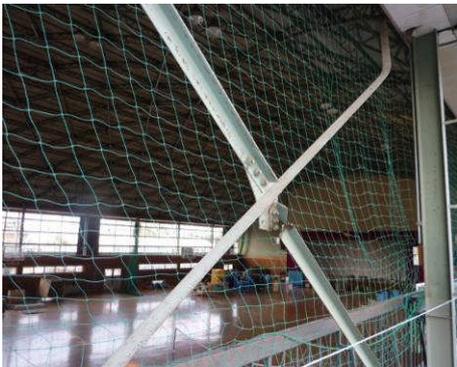
Buckling of brace member (Photo 3.47) and fracture of brace joint (Photos 3.48-3.50) were observed. Angle section was often used for many brace members, but circular hollow section steel (Photo 3.49) was also used for brace members. Fractured sections include steel plate inserted into steel pipe, end of bracing member and section loss part by bolt hole. These types of the damage are classified into the severe damage category based on the damage evaluation standard [3.7]. The gymnasiums constructed under the previous seismic code that were severely damaged by the Mid Niigata Prefecture earthquake in 2004 had accounted for about 30% of the total [3.4, 3.5, 3.6]. It is impressed that a rate of the gymnasiums severely damaged by the Tohoku earthquake was lower than by the Mid Niigata Prefecture earthquake in 2004.

Photo 3.47 Buckling of Brace

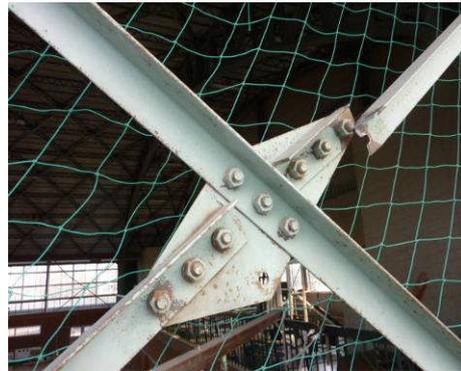
Photo 3.48 Net Section Fracture at Bolt Hole

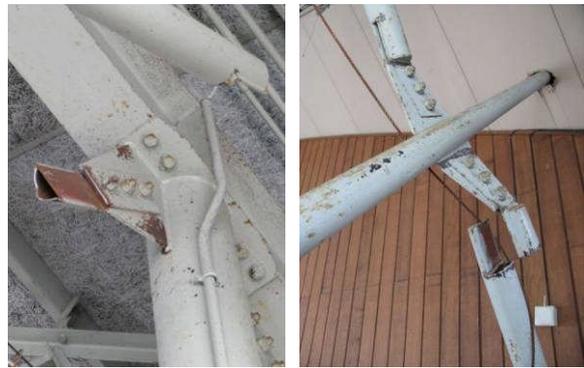
a) Fracture at column top b) Fracture at brace crossing
Photo 3.49 Fracture of Brace Welded Connection

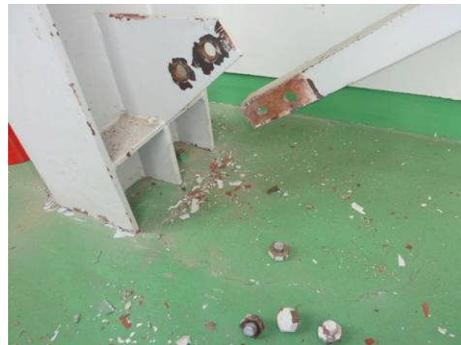
Photo 3.50 Fracture of Bolts

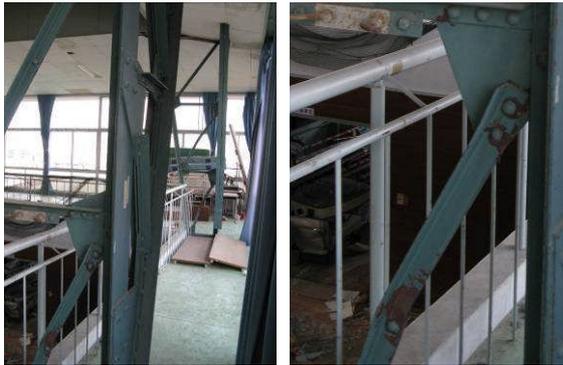
In one of the investigated gymnasiums, buckling of diagonal members in some latticed columns was observed (Photo 3.51). Damage of column buckling caused in steel frames for span direction had not been observed under the damage investigations of the Mid Niigata Prefecture earthquake in 2004 [3.4, 3.5, 3.6].

a) Latted column b) Buckling of diagonal member
 Photo 3.51 Buckling of Diagonal Member of Latted Column

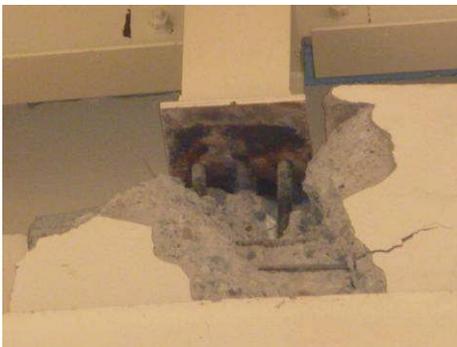
In the investigated gymnasiums, exposure of anchor bolts due to spalling of the concrete at connection (bearing support part) between the RC column and steel roof frame (Photo 3.52), spalling of finish mortars on the RC column at the roof bearing support part, pullout of hole-in anchors were observed. This type of the damage was observed in some gymnasiums in this damage investigation.

Photo 3.52 Spalling of Concrete

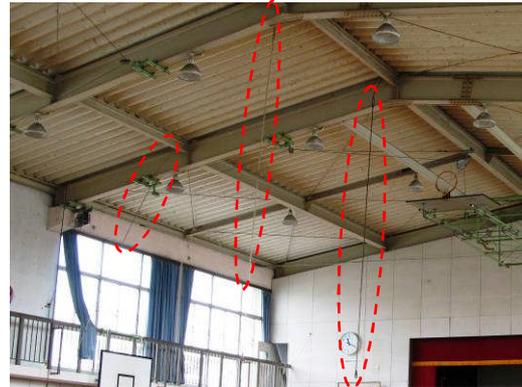
Roof horizontal braces were damaged in 2 high school gymnasiums and 5 elementary and junior high school gymnasiums. Such damage mainly occurred at horizontal braces with turnbuckles; obvious deflection of the horizontal brace, fracture at thread and fracture of bolt connections were observed (Photo 3.53).

Photo 3.53 Fracture of Horizontal Brace

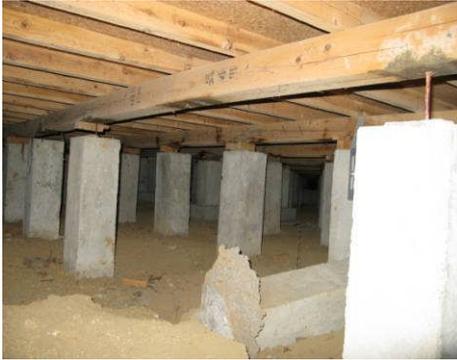
As the other types of the structural damage, the following damage was observed; (a) overturning of floor strut (Photo 3.55), (b) tilting of concrete block self-standing wall and (c) peeling of paints of beam member which was observed near the top of the V-shaped roof beam or arch beam (Photo 3.56). In terms of the peeling of paints, it is undetermined whether a yielding occurred to the beam member or not.

Photo 3.55 Overturning of Floor Strut

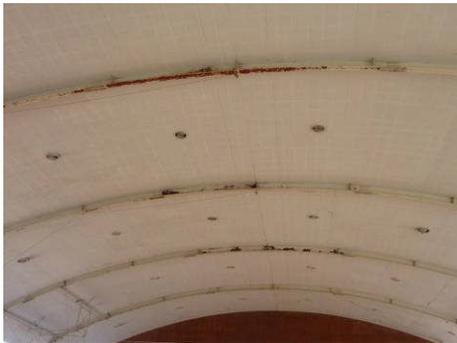
Photo 3.56 Peeling of Paints of Beam

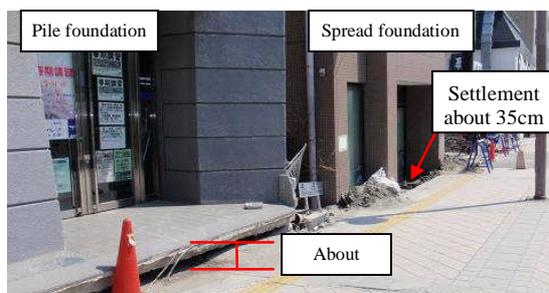
In Irifune, a difference in settlement between adjacent buildings on spread and pile foundations was observed. The building on spread foundation subsided about 35 cm from the front sidewalk, while the building on pile foundation was elevated about 30 cm (Photo 3.66). Other settled and tilted buildings were dotted

Photo 3.66 Difference in Damage between Support Mechanisms

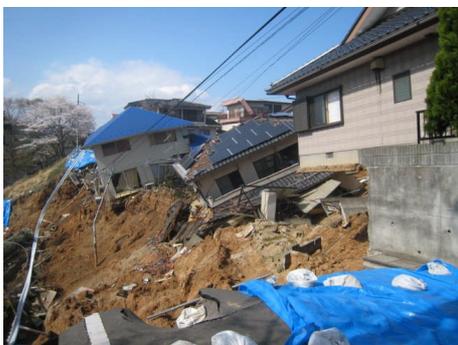
This area is located at one corner of a large-scale housing area where a hill was developed. The result of visual inspection showed ground transformation by land sliding on the slope of the hill. This ground transformation caused serious damage to houses. In the result, some houses were in a state of sliding on the slope of the hill (Photo 3.69). On the other hand, houses near the top of the hill suffered only damage associated with slight transformation of housing area embankment.

Photo 3.69 Land Sliding on Slope on the Southwest of the Hill and Sliding House

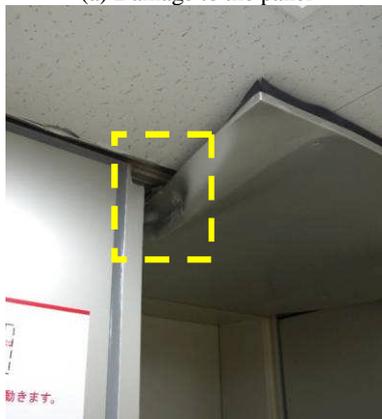
(b) Damage to the expansion joint

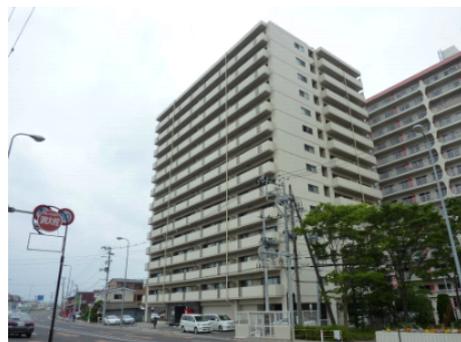
- a) According to the person in charge of the building, no furniture was turned over and no structural damage was observed inside of rooms. However, the damage to the expansion joint was observed.
- b) Drop of the ceramic tiles on outer wall (Photo 3.73) and shear crack on the wall in the first floor parking space (Photo 3.74) were observed. The subsidence of ground around 10 cm was observed near the building.
- c) No damage was found to NRBs by visual inspection (Photo 3.75), however, paint of U-shape dampers was peeled off (Photo 3.76) and many cracks were found on Lead dampers (Photo 3.77).

Photo 3.72 Overview of SI building B

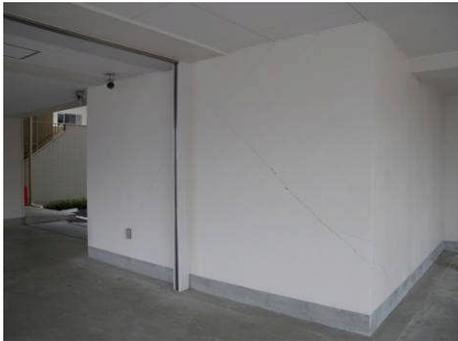
Photo 3.74 Shear Crack on the Wall

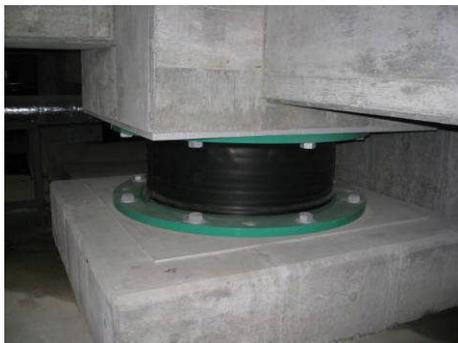
Photo 3.75 NRB

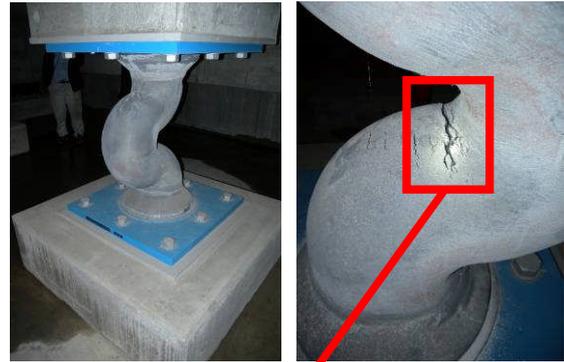
Photo 3.77 Lead Damper and Crack on the Surface

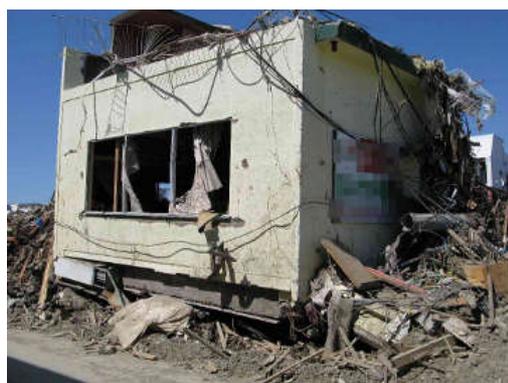
Photo 4.1 Story Collapse of 2-story Reinforced Concrete Building

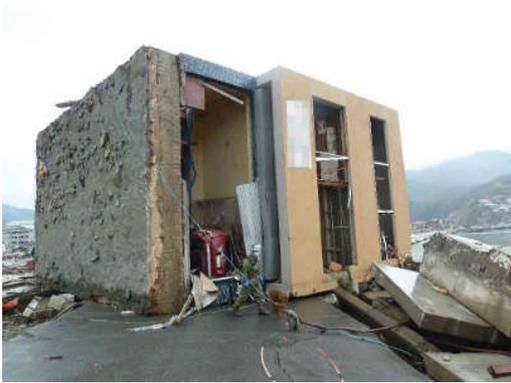
Photo 4.2 Overturning of 3-story Reinforced Concrete Building

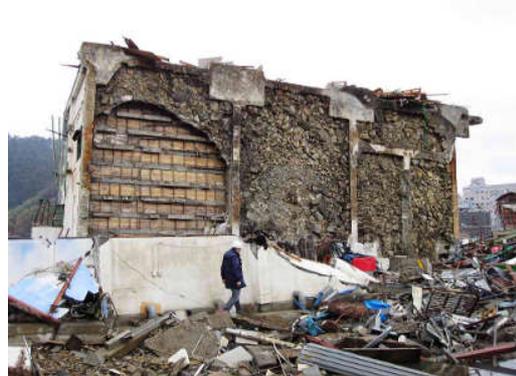
Photo 4.3 2-story Reinforced Concrete Building that Climbed over the Fence and Overturned

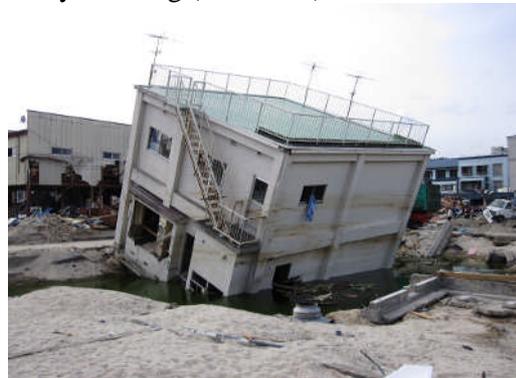
Photo 4.4 2-story Reinforced Concrete Building that was Tilted by Scouring

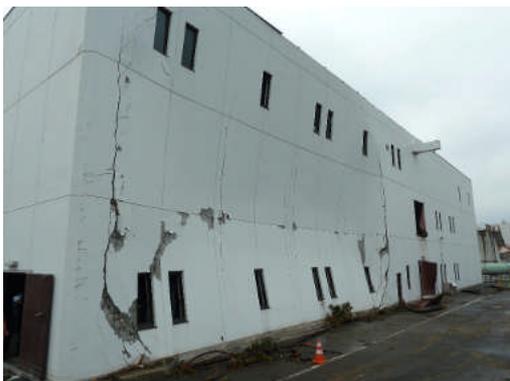
Photo 4.5 Out-of-plane Fracture of Reinforced Concrete Shear Wall without Floor

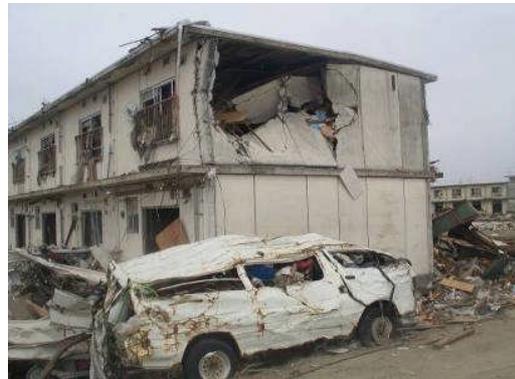
Photo 4.6 Wall Opening Generated by Debris Impact

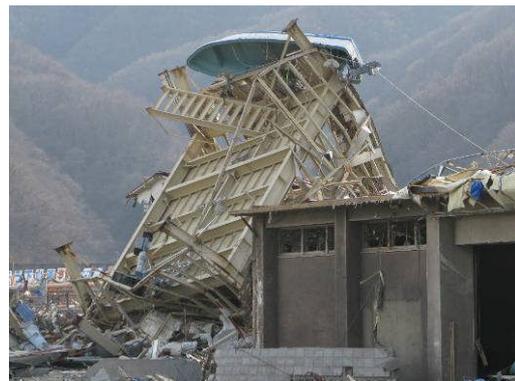
Photo 4.7 Steel Building Overturned by Fracture of Column Base Anchor Bolts

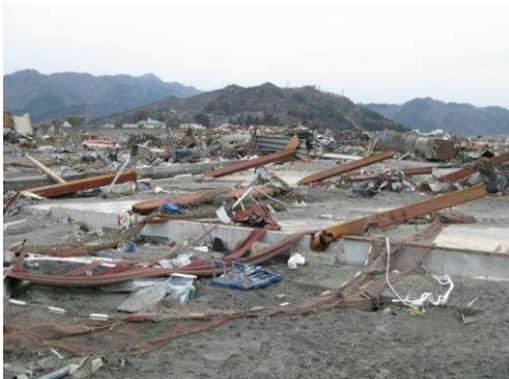
Photo 4.8 First-floor Columns Falling in the Same Direction

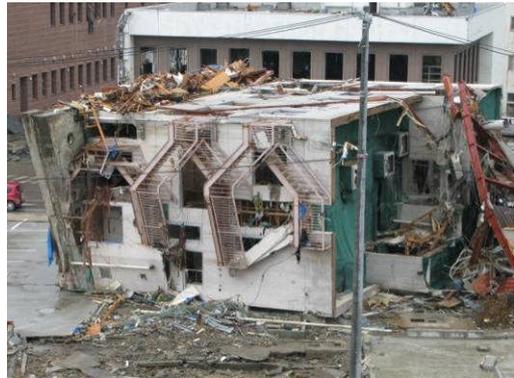
Photo 4.9 Overturning of 3-story Steel Building

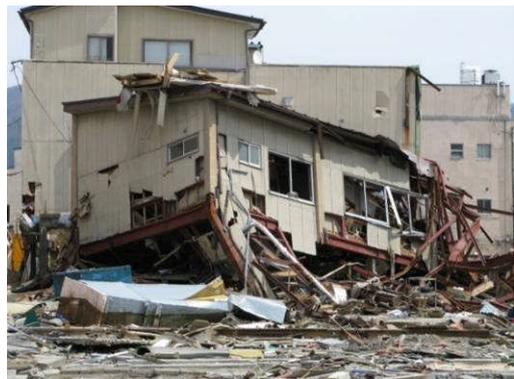
Photo 4.10 Story Collapse of First Floor in 2-story Steel Building

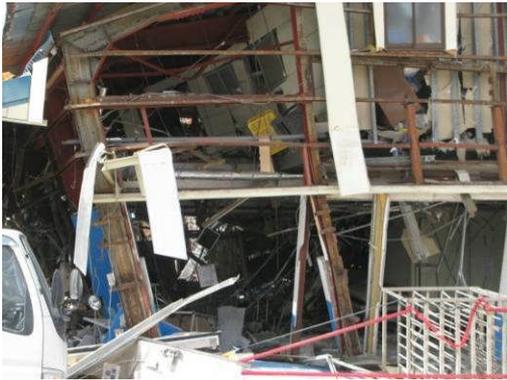
Photo 4.11 Tilted Gabled Roof Frame

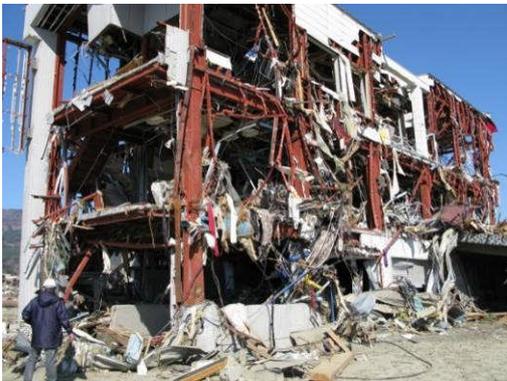
Photo 4.12 Remaining 3-story Steel Building

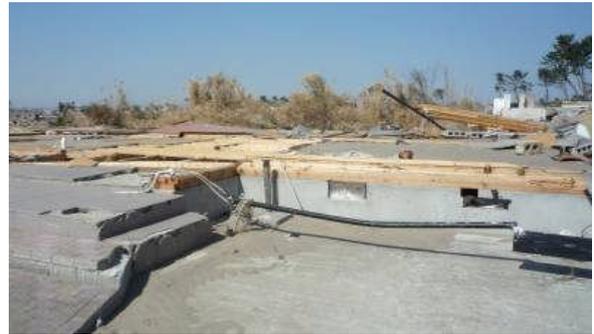
Photo 4.13 Remaining Ground Sill after Washout of Superstructure

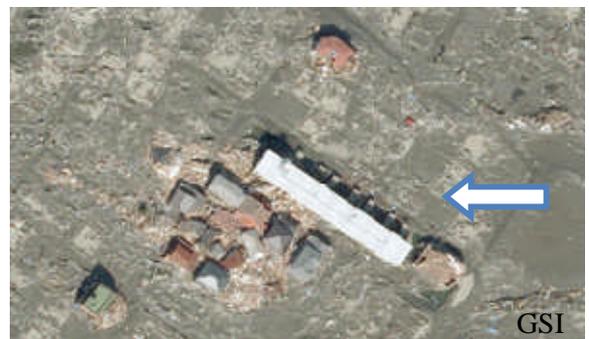
Photo 4.14 Remaining Wood Houses Behind Remaining Building
