*A SURVEY REPORT FOR BUILDING DAMAGES*  
*DUE TO*  
*THE 1995 HYOGO-KEN NANBU EARTHQUAKE*

*March 1996*

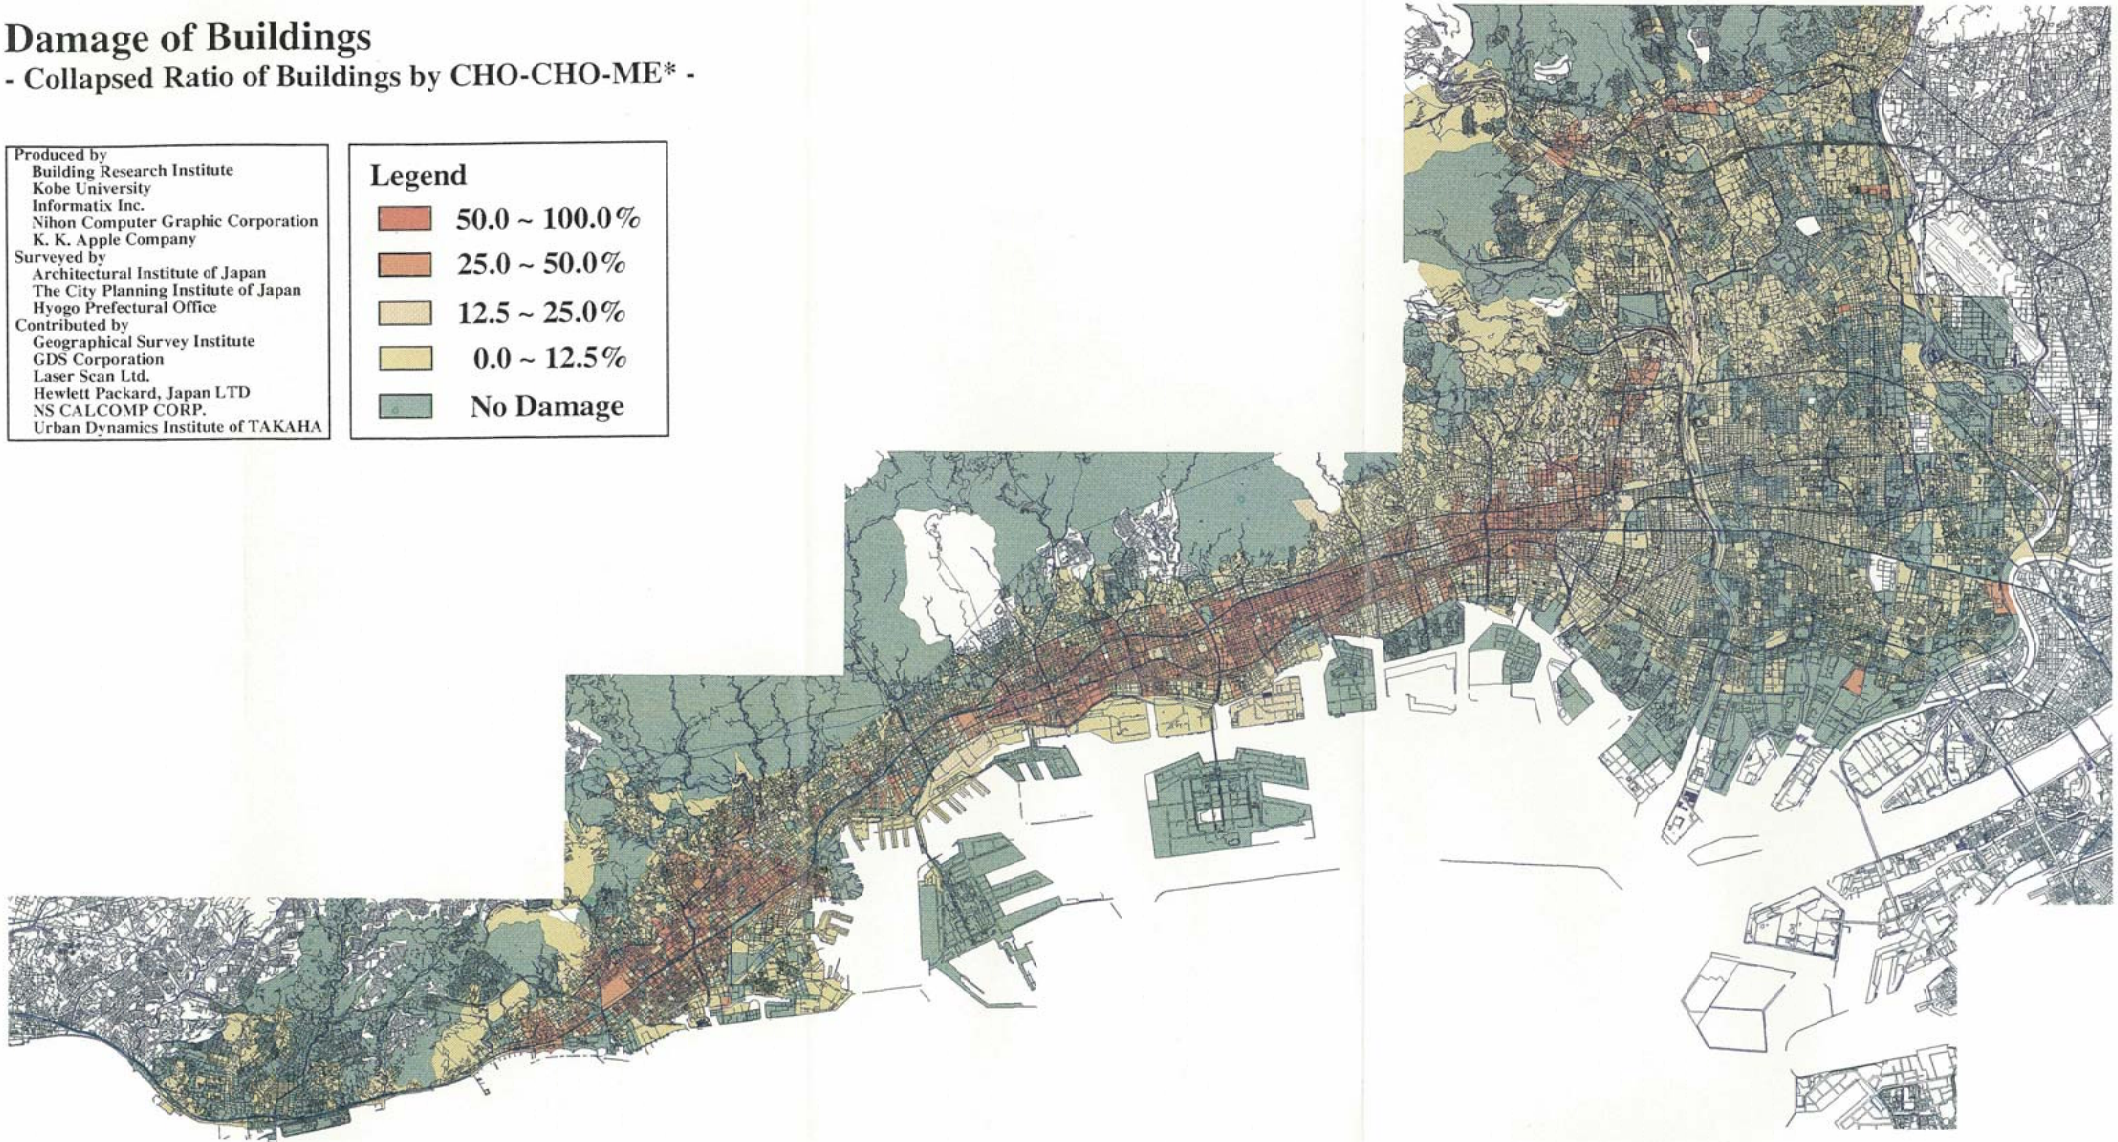
This map indicates collapsed ratio of buildings based on number of buildings, damaged by the 1995 Hyogo-ken Nanbu Earthquake, of each chocho-me (i.e. Japanese addressing system). The building damage information is based on the cooperated survey by Architectural Institute of Japan, City Planning Institute of Japan and Hyogo Prefectural Office. Number of surveyed buildings is about 440 thousands. Building Research Institute made the information into computerized data using Geographical Information System (GIS), and generated some indices regarding building damage ratio of each chocho-me or block by summarizing each building damage in cooperation with Kobe University et al.

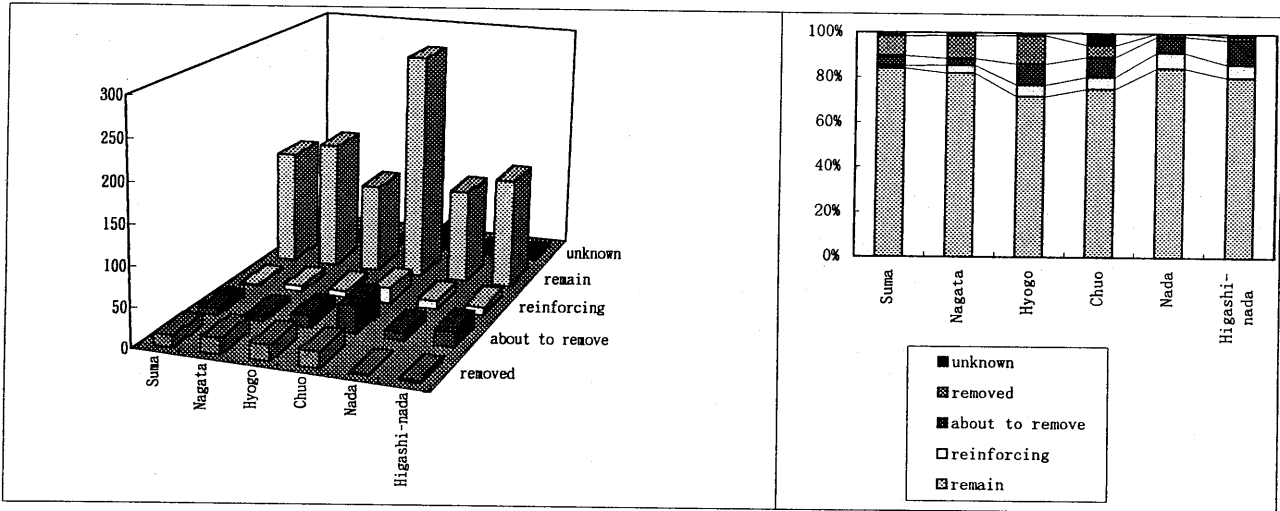
Fig. 2.2.1.1 relationship between address and state of building

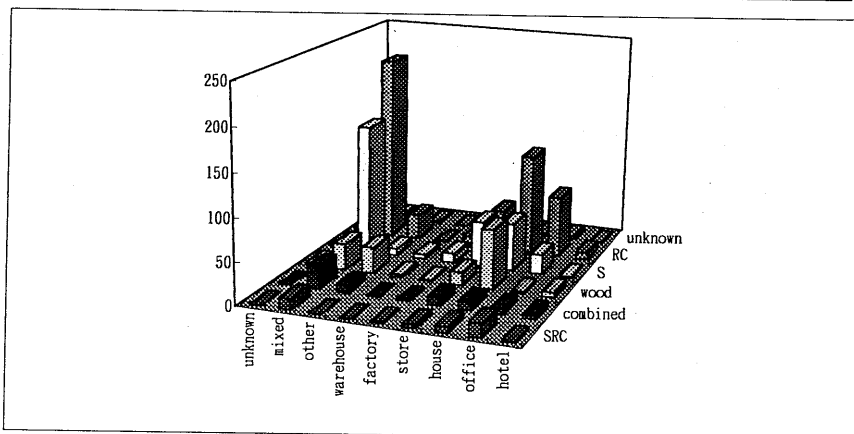
Fig. 2.2.1.2 relationship between usage and structural kind

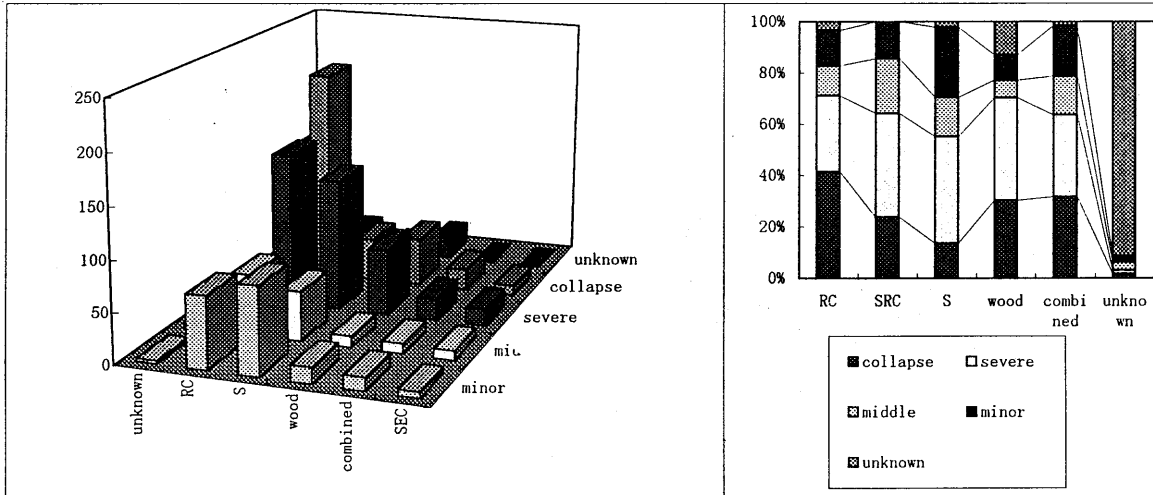
Fig. 2.2.1.3 relationship between structural kind and damage level

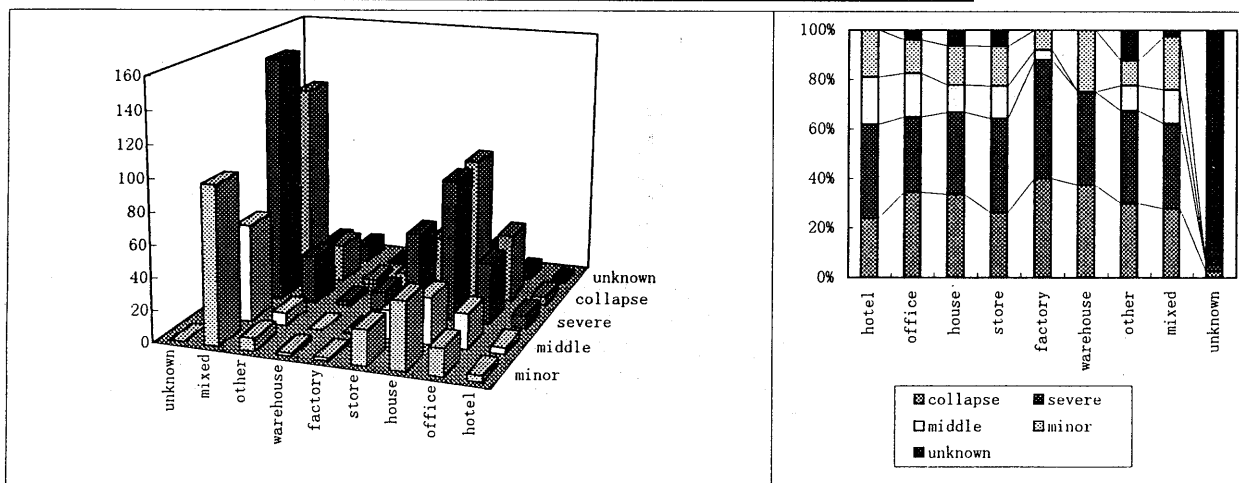
Fig. 2.2.1.4 relationship between structural kind and damage level

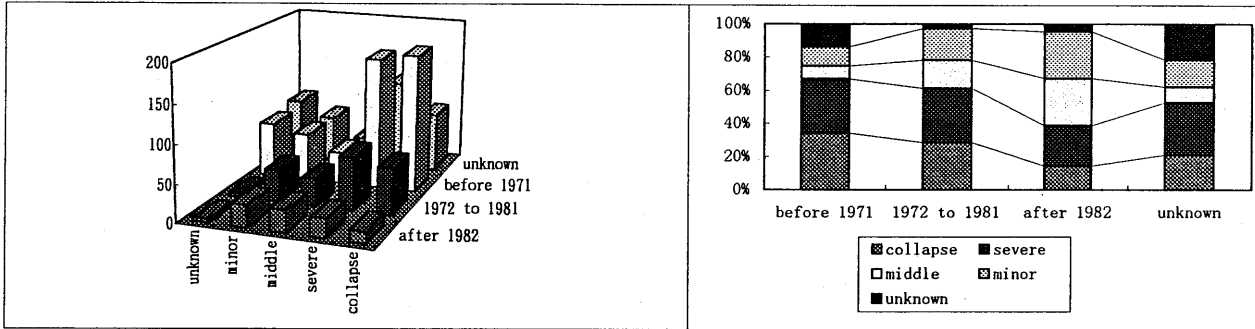
Fig. 2.2.1.5 relationship between damage level and construction year

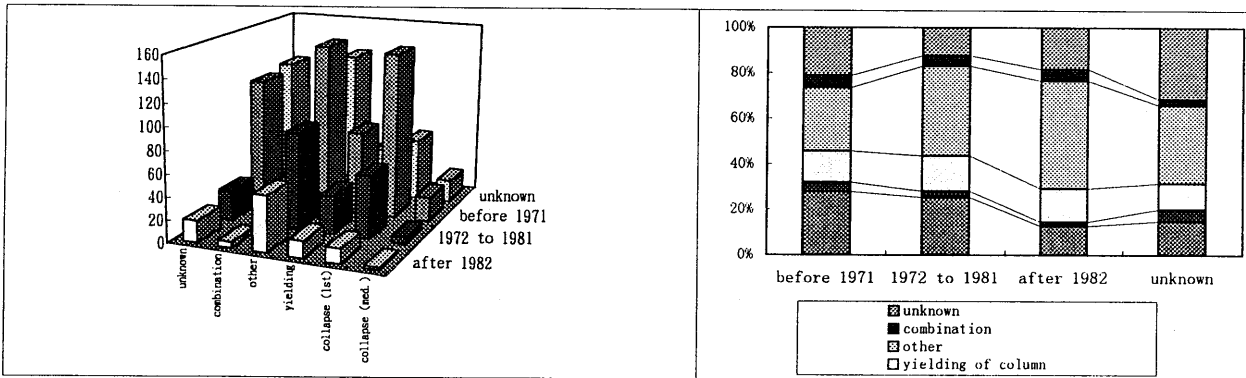
Fig. 2.2.1.6 relationship between structural damage and construction year

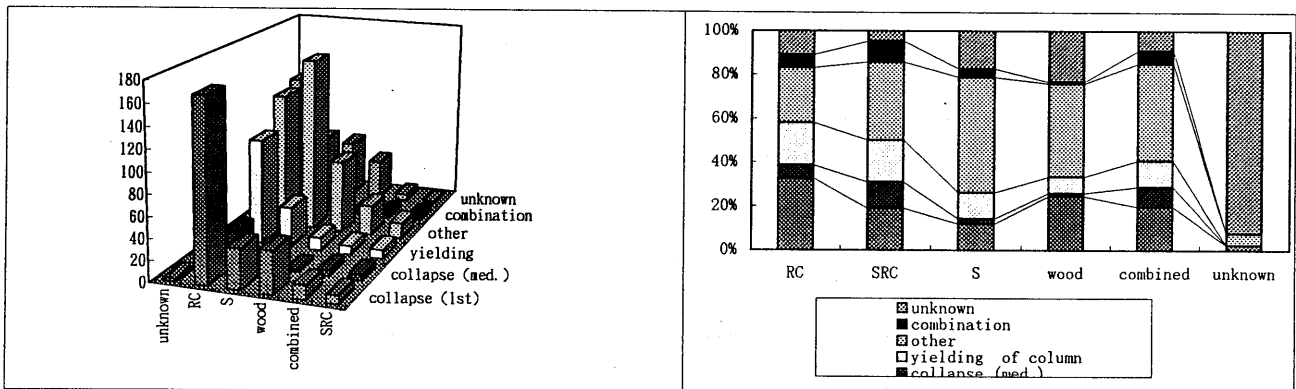
Fig. 2.2.1.7 relationship between structural form and structural damage

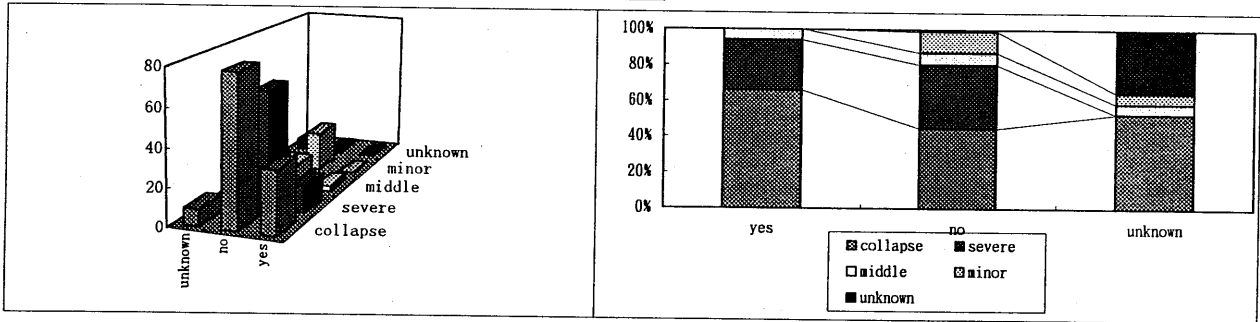
(a) constructed before 1971

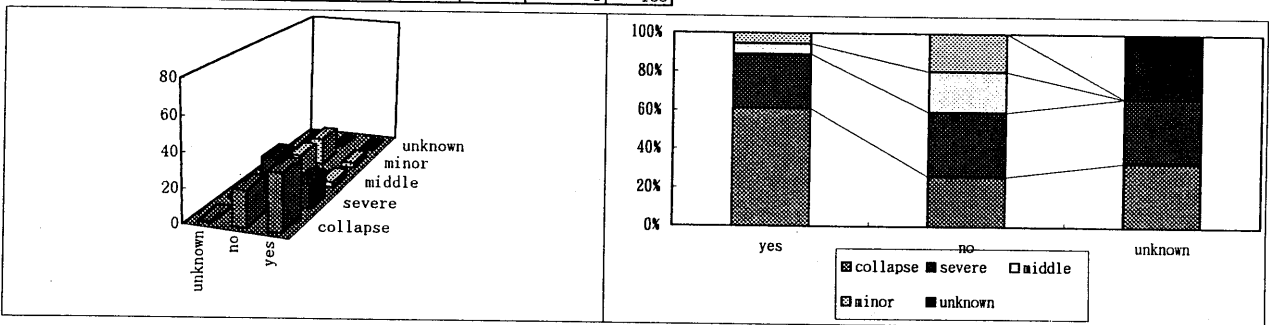
(b) constructed from 1972 to 1981

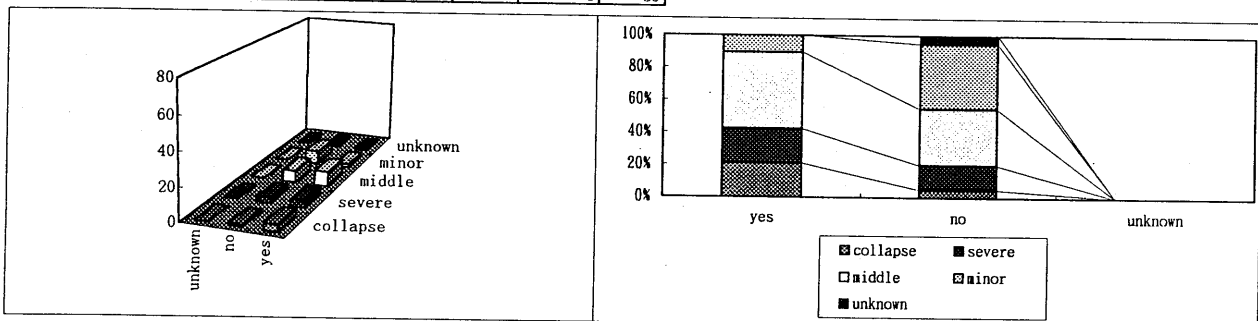
(c) constructed after 1982

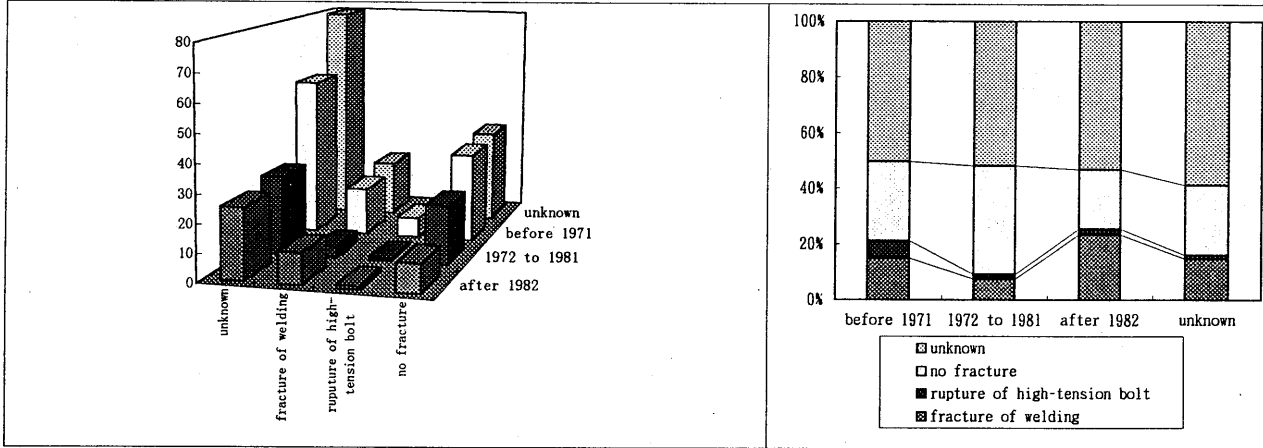
Fig. 2.2.1.9 relationship between damage of joint and construction year (S structure)

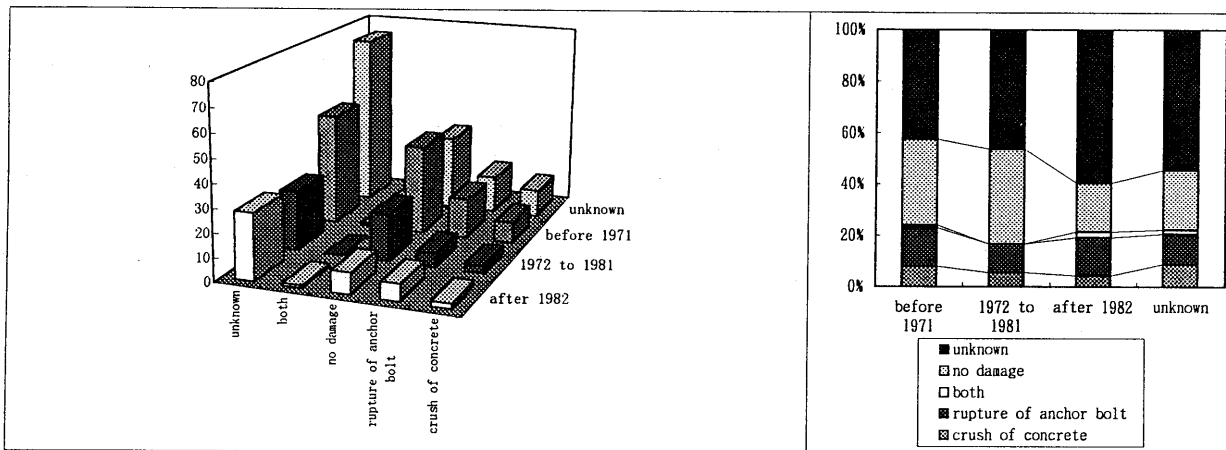
Fig. 2.2.1.10 relationship between damage of column foot and construction year

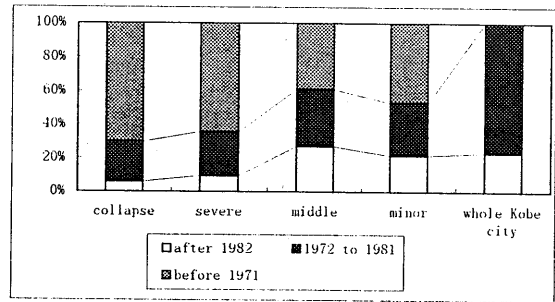
Construction year	Damage level						Total (whole Kobe city)
	collapse	severe	middle	minor	unknown	Total	
before 1971	183	174	42	63	73	535	303000
1972 to 1981	62	71	37	42	6	218	
after 1982	15	25	29	29	5	103	
unknown	79	119	35	61	81	375	
Total	339	389	143	195	165	1231

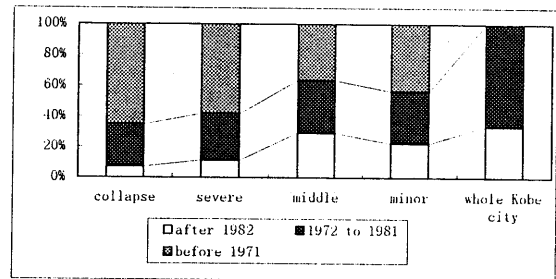
(b) non-wood structure

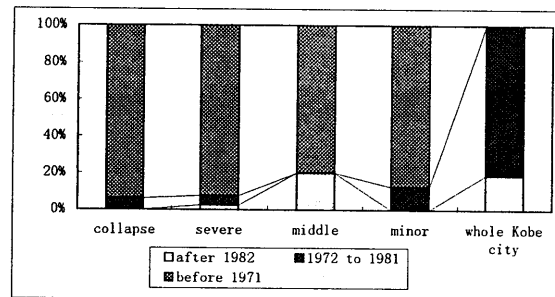
Construction year	Damage level						Total (whole Kobe city)
	collapse	severe	middle	minor	unknown	Total	
before 1971	30	36	4	7	17	94	224000
1972 to 1981	2	2	0	1	1	6	
after 1982	0	1	1	0	1	3	
unknown	17	26	6	8	2	59	
Total	49	65	11	16	21	162

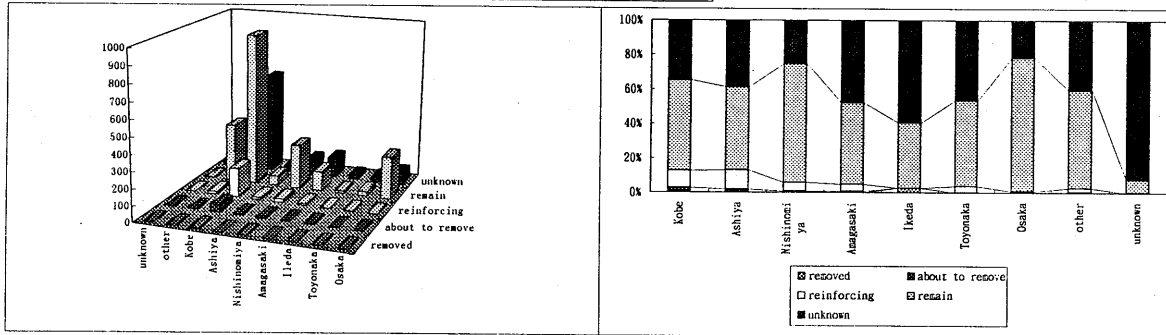
State	Address (city)								Total
	Hyogo pref.				Osaka pref.				
	Kobe	Ashiya	Nishinoi	Awagasaki	Ikeda	Toyonaka	Osaka	other	unknown
removed	5	0	0	0	1	0	0	0	0
about to remove	43	2	3	2	0	0	0	1	0
reinforcing	175	13	20	10	0	2	3	15	0
remain	936	56	270	119	14	27	260	357	1
unknown	616	45	98	121	22	25	72	256	12
Total	1775	116	391	252	37	54	335	629	13

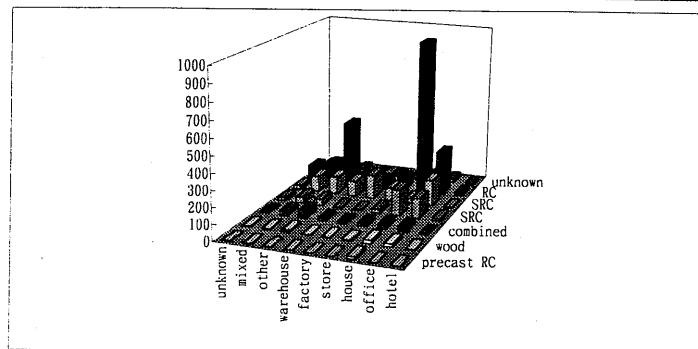
Fig. 2.2.2.2 relationship between usage and structural kind

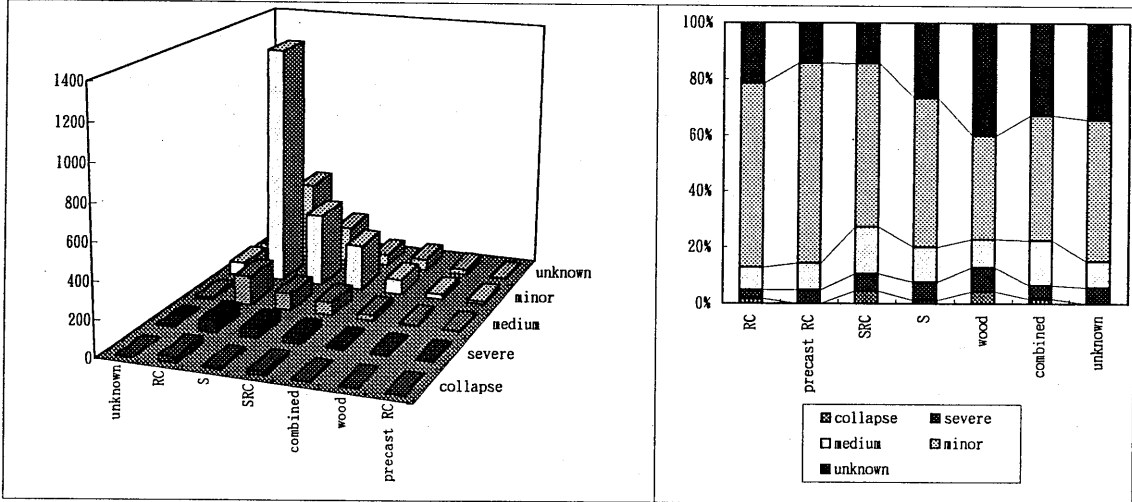
Fig. 2.2.2.3 relationship between damage level and structural kind

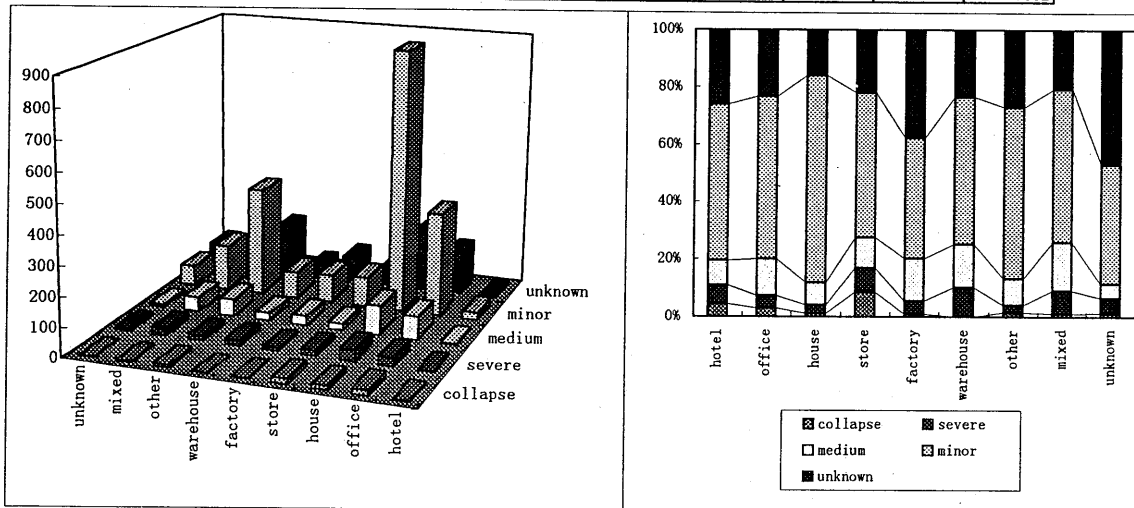
Fig. 2.2.2.4 relationship between damage level and usage

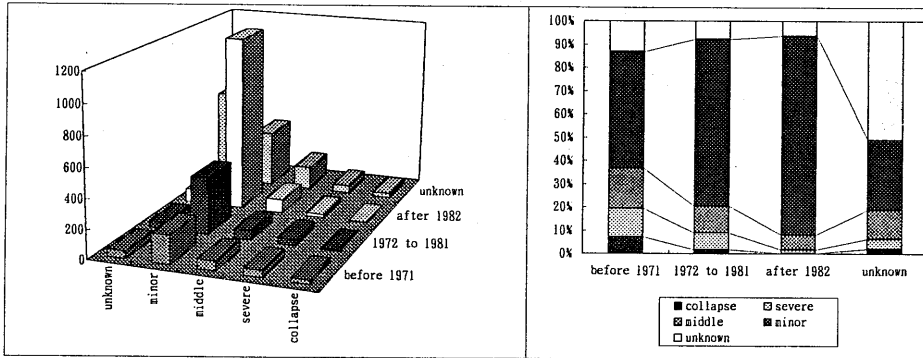
Fig. 2.2.2.5 relationship between damage level and construction year

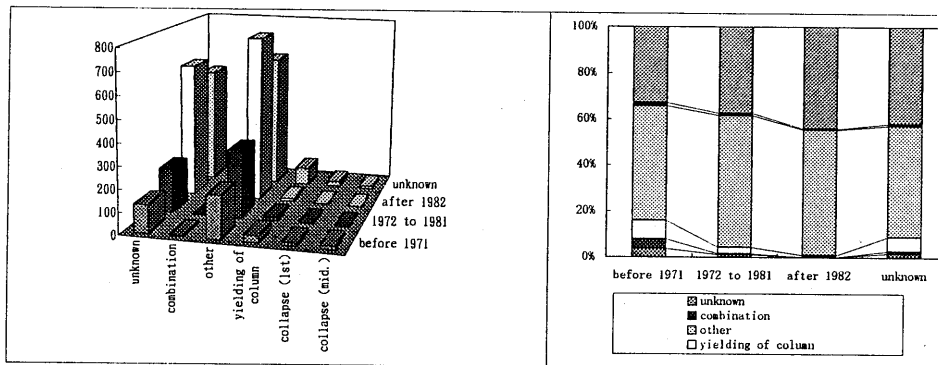
Fig. 2.2.2.6 relationship between construction year and structural damage

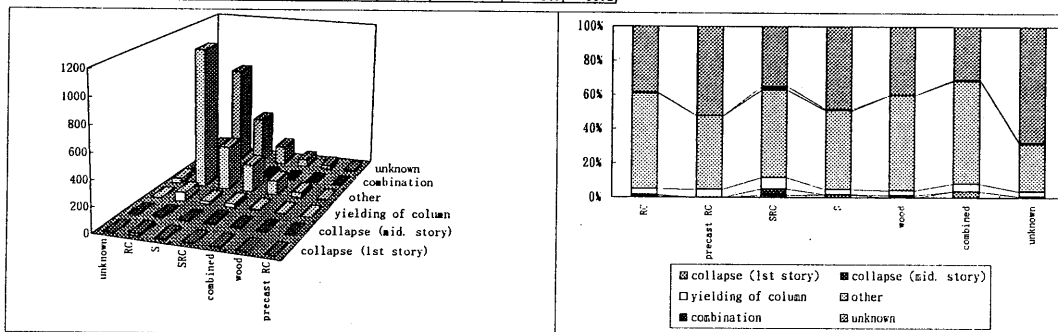
Fig. 2.2.2.7 relationship between structural form and structural damage

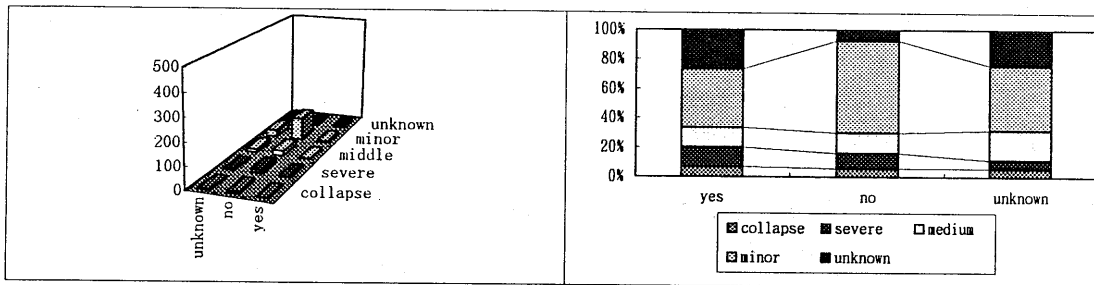
(a) constructed before 1971

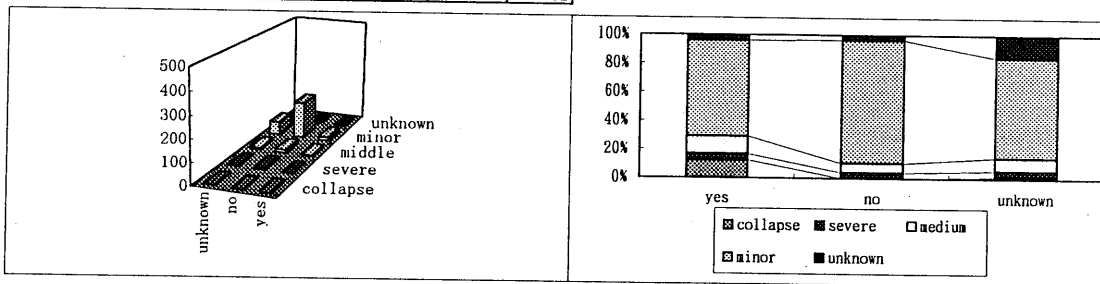
(b) constructed from 1972 to 1981

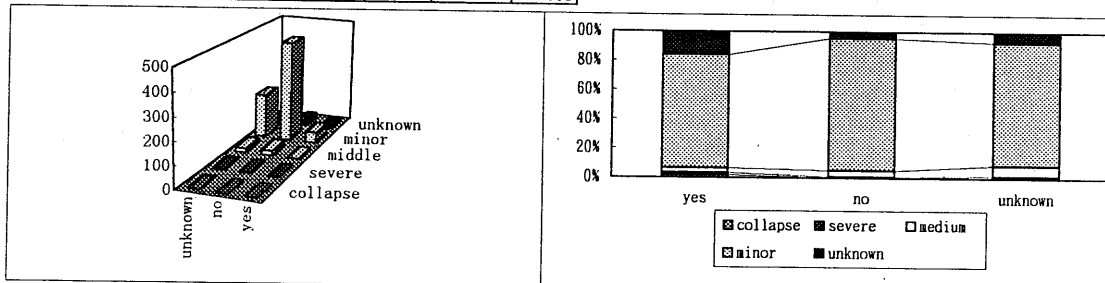
(c) constructed after 1982

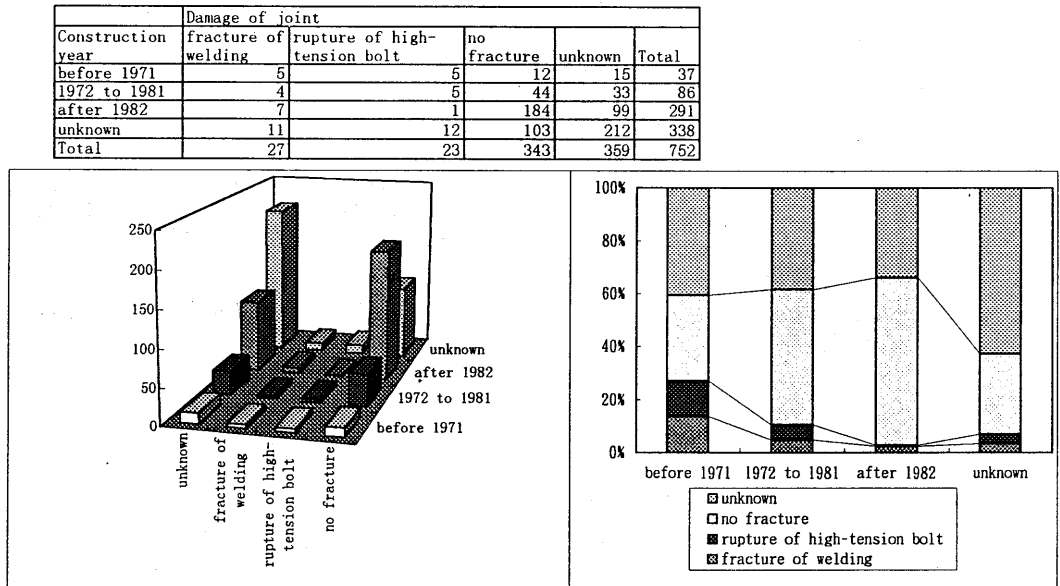
Fig. 2.2.2.9 relationship between damage of joint and construction year (S structure)

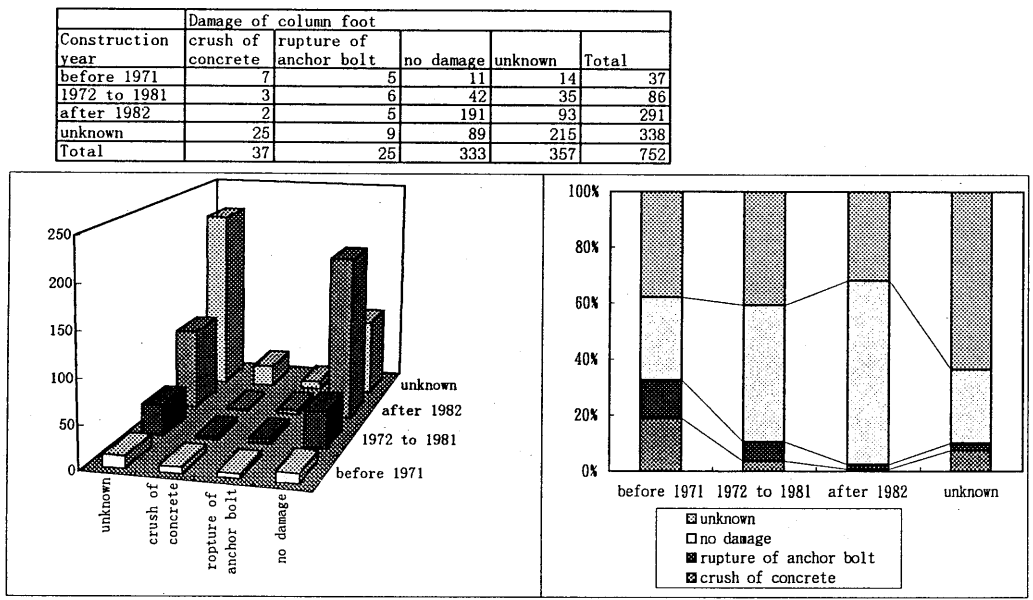
Fig. 2.2.2.10 relationship between damage of column foot and construction year (S structure)

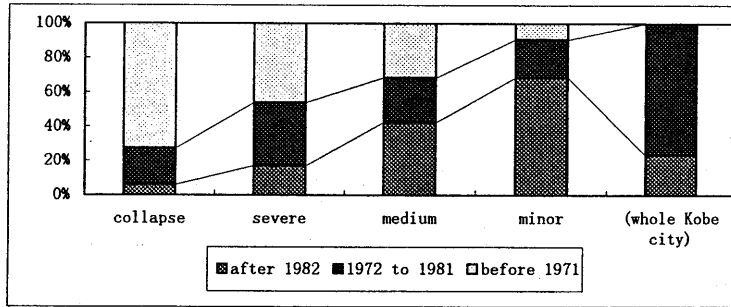
Construction year	Damage level						Total (whole Kobe city)
	collapse	severe	medium	minor	unknown	Total	
before 1971	24	35	48	71	30	208	303000
1972 to 1981	7	28	40	171	19	265	
after 1982	2	13	65	526	33	639	
unknown	27	45	114	181	296	663	
Total	60	121	267	949	378	1775

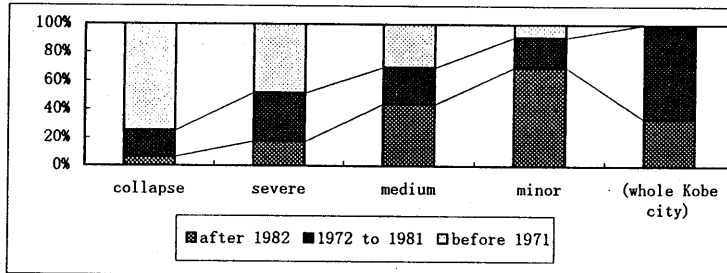
(b) non-wood structure

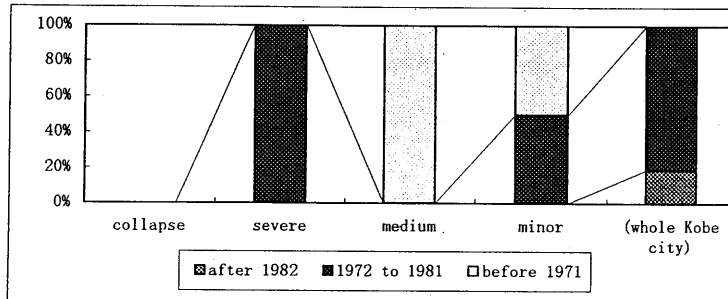
Construction year	Damage level						Total (whole Kobe city)
	collapse	severe	medium	minor	unknown	Total	
before 1971	0	0	1	2	0	3	224000
1972 to 1981	0	1	0	2	0	3	
after 1982	0	0	0	0	0	0	
unknown	2	1	3	5	4	15	
Total	2	2	4	9	4	21

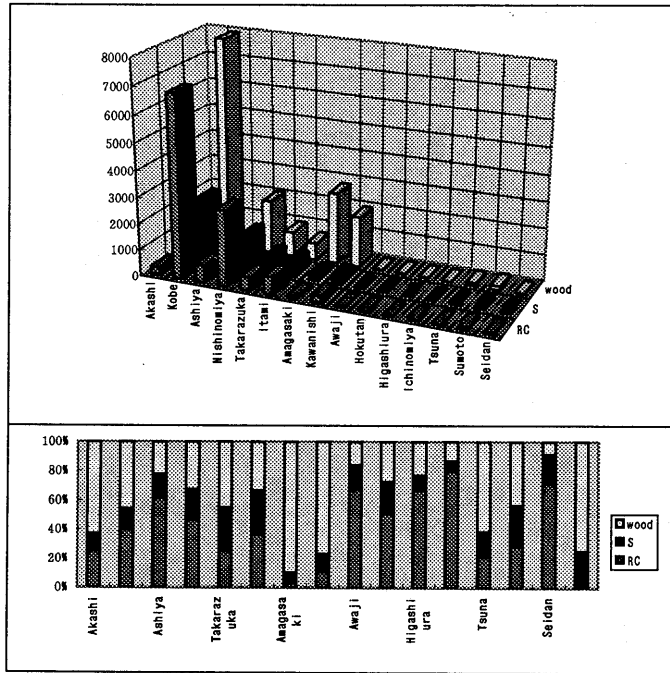
Fig. 2.2.3.1 number of building (whole area)

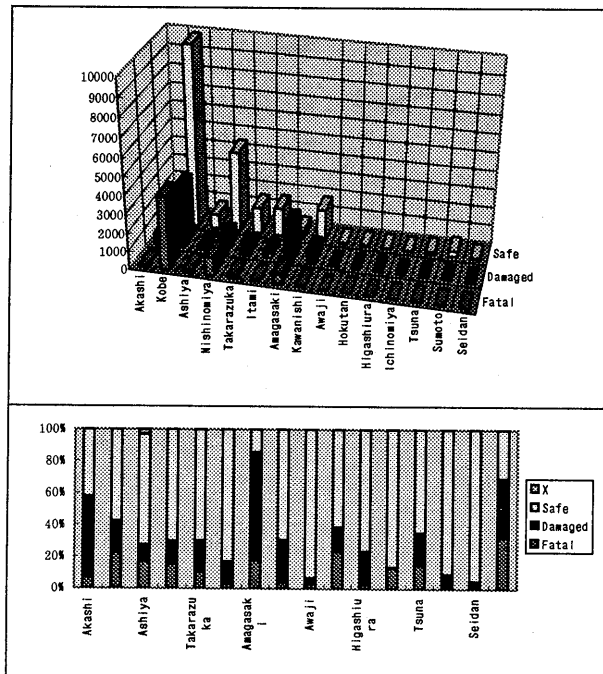
Fig. 2.2.3.2 assessment result (whole area)

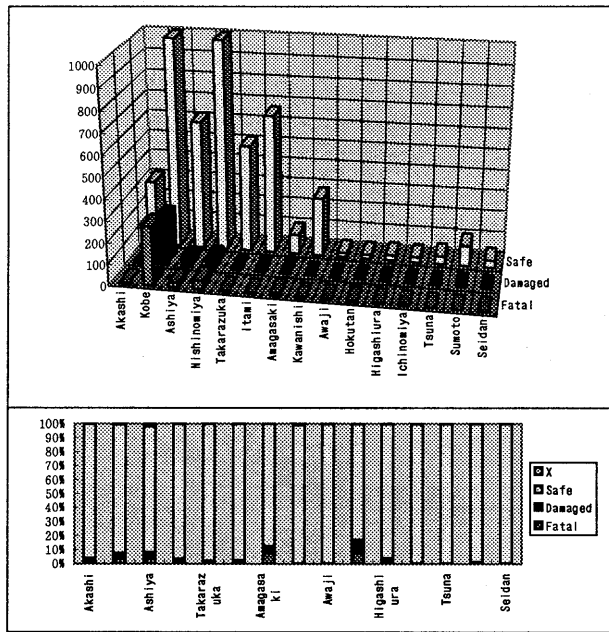
Fig. 2.2.3.3 city and assessment (RC structure)

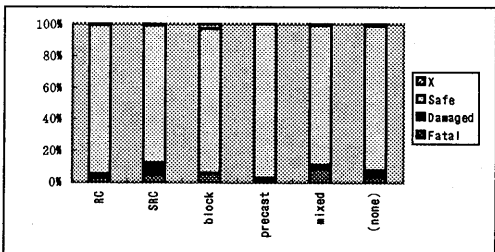
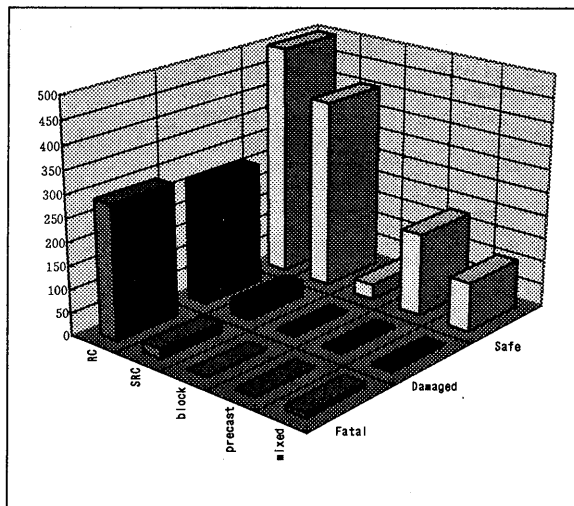
Fig. 2.2.3.4 type and assessment (RC structure)

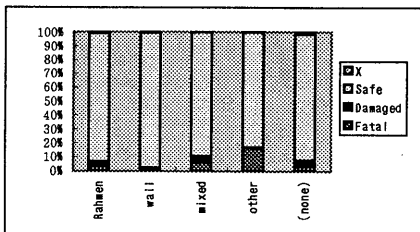
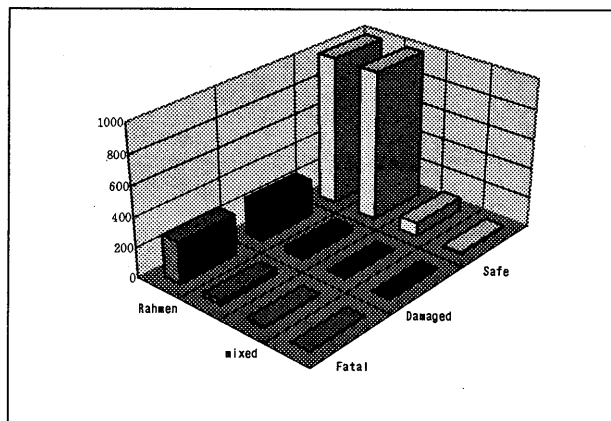
Fig. 2.2.3.5 system and assessment (RC structure)

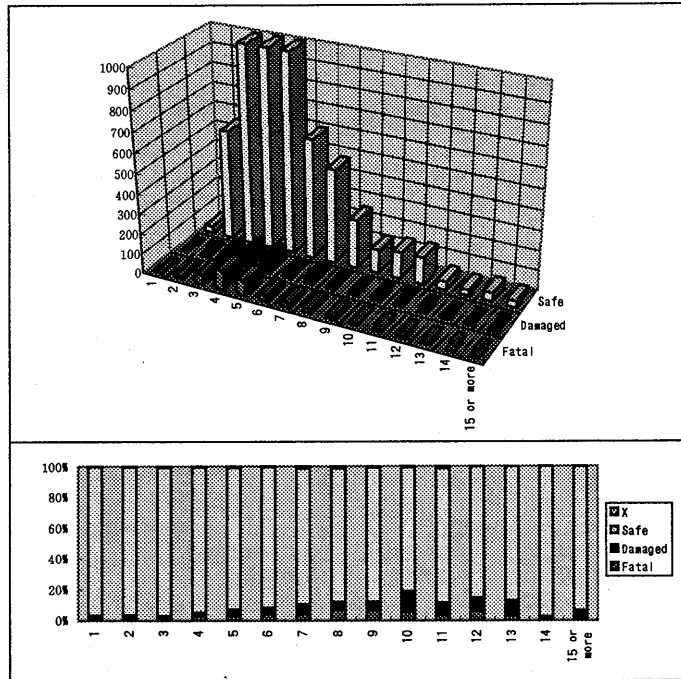
Fig. 2.2.3.6 story and assessment (RC structure)

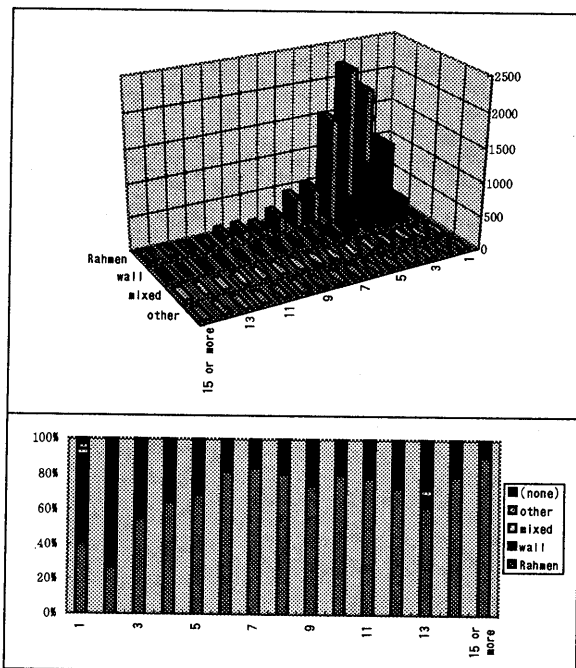
Fig. 2.2.3.8 system and story (RC structure)

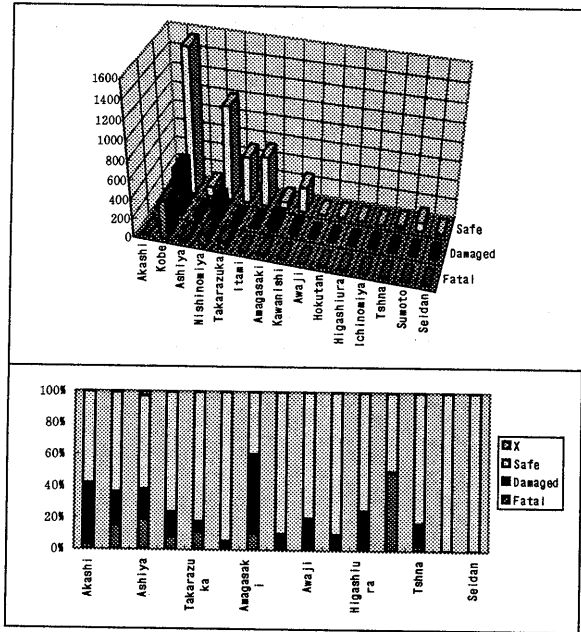
Fig. 2.2.3.9 city and assessment(S structure)

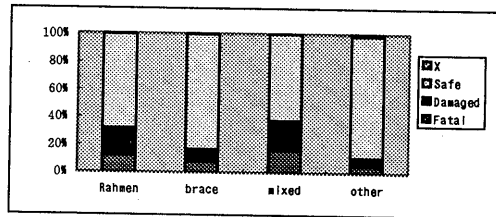
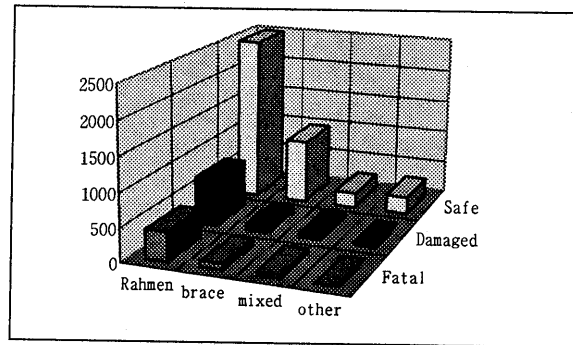
Fig. 2.2.3.10 system and assessment(S structure)

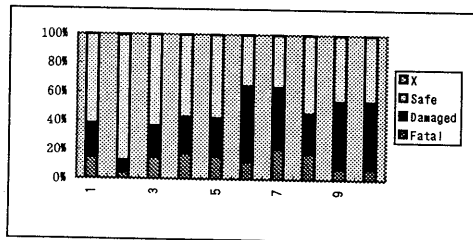
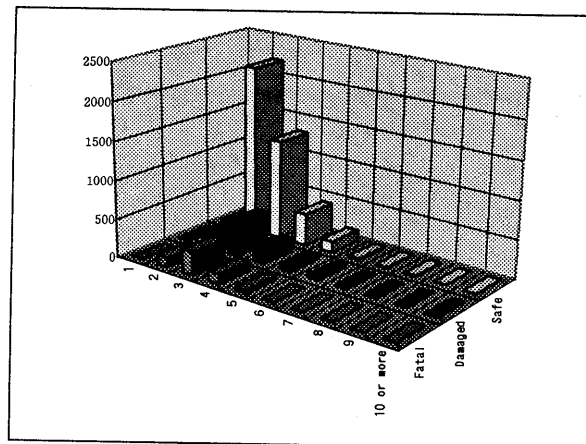
Fig. 2.2.3.11 story and assessment(S structure)

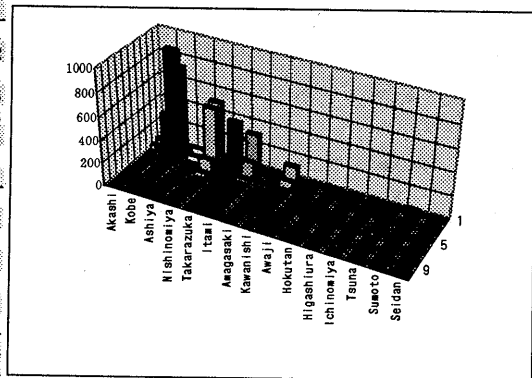
Fig. 2.2.3.13 city and story (S structure)

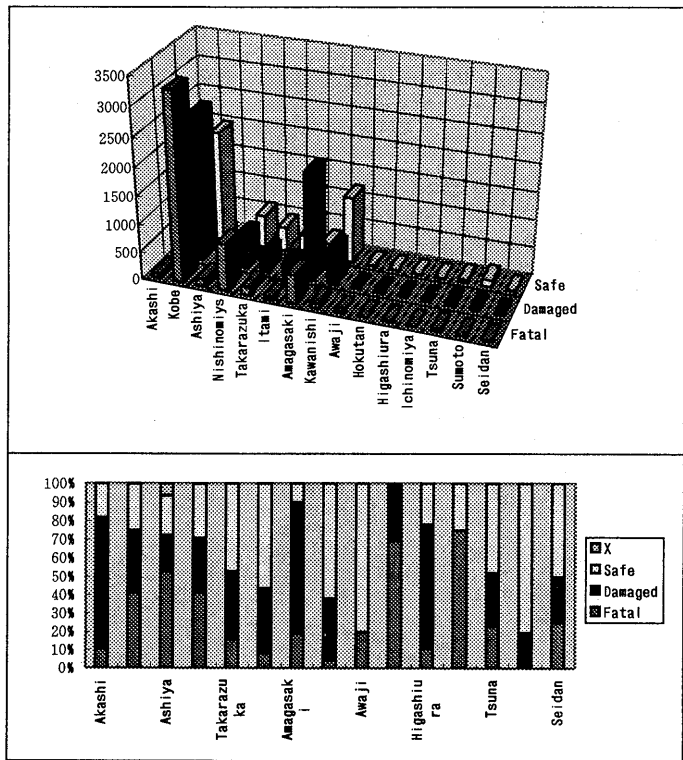
Fig. 2.2.3.14 city and assessment (wood structure)

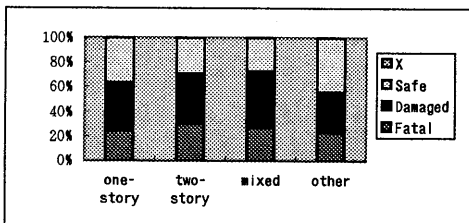
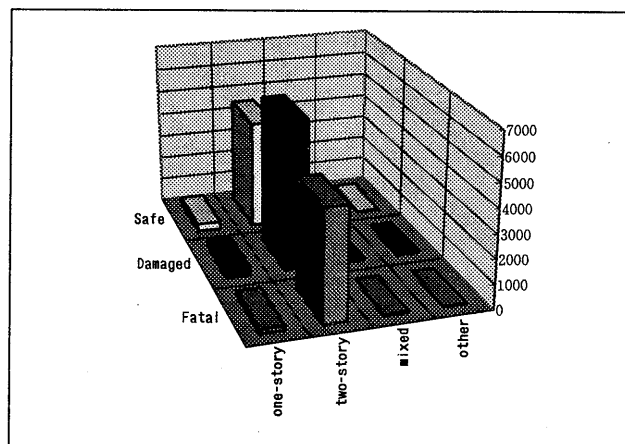
Fig. 2.2.3.15 story and assessment (wood structure)

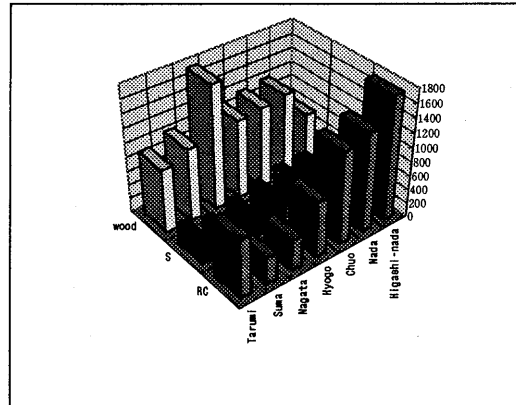
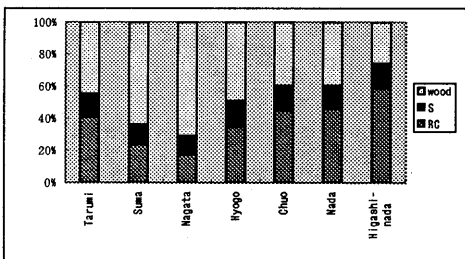
Fig. 2.2.3.16 number of buildings (Kobe city)

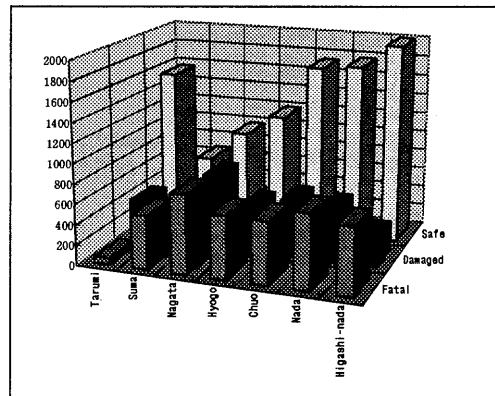
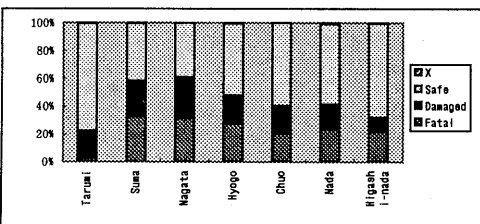
Fig. 2.2.3.17 assessment result (Kobe city)

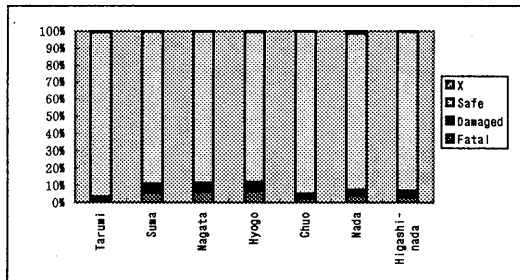
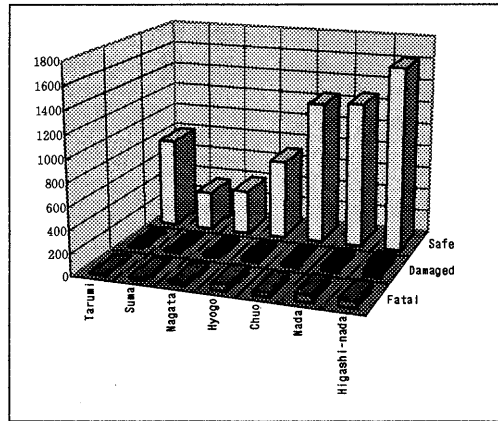
Fig. 2.2.3.18 ward and assessment(Kobe city: RC)

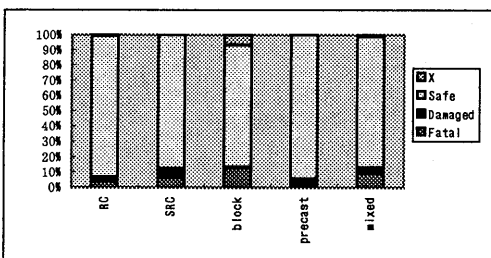
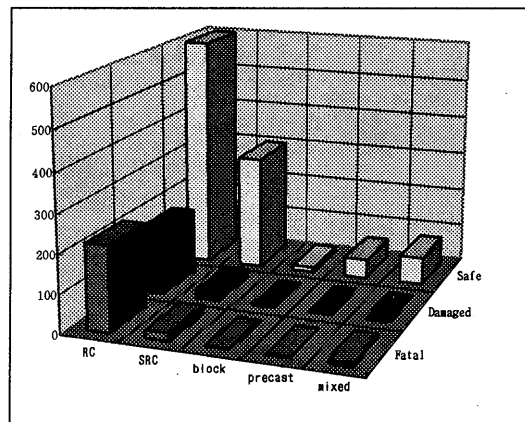
Fig. 2.2.3.19 type and assessment (Kobe city: RC)

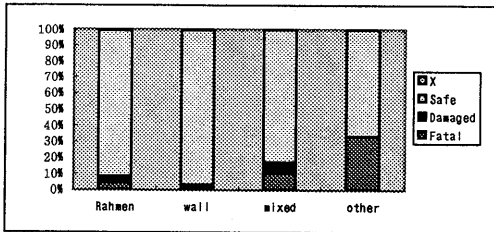
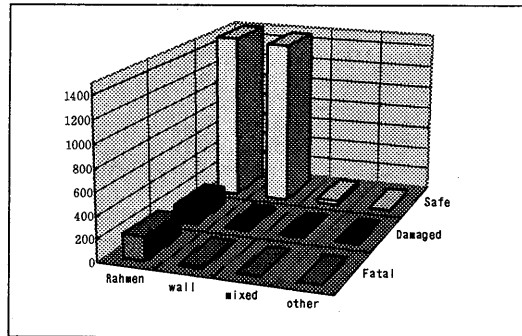
Fig. 2.2.3.20 system and assessment (Kobe city: RC)

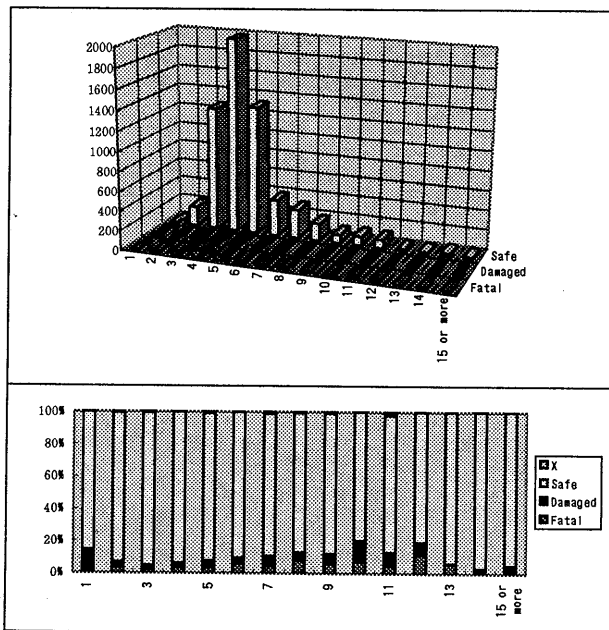
Fig. 2.2.3.21 story and assessment (Kobe city: RC)

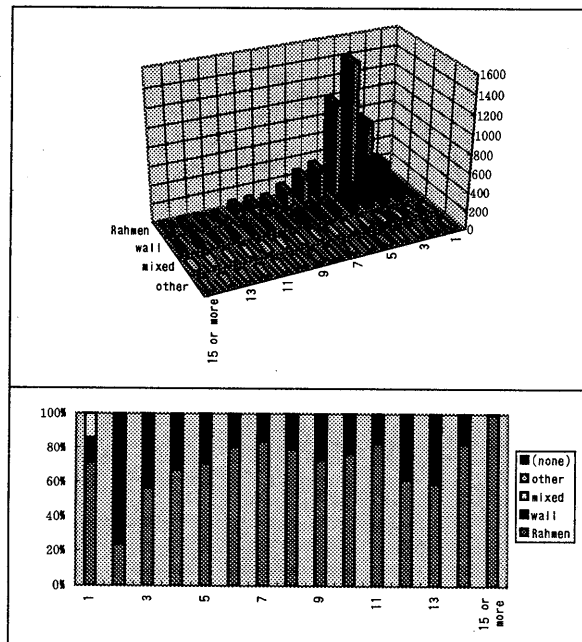
Fig. 2.2.3.23 system and story (Kobe city: RC)
