*A SURVEY REPORT FOR BUILDING DAMAGES*  
*DUE TO*  
*THE 1995 HYOGO-KEN NANBU EARTHQUAKE*

*March 1996*

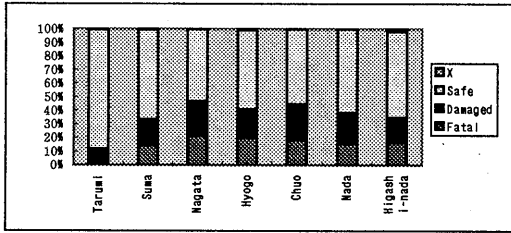
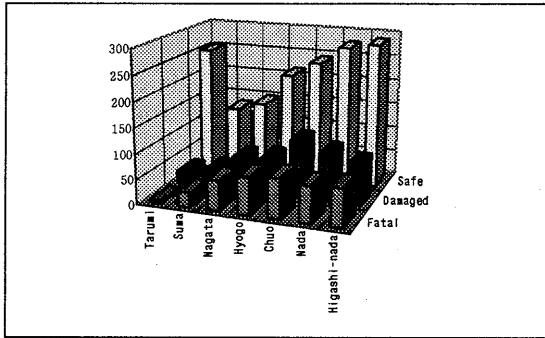
Fig. 2.2.3.24 ward and assessment (Kobe city: S)

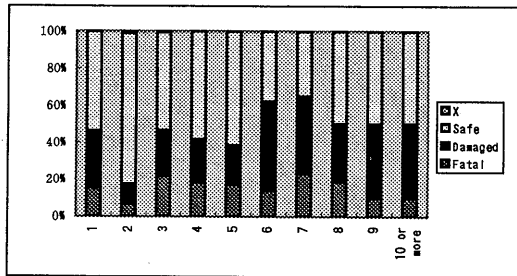
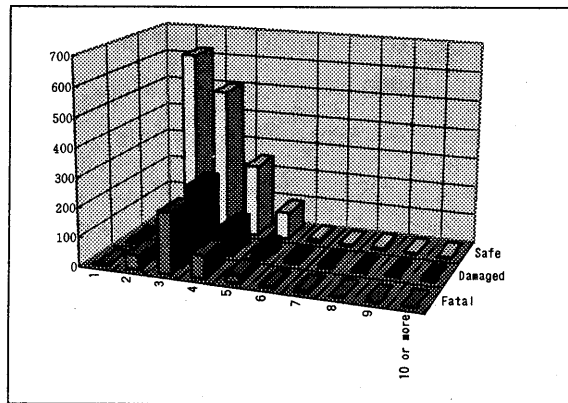
Fig. 2.2.3.25 story and assessment (Kobe city: S)

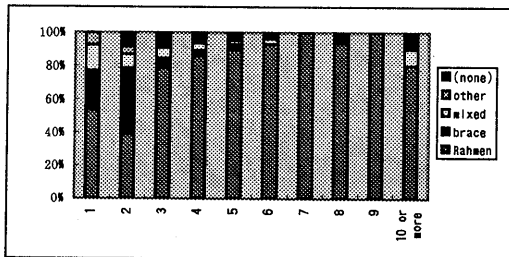
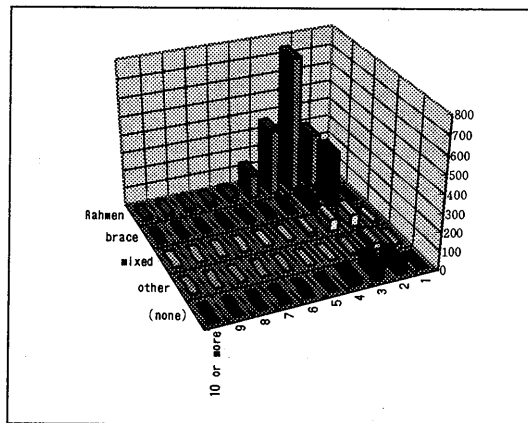
Fig. 2.2.3.26 system and story (Kobe city: S)

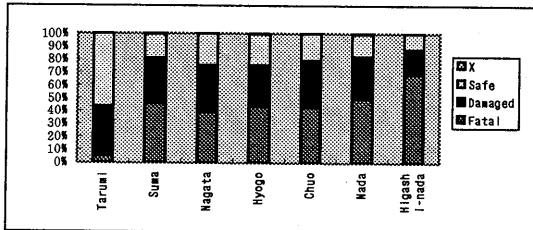
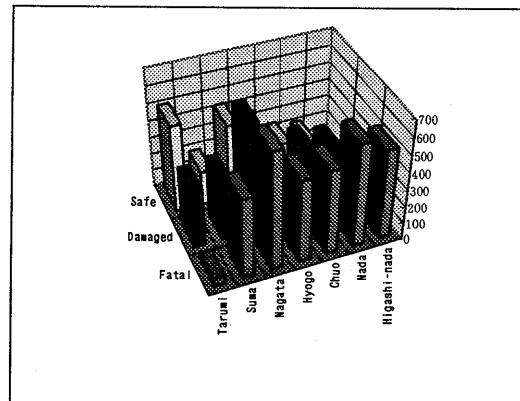
Fig. 2.2.3.27 ward and assessment (Kobe city: wood)

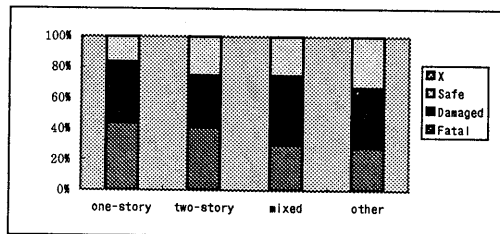
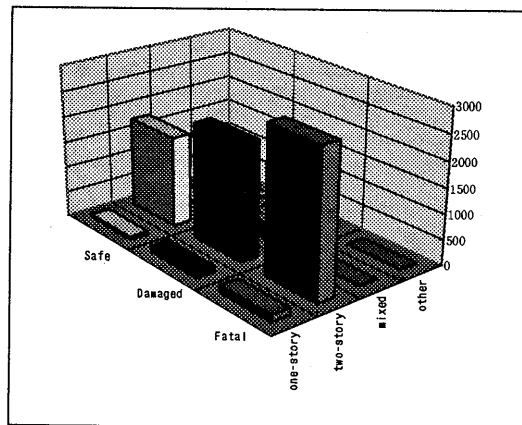
Fig. 2.2.3.28 story and assessment (Kobe city: wood)

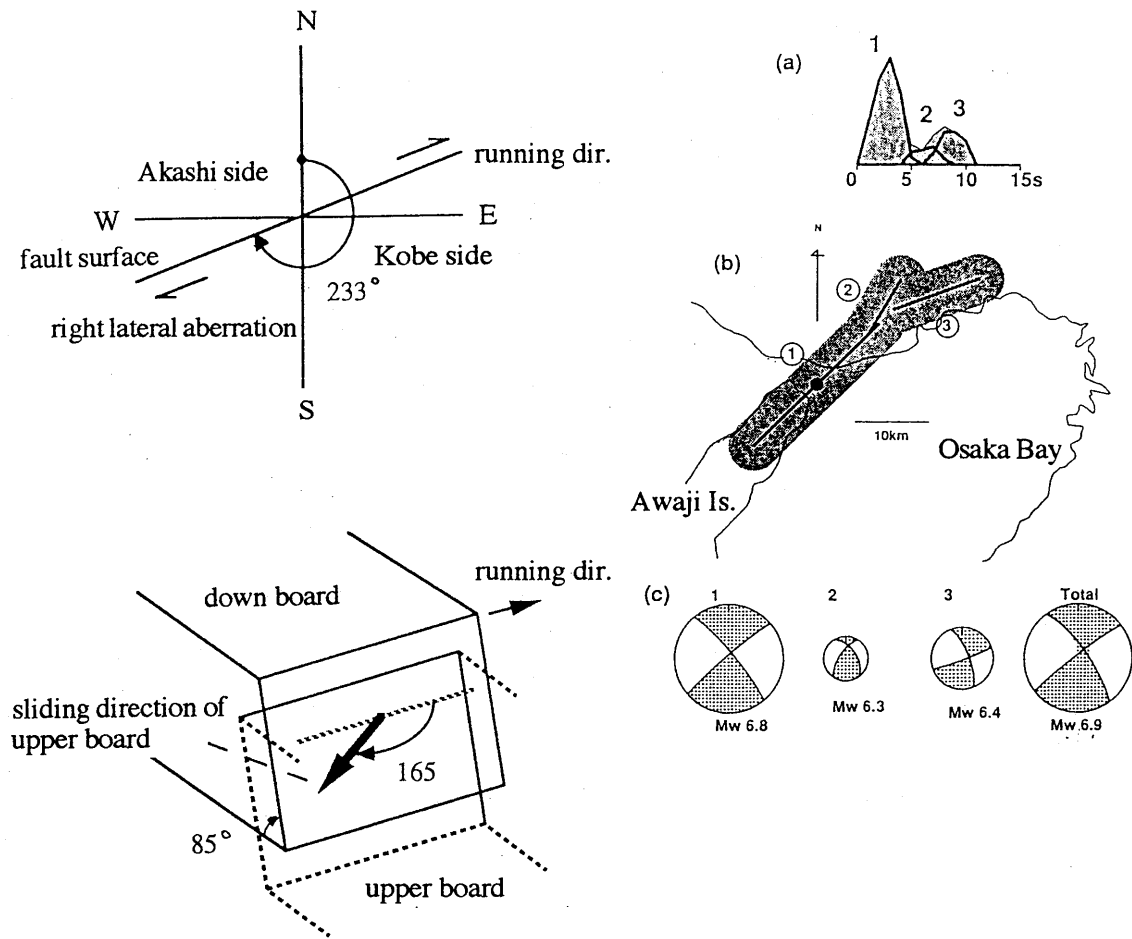
Fig.3.1.1.1 Fault Fracture Mechanism at Epicenter, 1995 Hyogoken-Nanbu Earthquake (by Kikuchi)

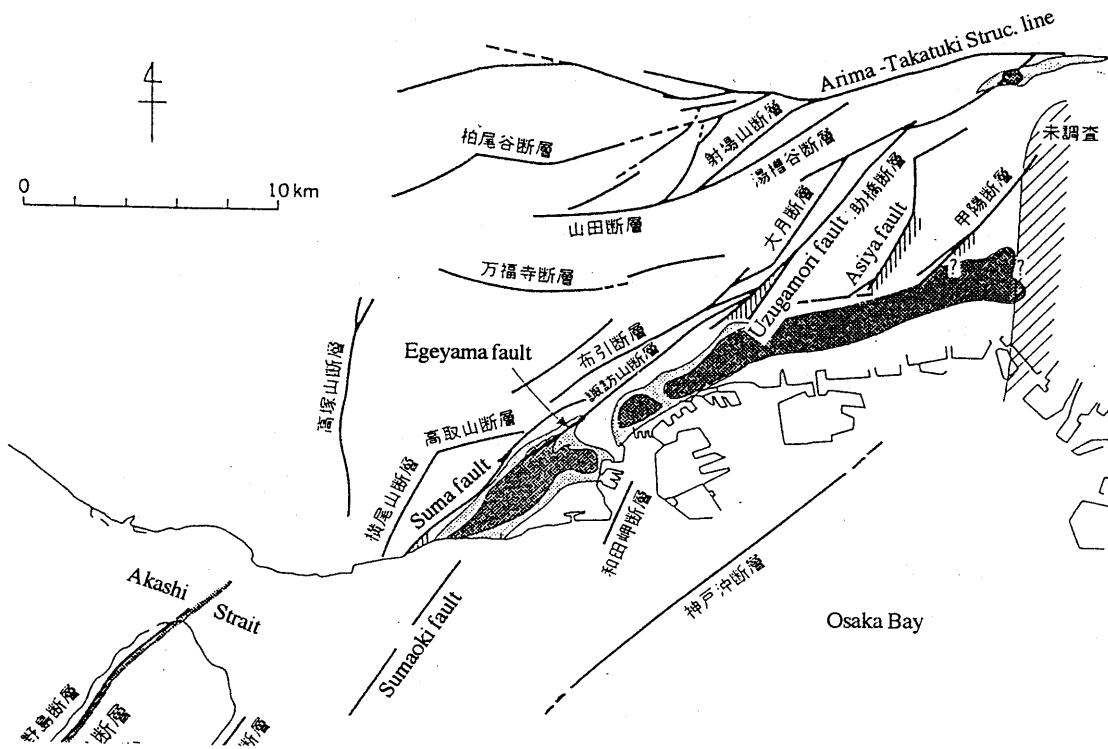
Fig.3.1.1.2 Active Faults at Kobe Area (by Shimamoto, 1995)

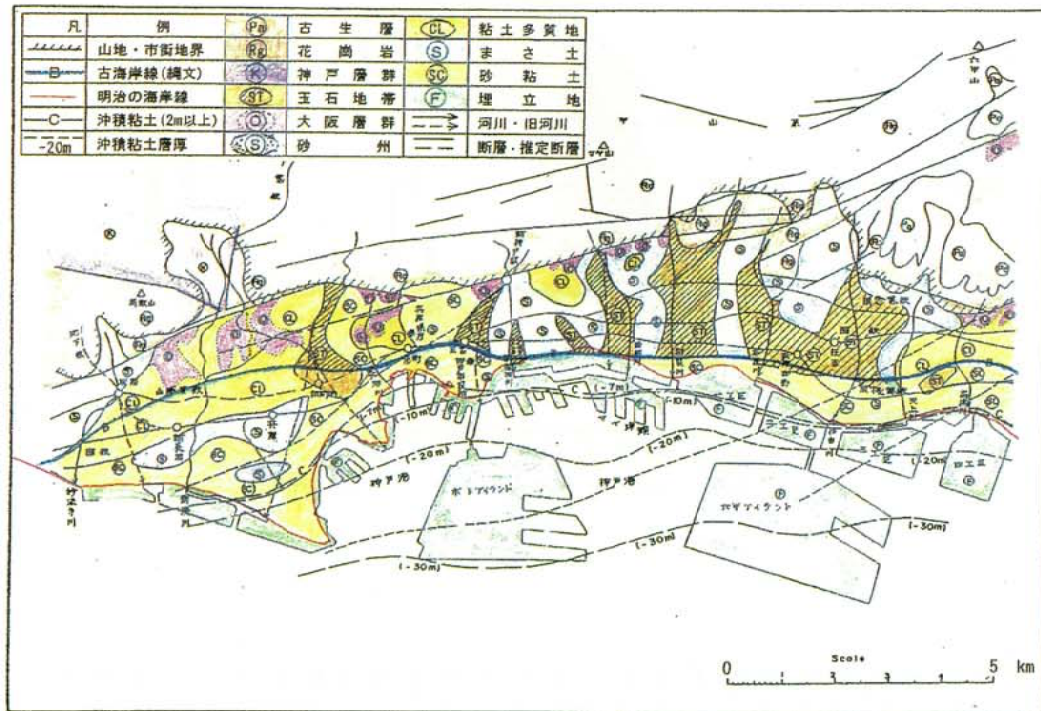
Fig.3.1.2.1 Outlines of Soil Condition at Kobe City Area (Y.Iwami et al ,1982)

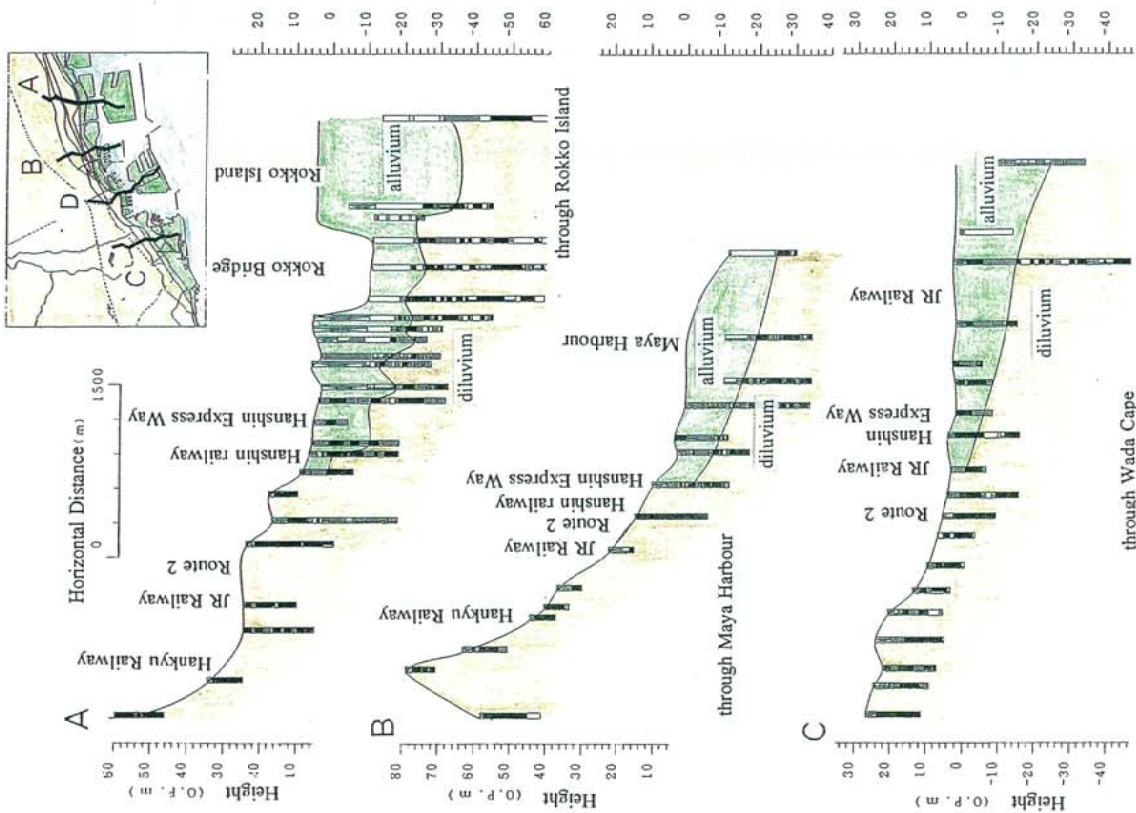
Fig.3.1.2.2 North - South Cross Section of the Damaged Area  
 ("Kansai Jiban, 1992", Geotechnical Engineering Society)

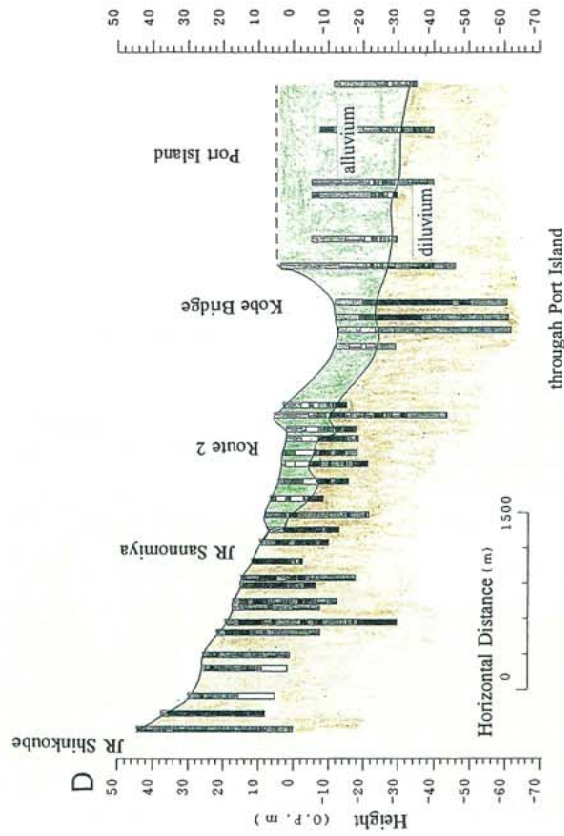
Fig.3.1.2.3 North - South Cross Section through Port Island  
 ("Kansai Jiban, 1992", Japanese Geotechnical Society)

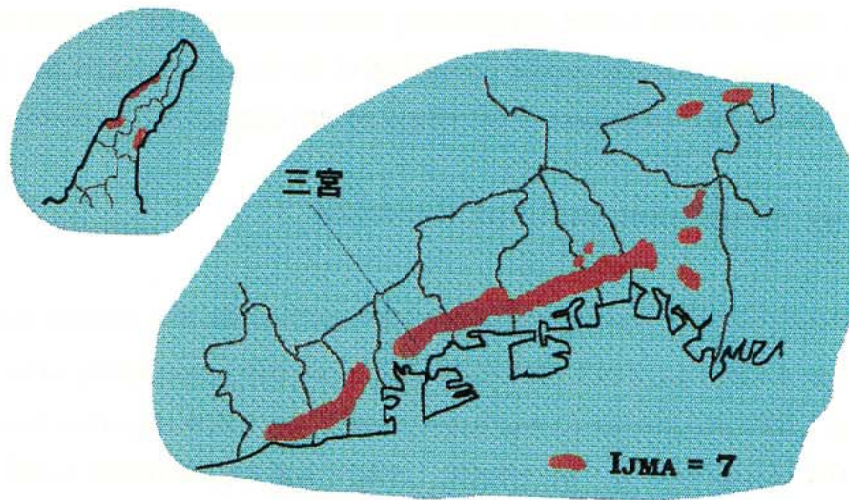
Fig.3.1.3.1 Siesmic Intensity 7 Area by the Meteorological Agency  
 ( Department of Earthquake and Vocanoes,Meteorological Agency )

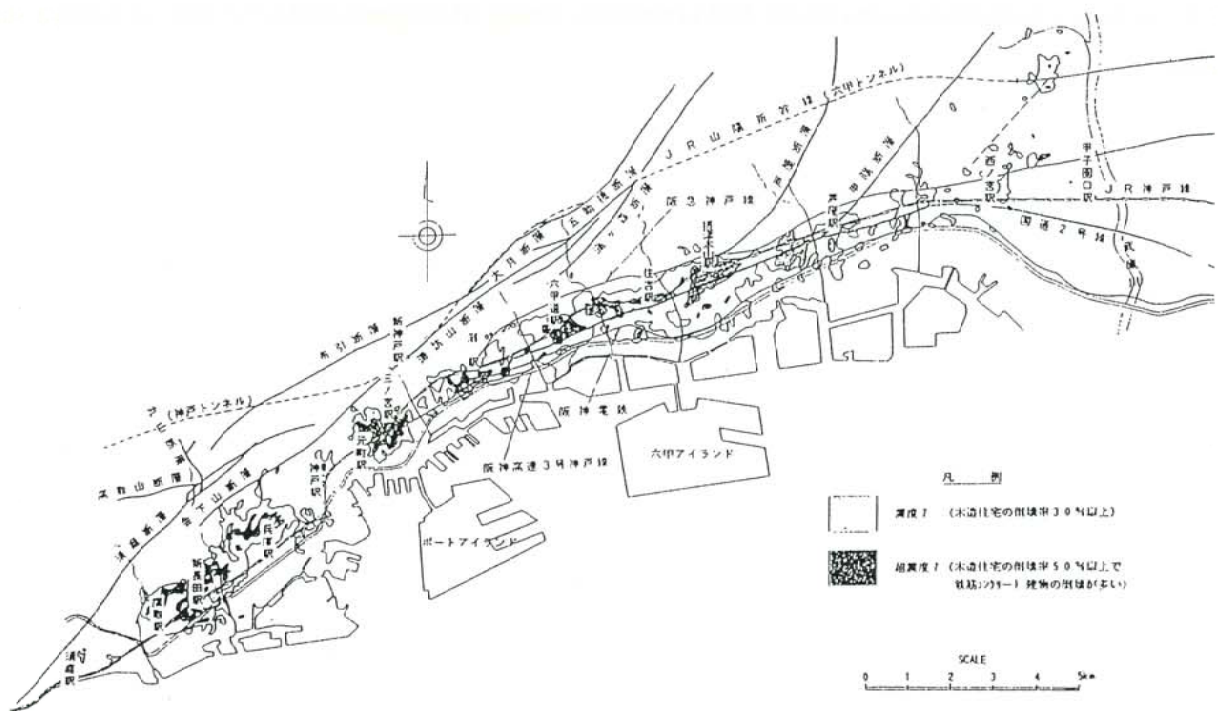
Fig. 3.1.3.2 Damage Classification through Site Detailed Survey  
 ( by Cuou Kaihatu Co., )

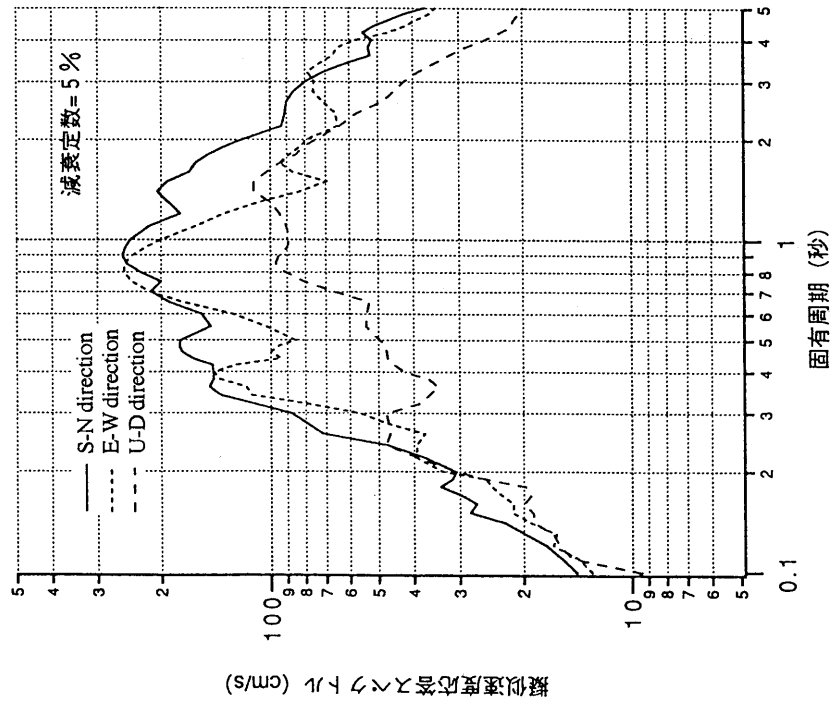
Fig.3.1.4.5 Pseudo Velocity Response  
Spectrum  
( reported by Meteorological Agency)

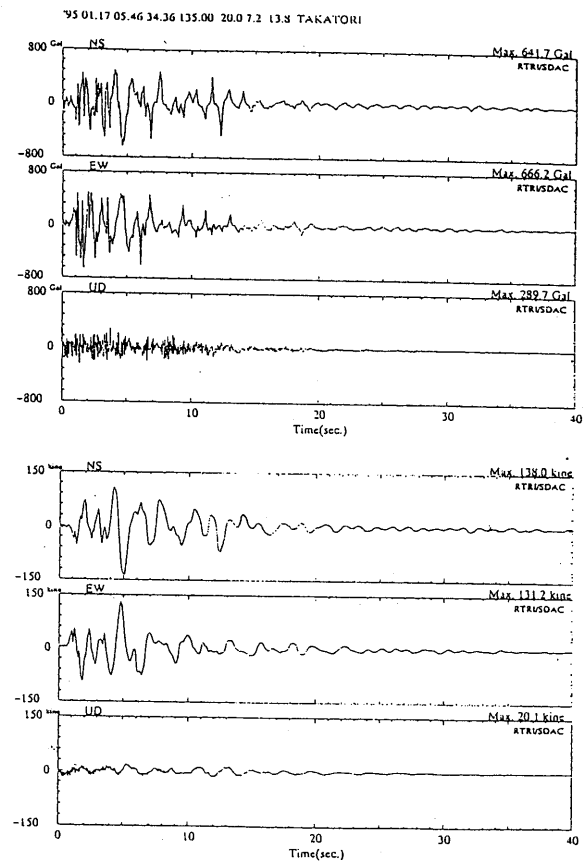
Fig.3.1.4.13 Observed Record at Takatori Sta.  
( above ; acc., lower; velocity )  
( by Jishin Joho No 23 )

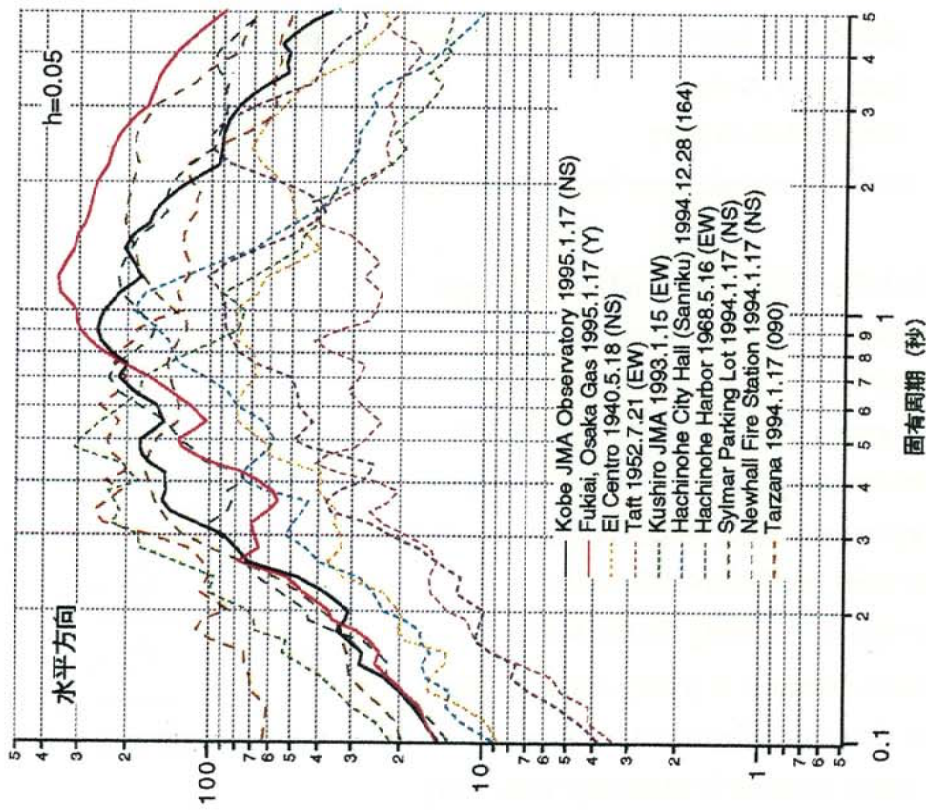
Fig.3.1.5.1 Comparison of Acceleration Response Spectrum for Records in Building

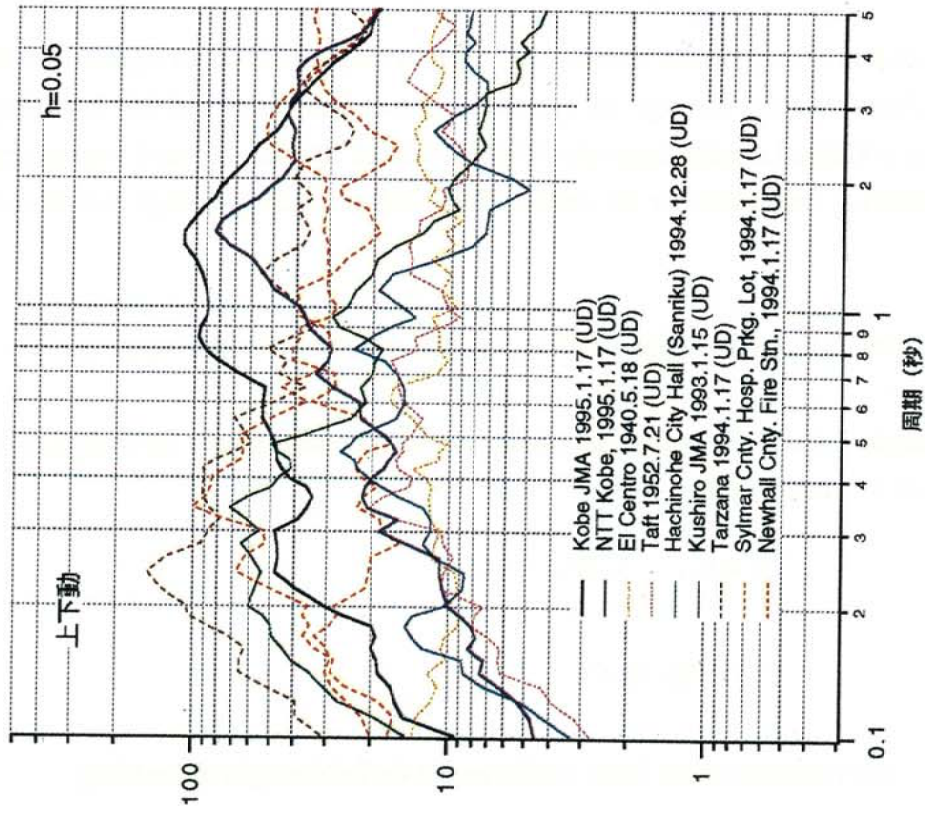
Fig.3.1.5.2 Comparison of Velocity Response Spectrum for Records in Building

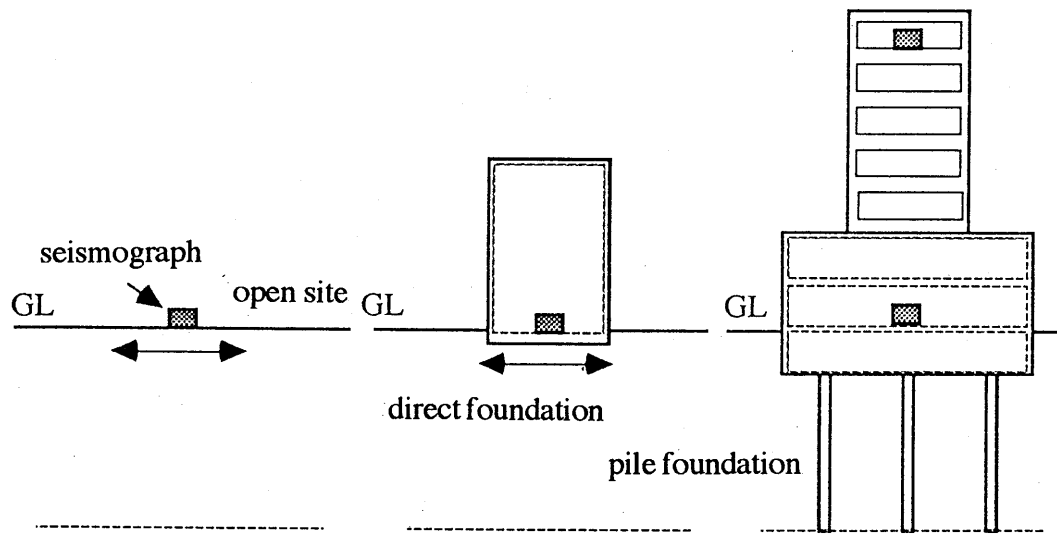
Fig.3.1.6.4. Various Condition of Earthquake Observation

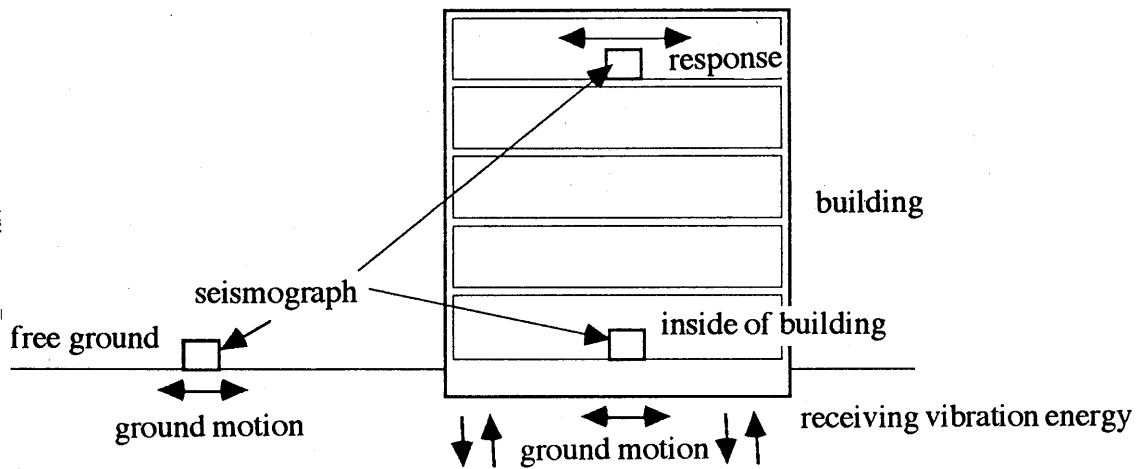
Fig.3.1.6.5 Motion of Free Field and Building

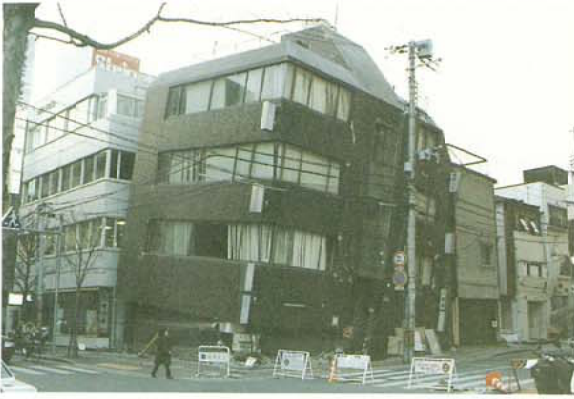
Photo. 3.2.1.1 4 story building  
Collapse by the shear fracture of the corner column of the first floor  
The story collapse of the piloti of the first floor

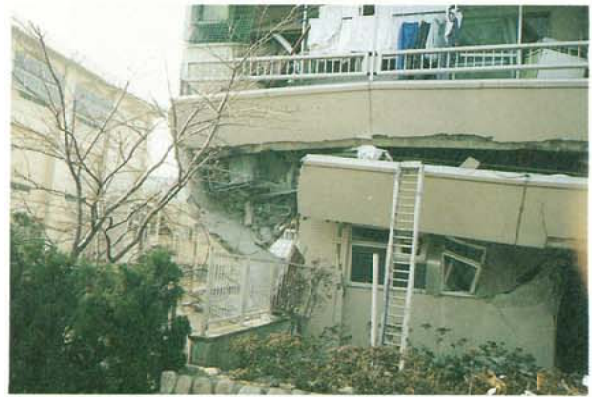
Photo. 3.2.1.5 7 story RC structured  
apartment house  
The story collapse of the second floor The number of the wall of the first floor is more than that on the upper floor. The shear fracture is seen on the column and the wall of the first floor.

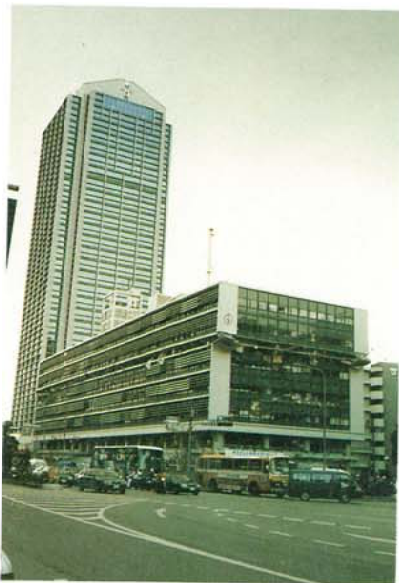
Photo. 3.2.1.3 8 story office building  
The 6th floor was suffered form the story collapse.(the building behind is non damaged)

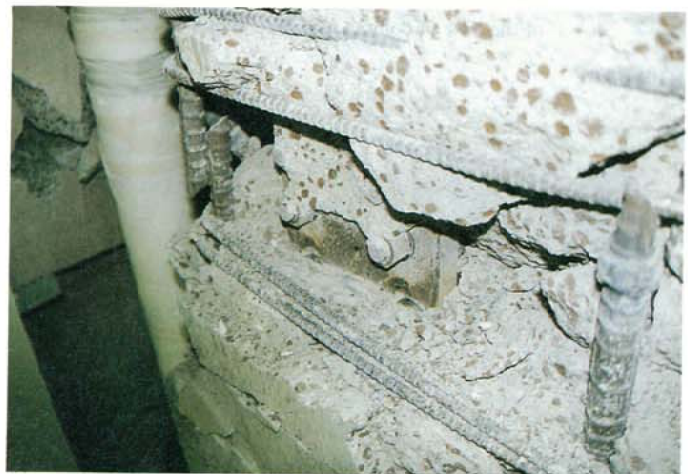
Photo. 3.2.1.6 11 story SRC structured  
governmental building  
Damage of the steel joint part of the peripheral column.(Fracture of the doubling plate of the joint part and the fracture of the main brace)

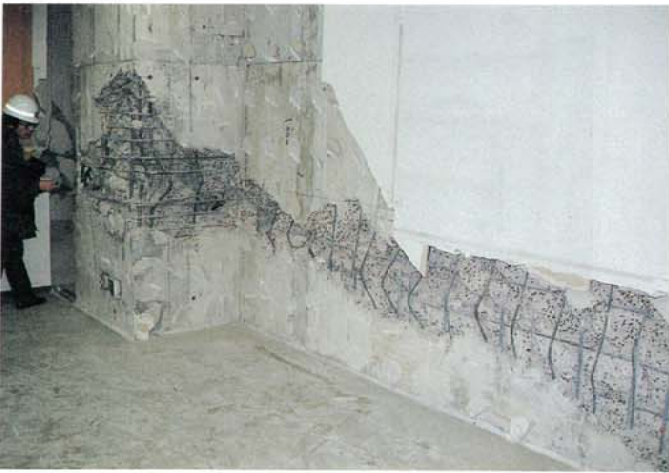
Photo. 3.2.1.7 11 story SRC structured governmental building  
Damage of the steel joint part of the peripheral column

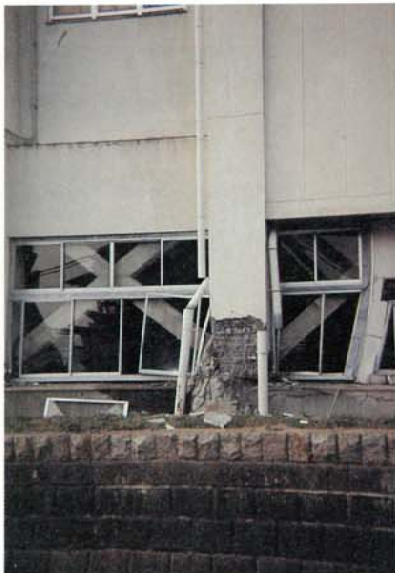
Photo. 3.2.1.8 4 story SRC structured office building  
The half of the column at the bottom of the anchor plate  
of the base of column was slipped to the north.

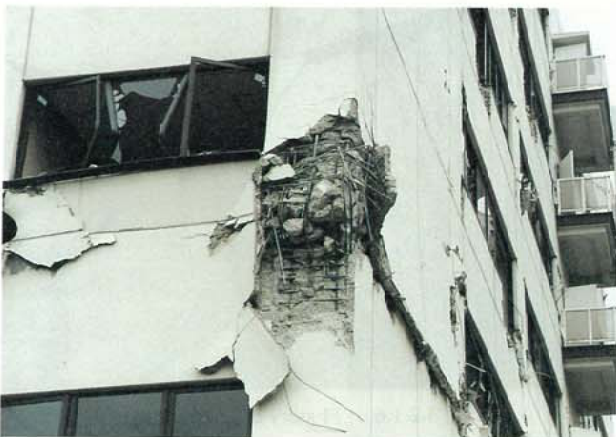
Photo.3.2.1.9 7 story (PH 1st floor) RC structured company building  
The shear fracture of the base of the column and the fracture of  
the foot of the earthquake resistant wall

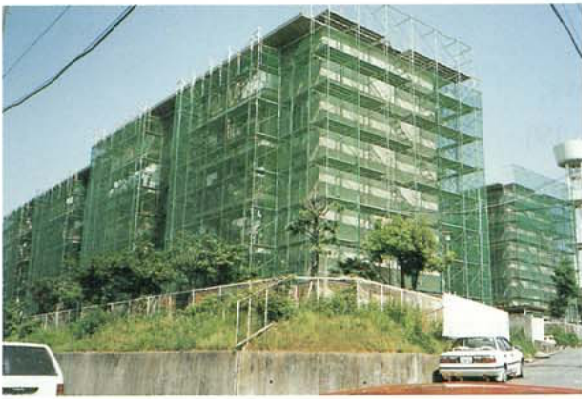
Photo.3.2.1.10 Total view of the building

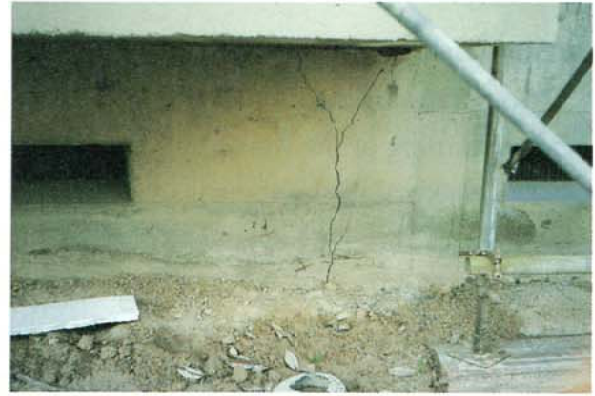
Photo. 3.2.1.13 Cracks of the base

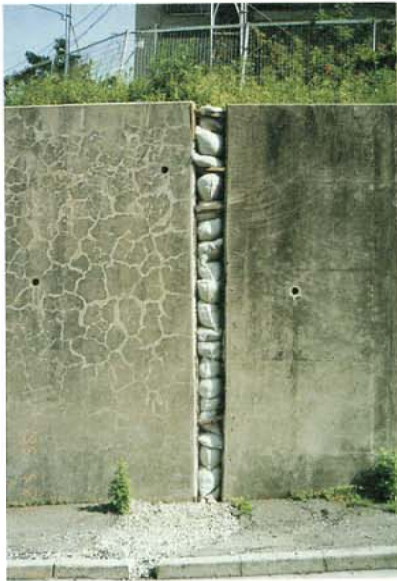
Photo. 3.2.1.11 Transfer of the breast wall (about 15cm)

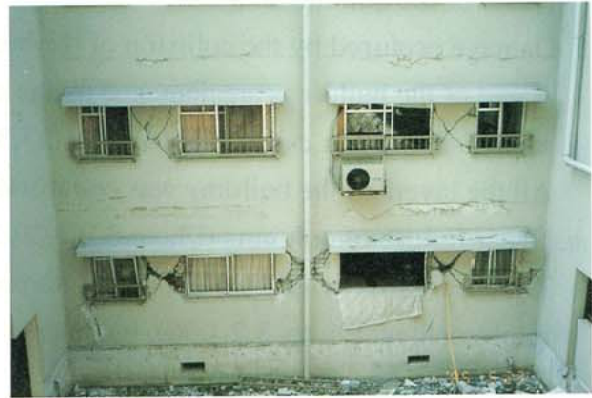
Photo. 3.2.1.14 Damage condition of the neighboring building (7 story frame structure)

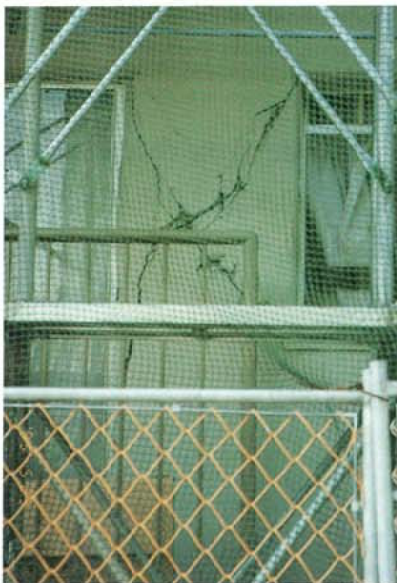
Photo. 3.2.1.12 Shear fracture creeping to the corners of the open part of the building ; windows & doors.

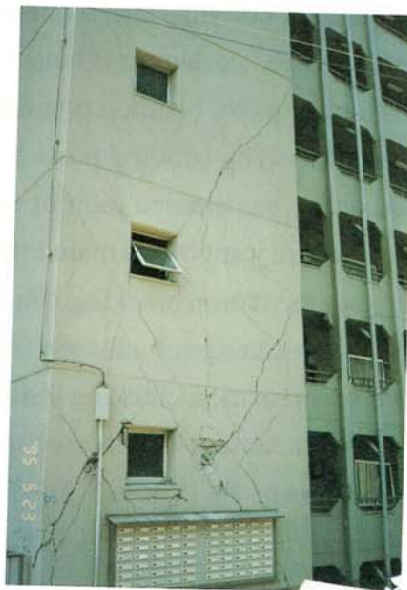
Photo. 3.2.1.15 Damage condition of the neighboring building (7 story frame structure; different one from the one of Photo. 3.2.1.14)

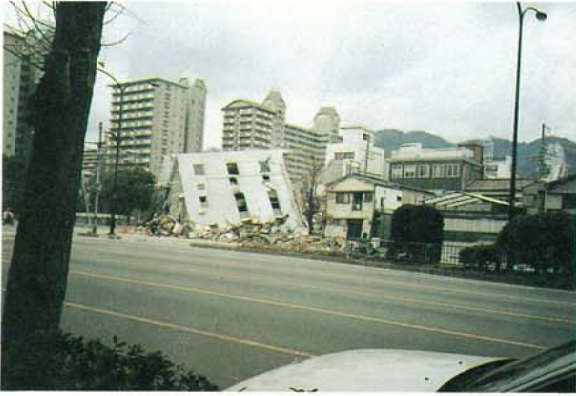
Photo.3.2.1.16 Overturning of the whole building

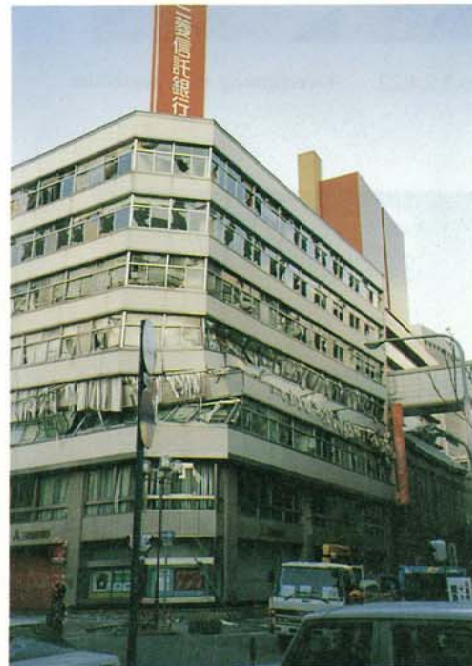
Photo. 3.2.1.19 Story collapse caused by the twist response

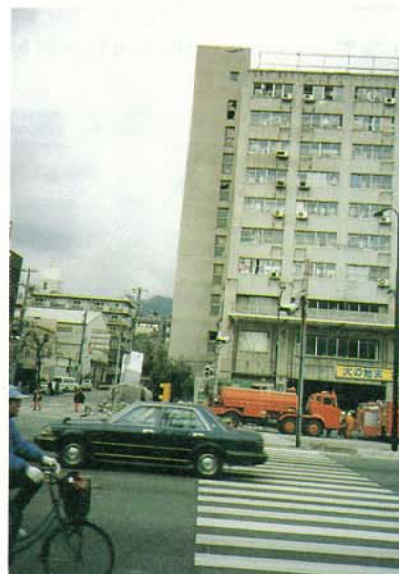
Photo.3.2.1.21 Fall of a penthouse

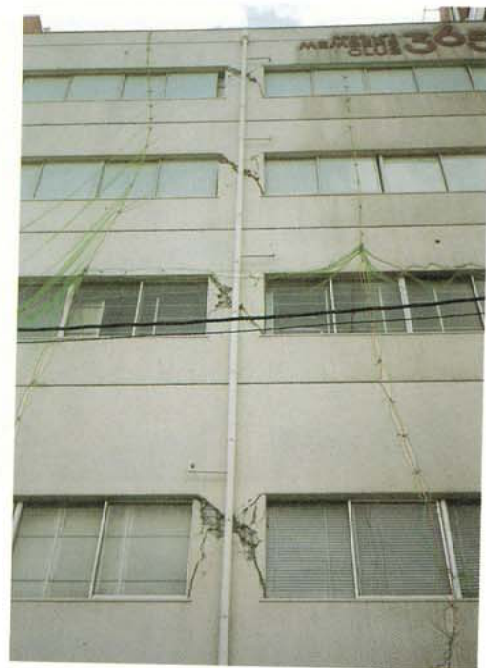
Photo. 3.2.1.30 Shear fractures of short columns

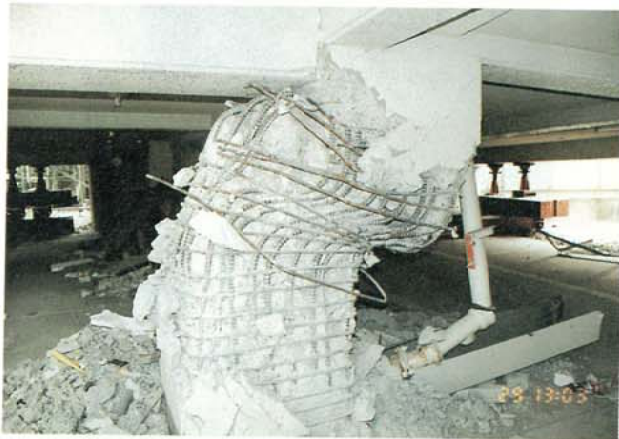
Photo. 3.2.1.31 Shear fracture of a column

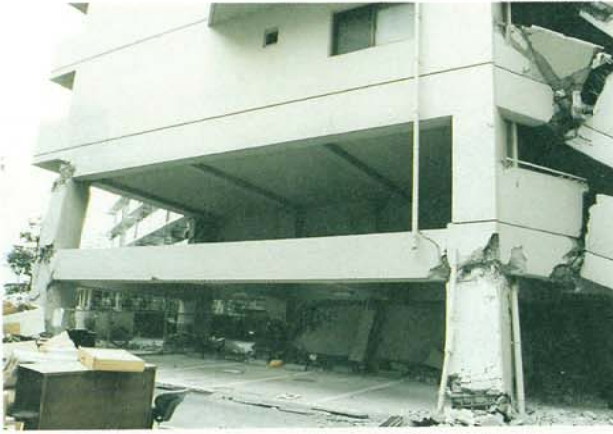
Photo. 3.2.1.33 Fracture of the top and base of columns

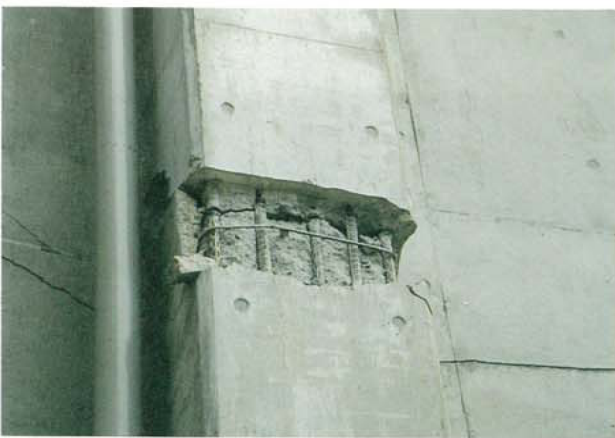
Photo. 3.2.1.37 Fracture of the gas pressure welding of the reinforcements

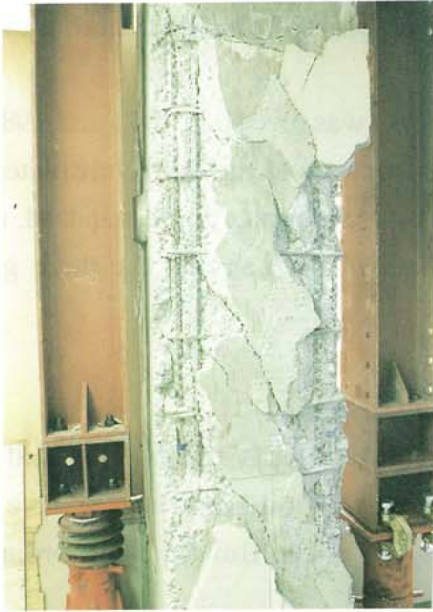
Photo. 3.2.1.39 Bond splitting failure of a column

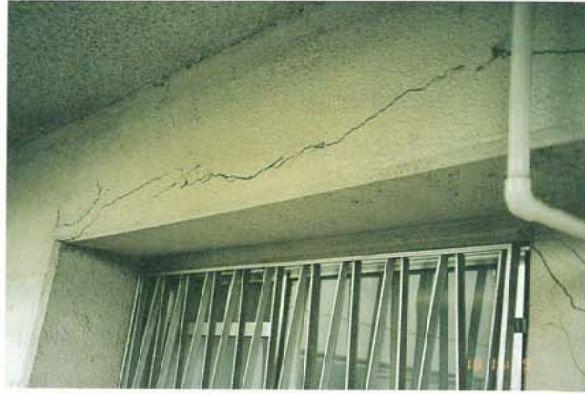
Photo.3.2.1.40 Bond splitting failure of a beam

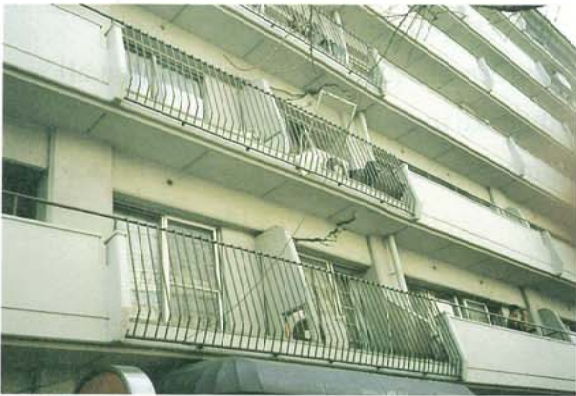
Photo. 3.2.1.41 Damage of beams mullion non-structural wall

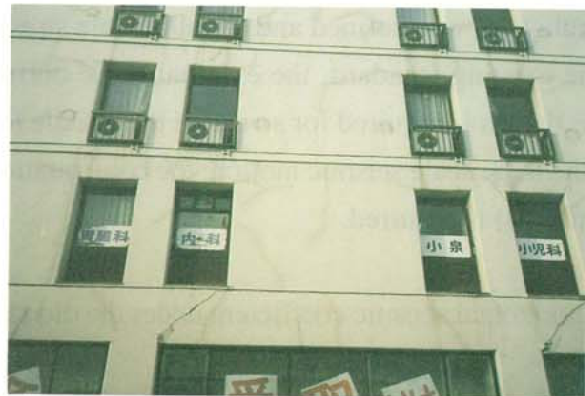
Photo. 3.2.1.42 Damage of beams mullion non-structural wall

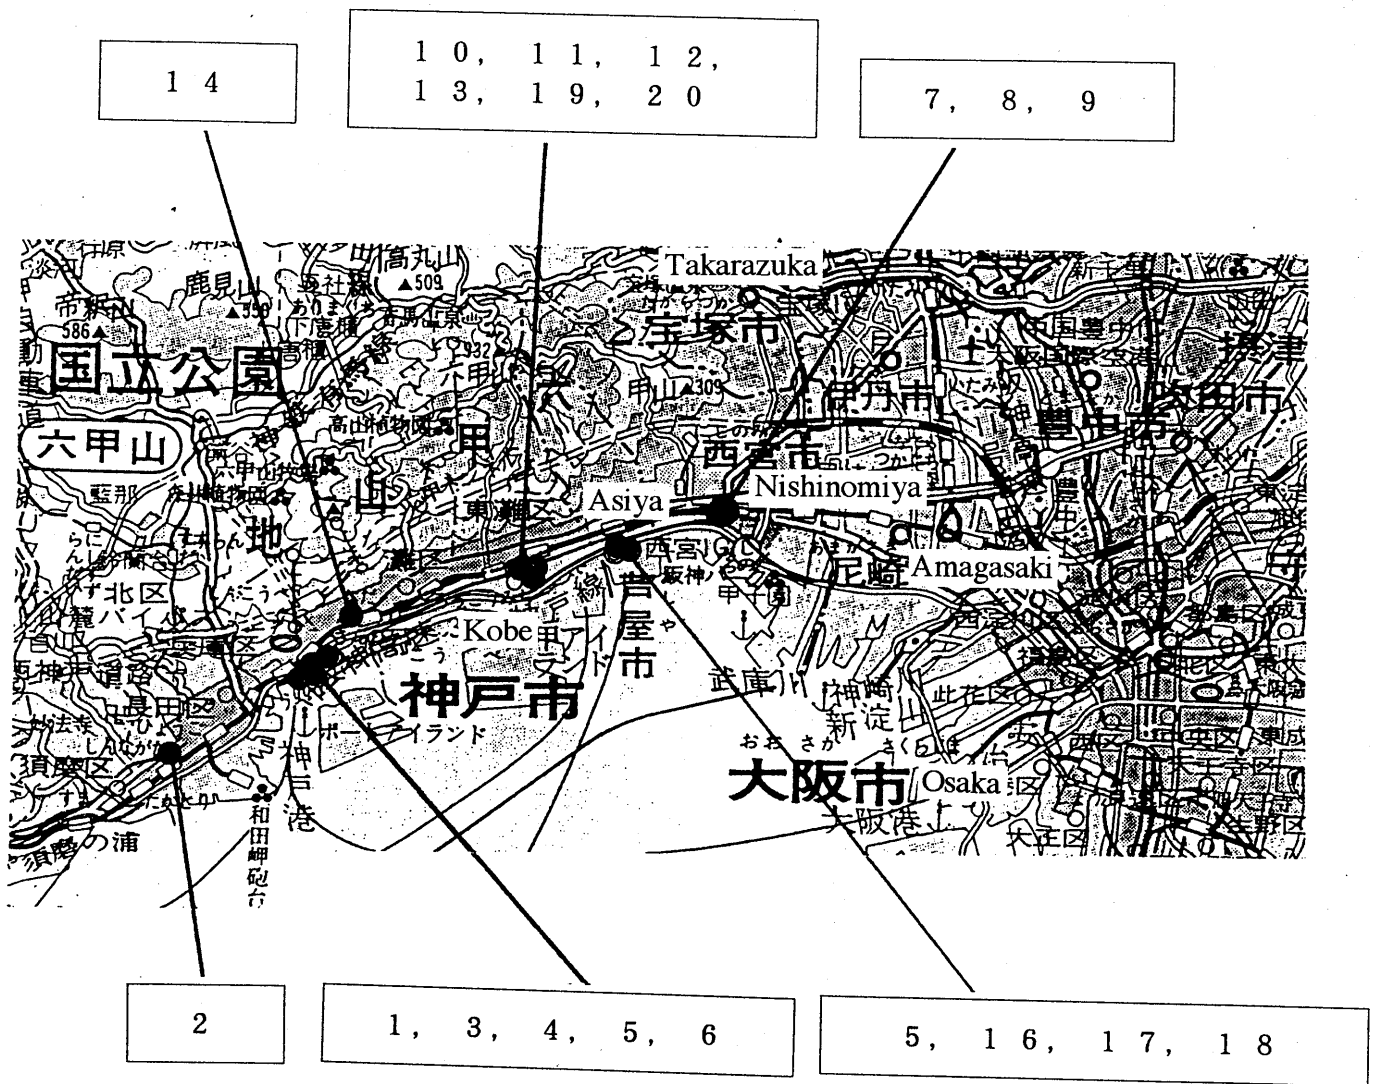
Fig. 3.2.1.2 Locations of the Buildings for Detailed Investigation

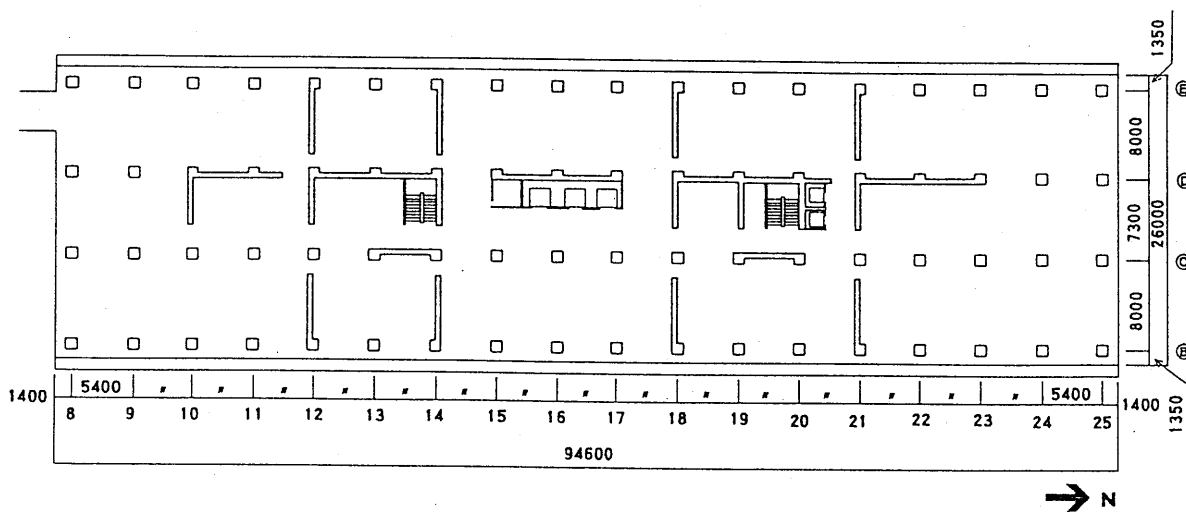
Fig. 3.2.1.3 Plan of the 1 st Floor

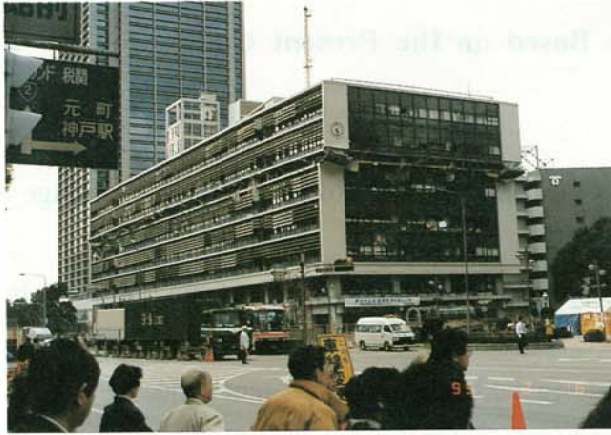
Photo.3.2.1.43 Total View ; The story collapse of the 6th floor

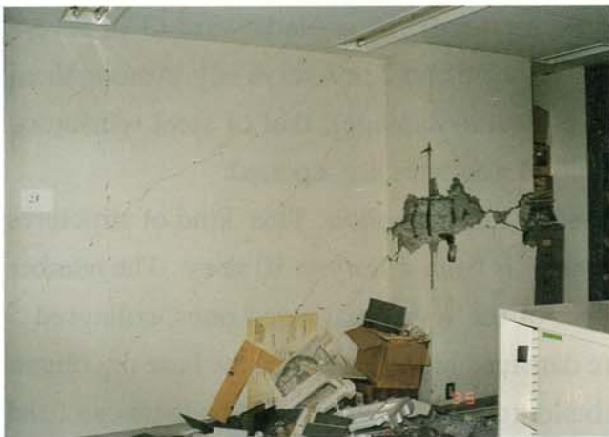
Photo.3.2.1.45 Bearing wall of the 2nd floor and the side column shear cracks ,buckling of the main column reinforcement

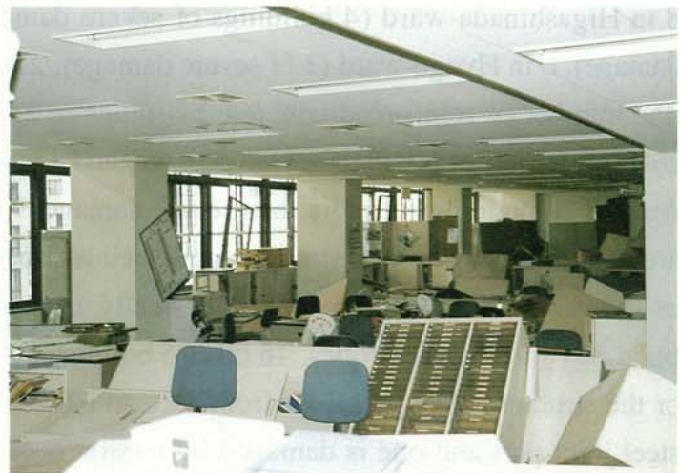
Photo. 3.2.1.48 Damage condition of the 7th roof floor of the 6th floor is pushed out to the 7th floor

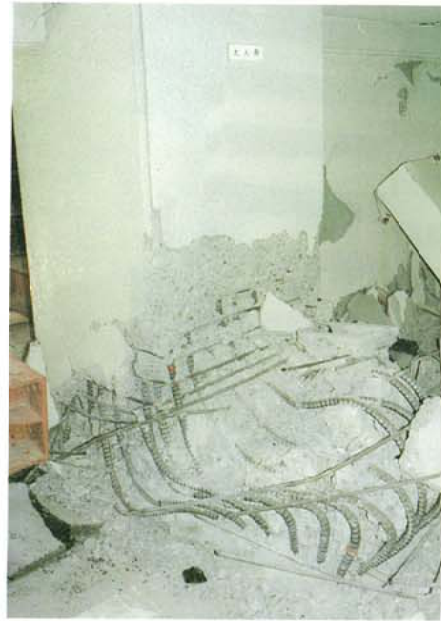
Photo. 3.2.1.56 Shear Crush of Column  
(1FL)

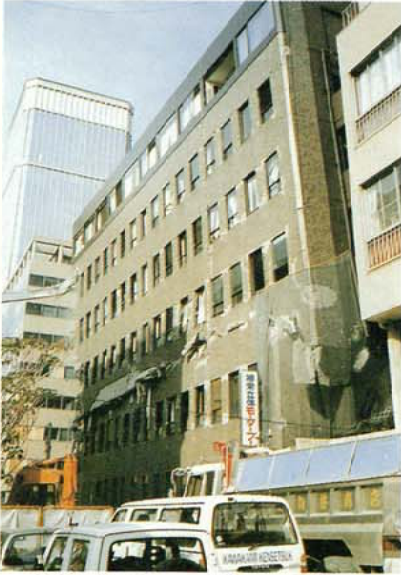
Photo . 3.2.1.58 Damage of 7 story Office Building

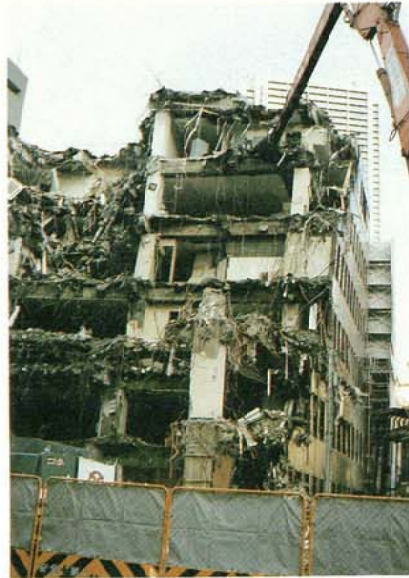
Photo . 3.2.1.59 Dismantling Condition of Building

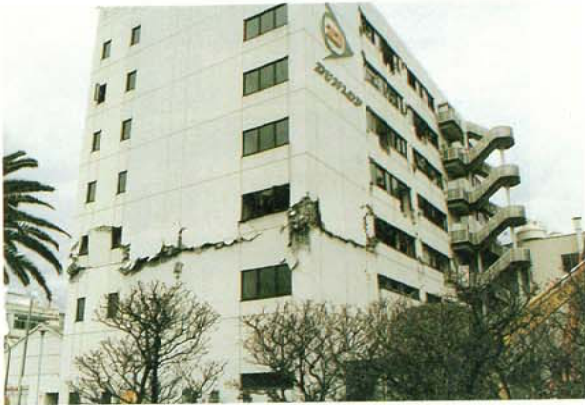
Photo . 3.2.1.60 Damage of relatively New Office Building

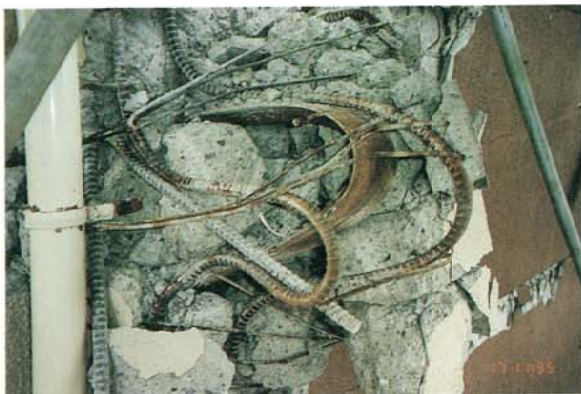
Photo . 3.2.1.61 Failure of SRC Column with Built-up Steel

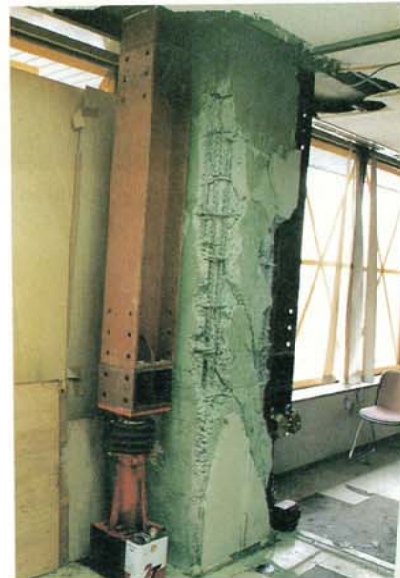
Photo . 3.2.1.62 Bond Splitting Failure of SRC Column

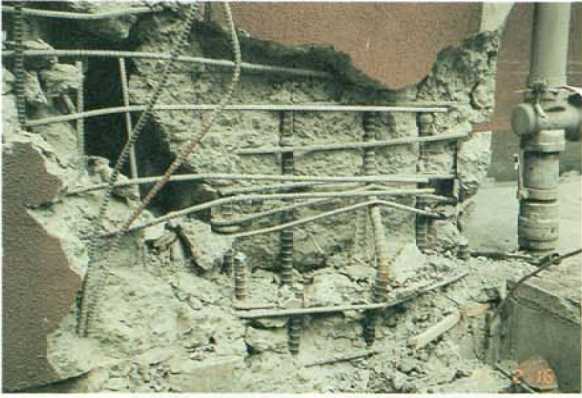
Photo . 3.2.1.63 Damages of Column Base

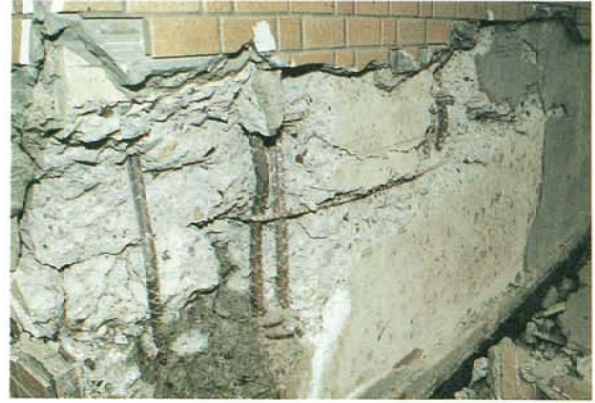
Photo . 3.2.1.64 Fracture of Splices of Steel

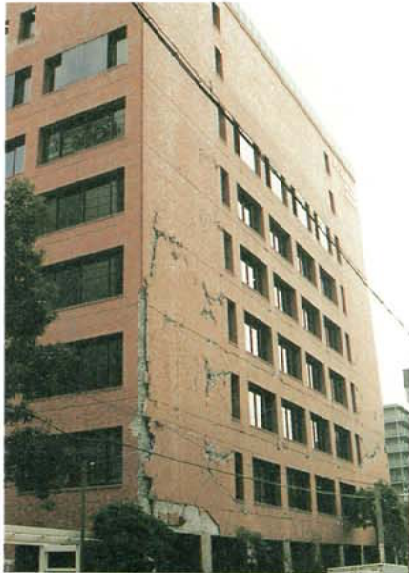
Photo . 3.2.1.65 Fracture of Anchor of Reinforcement
