*A SURVEY REPORT FOR BUILDING DAMAGES*  
*DUE TO*  
*THE 1995 HYOGO-KEN NANBU EARTHQUAKE*

*March 1996*

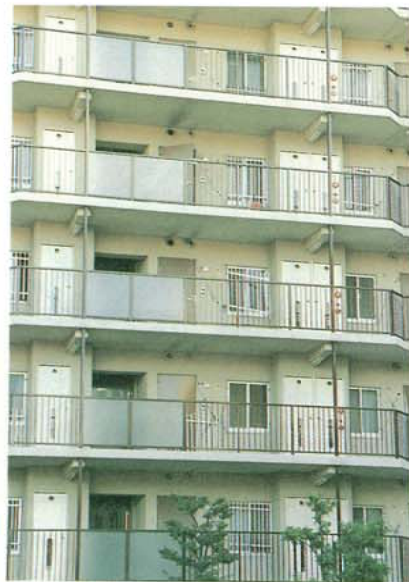
Photo . 3.2.1.66 Damage of Non-structural Partitions

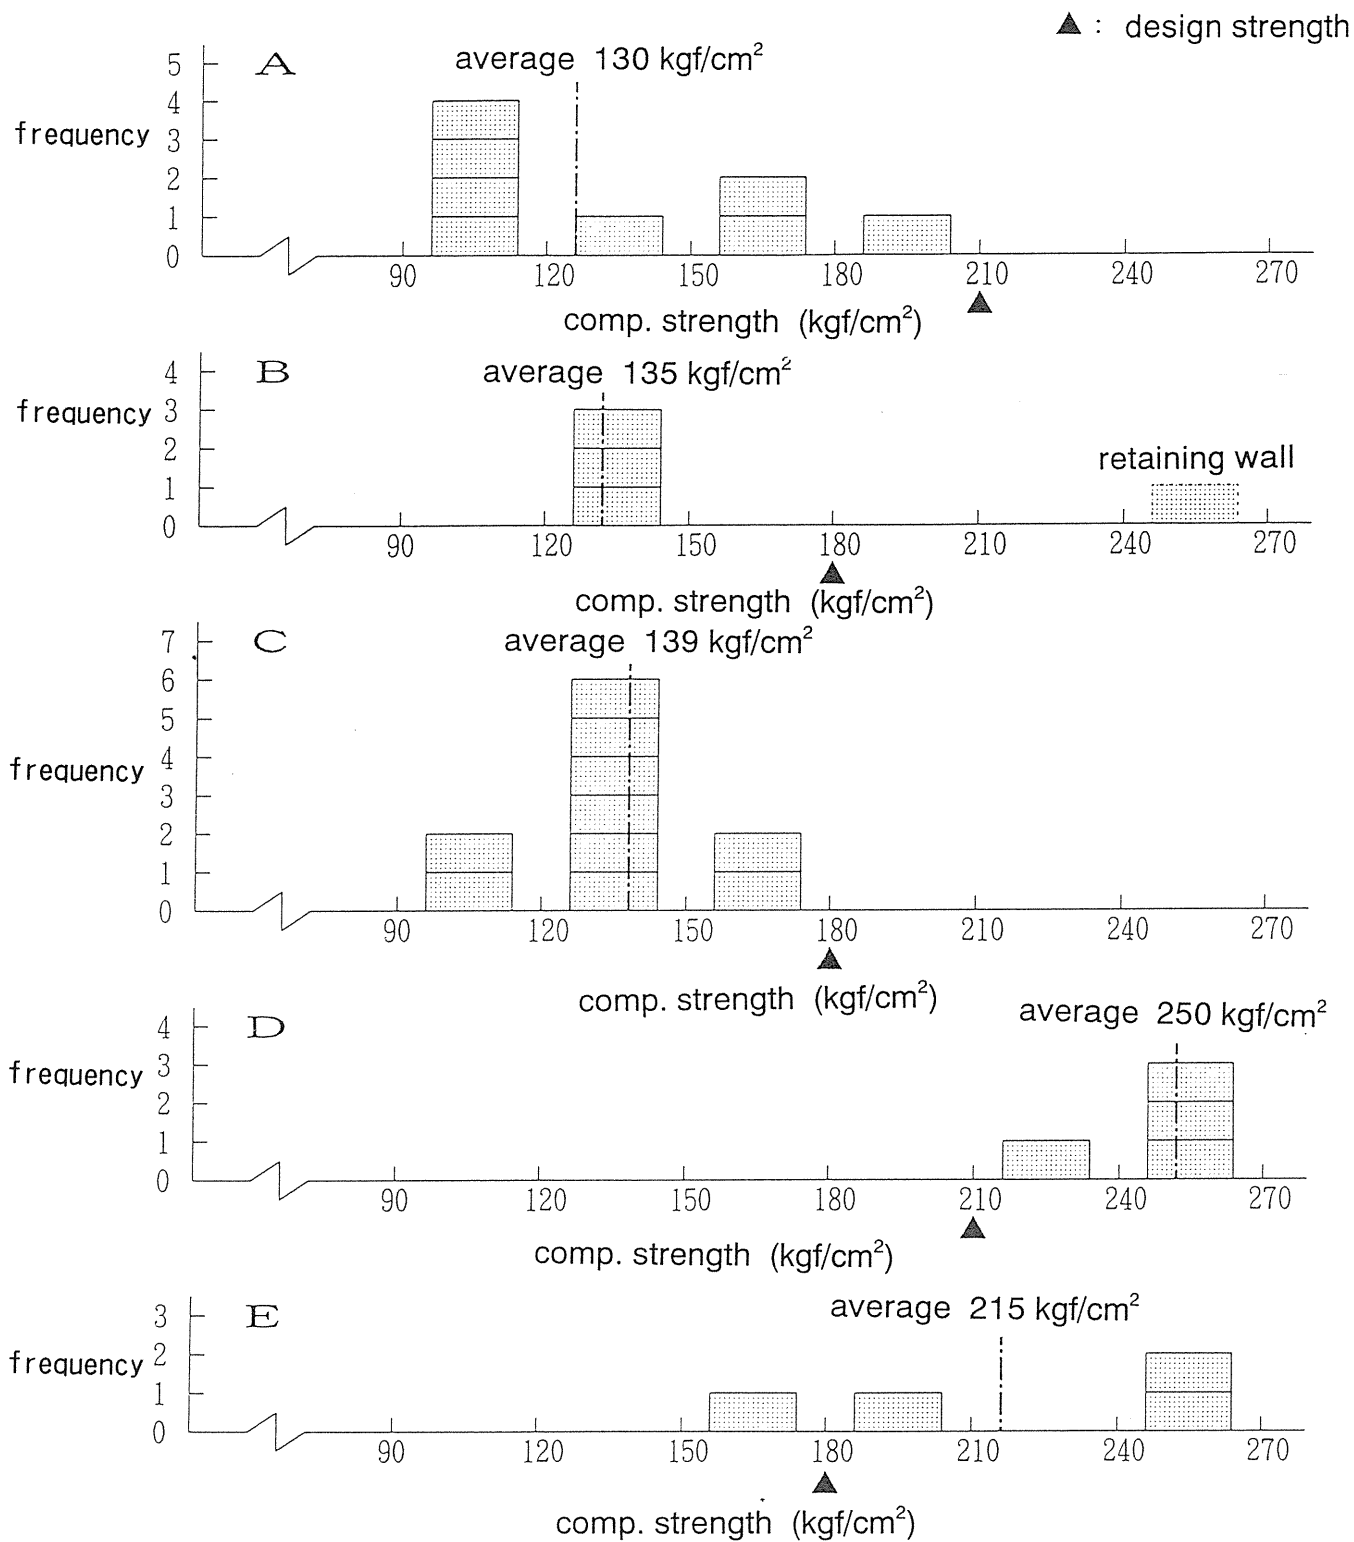
Fig. 3.2.1.6 Distribution of Concrete Compressive Strength for Each Surveyed Building

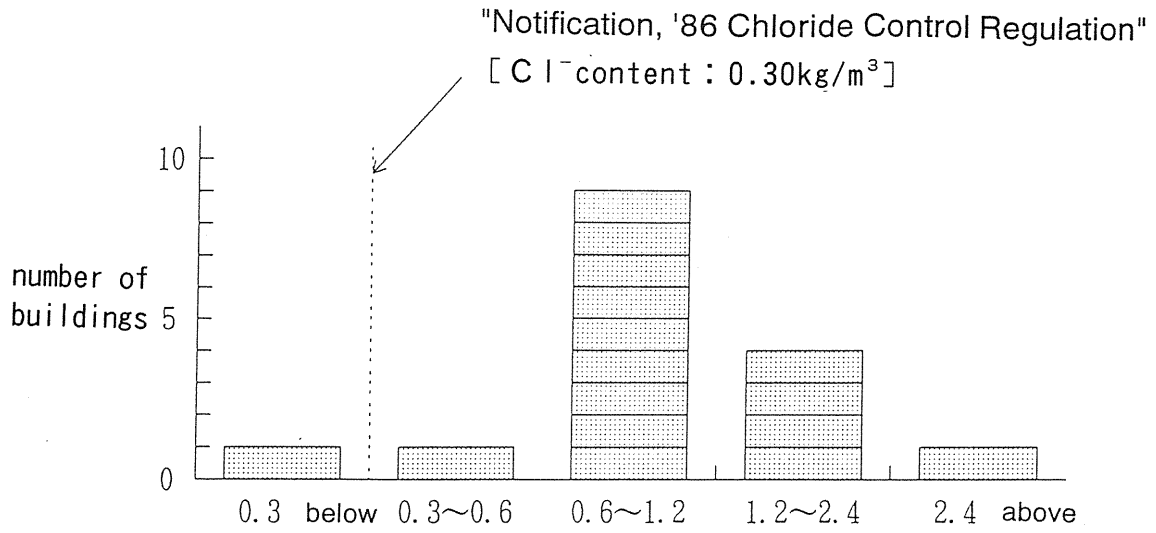
Fig. 3. 2. 1. 7 Chloride Ion ( $\text{Cl}^-$ ) ( $\text{kg/m}^3$ )

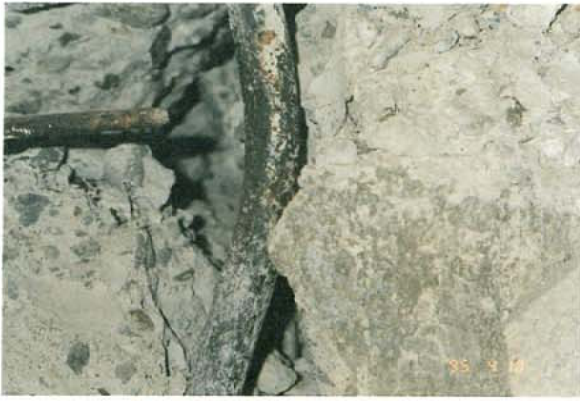
Photo.3.2.1.67 damaged hook by corrosion

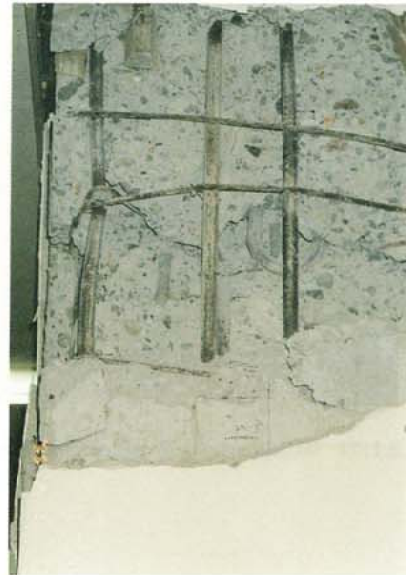
Photo.3.2.1.70 135degree hook in Reinforcement end

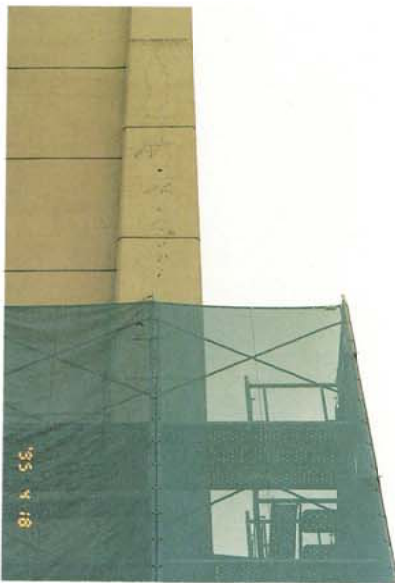
Photo.3.2.1.68 cracks along the axial direction Of column by alkali aggregate reaction

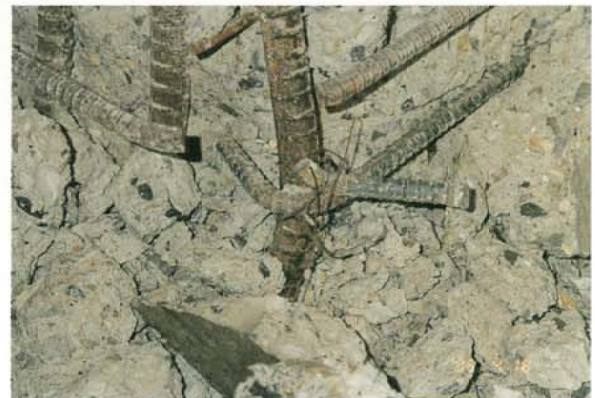
Photo.3.2.1.71 damaged bent part in reinforcement end

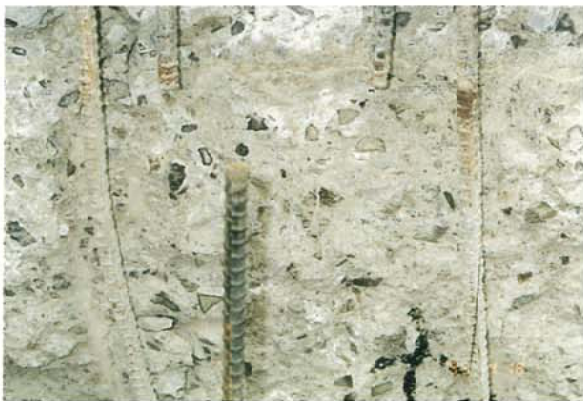
Photo.3.2.1.69 reaction rim around coarse aggregate by alkali aggregate reaction

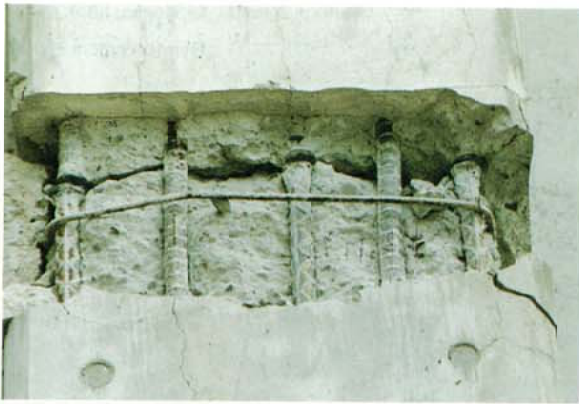
Photo.3.2.1.74 damaged joint in gas pressured welded parts

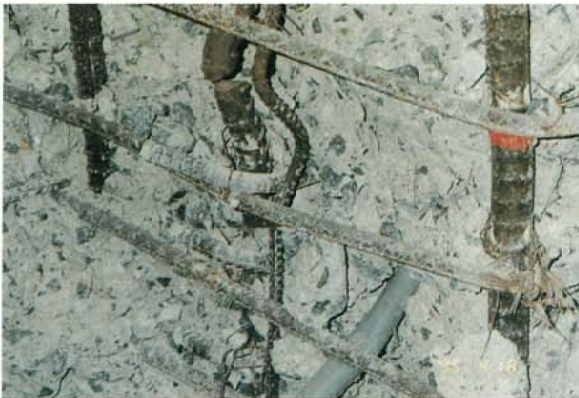
Photo.3.2.1.75 damaged gas pressure welded parts and not damage ones

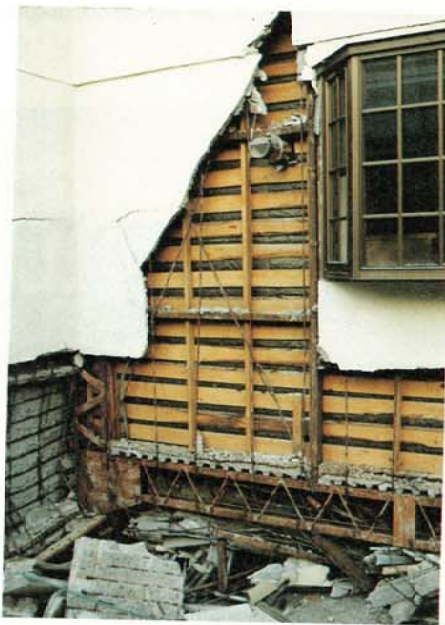
The welding joint between the column and diaphragm at the beam-to-column connection in the first story was fractured. The upper stories of the structure was collapsed.

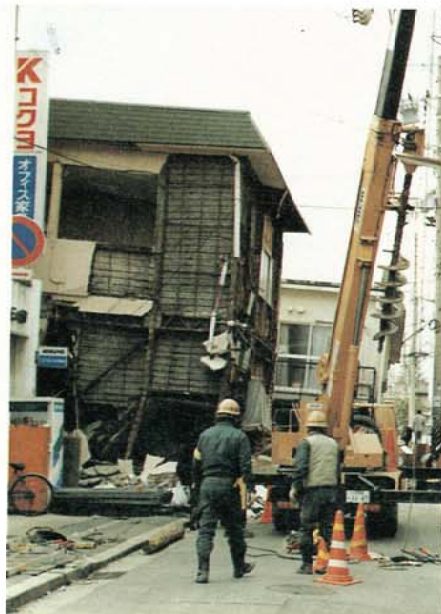
The first story was collapsed. The structure has two stories of moment resisting frames with vertical braces of steel bars. The members rusted heavily.

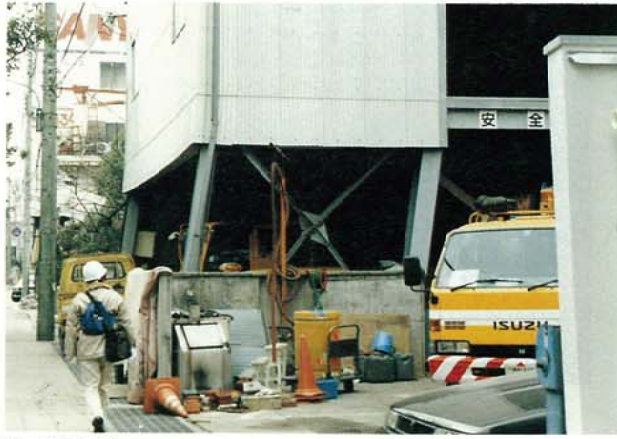
Two storied house rusted severely.

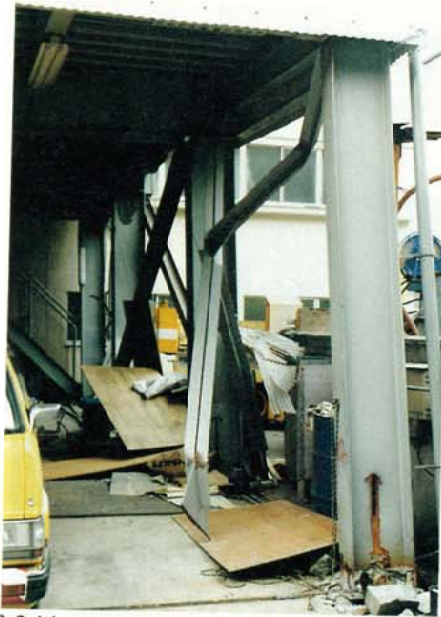
The damage was concentrated into the first story. The story drift was 1/8.

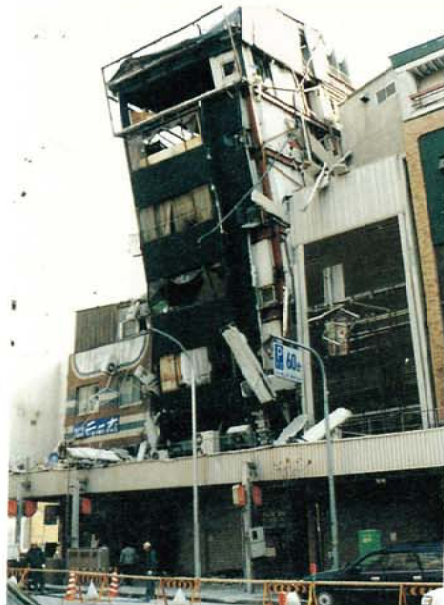
The gusset plate was fractured by the tension force from the brace.

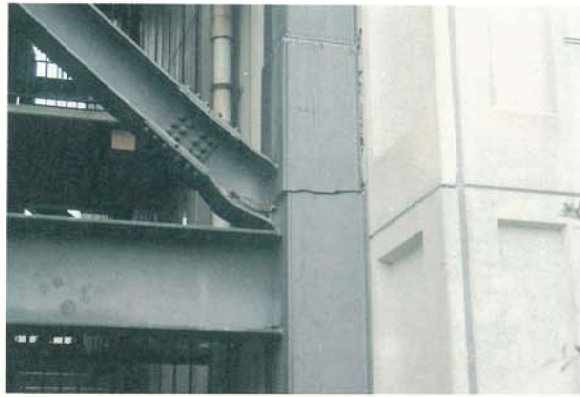
Photo 3.2.2.16  
The fracture of vertical member with square-hollow-box section and H-shape brace.

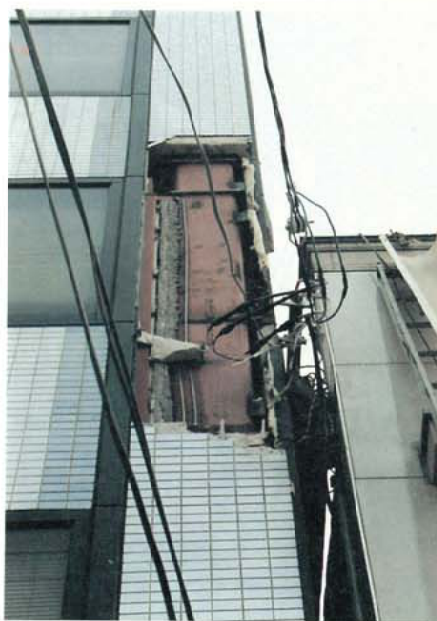
Photo 3.2.2.17  
Two buildings collided.

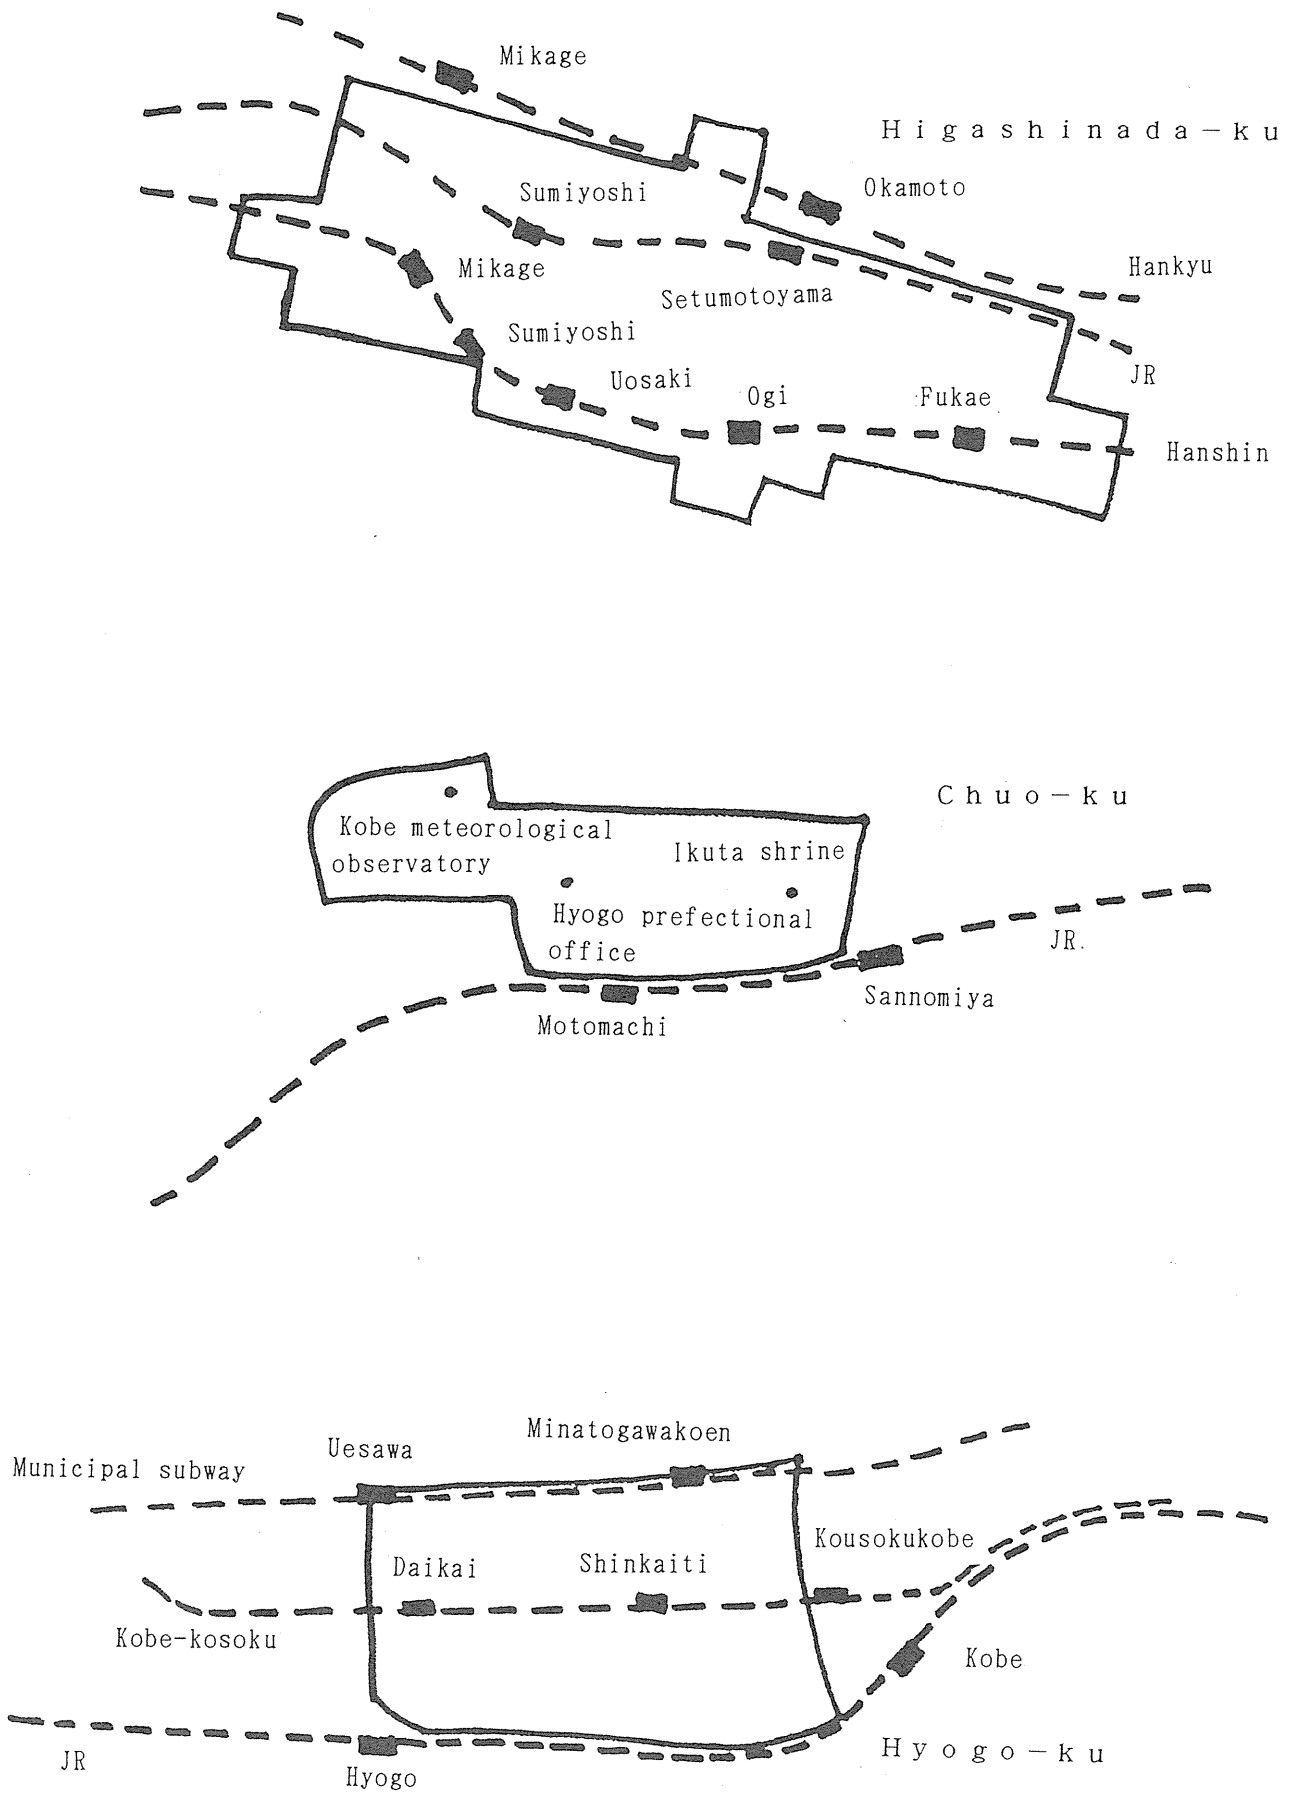
Fig. 3.2.2.1 Specified Area for the all buildings investigation

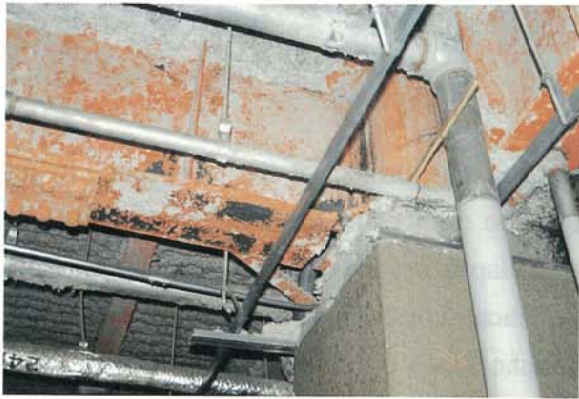
Photo 3.2.2.18 Fractured lower beam flange after largely plastic yielding (Building A)

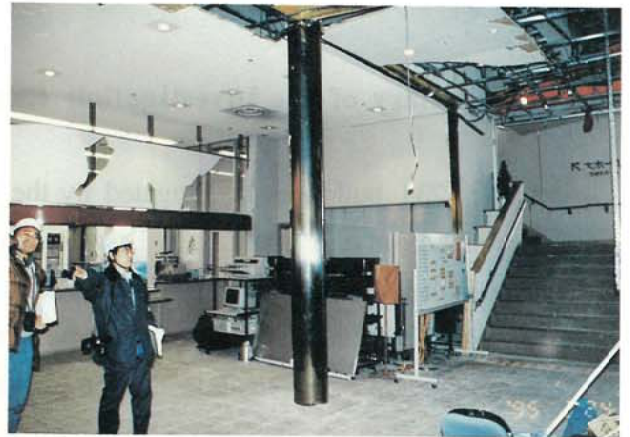
Photo 3.2.2.19 Damaged building interior due to pounding on parking building below (Building B)

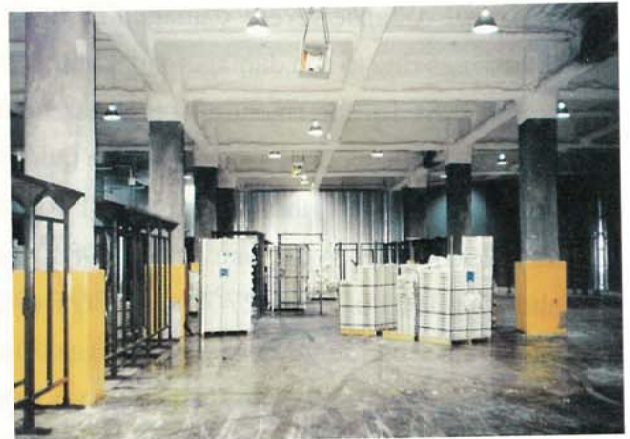
Photo 3.2.2.21 No damaged storage building (Building D)

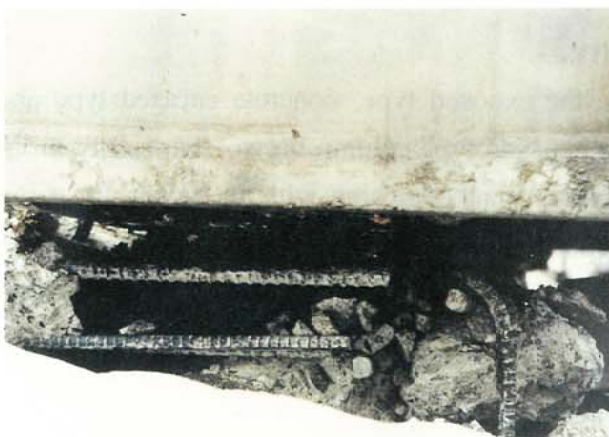
Photo 3.2.2.22 Damage of exposed column base (Building H)

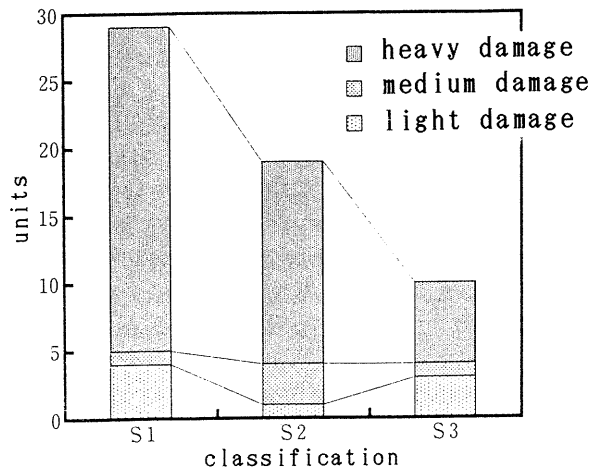
Fig.3.2.3.1 Damages of wooden houses in Nagata-ku

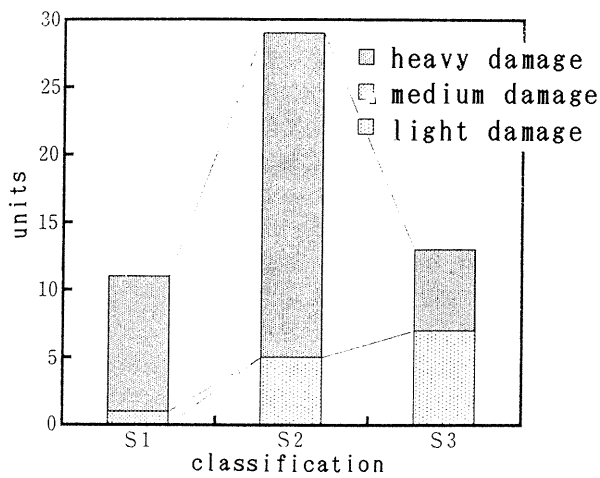
Fig.3.2.3.2 Damages of wooden houses in Nada-ku

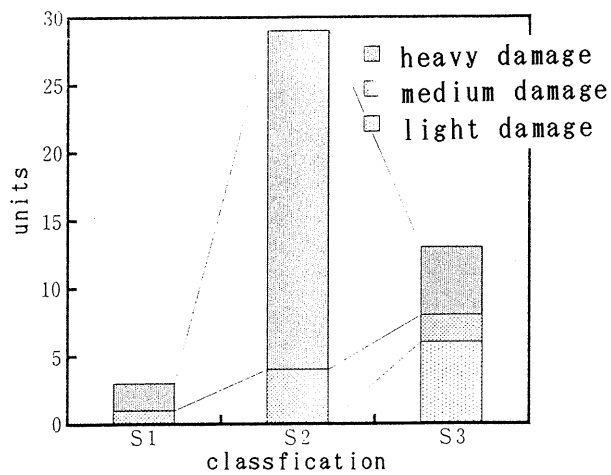
Fig.3.2.3.3 Damages of wooden houses in Higashinada-ku

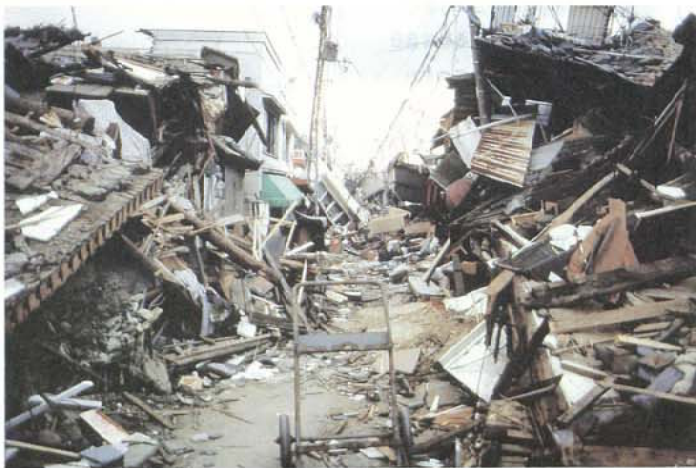
Photo 3.2.3.1 Collapse of wooden houses

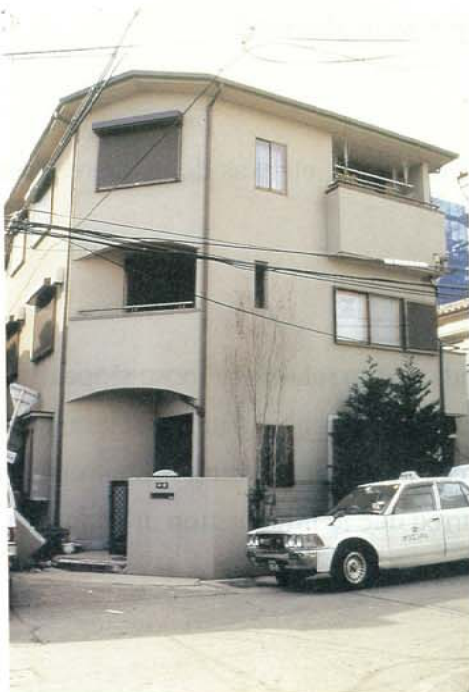
Photo 3.2.3.11 Three storey wooden building without damages

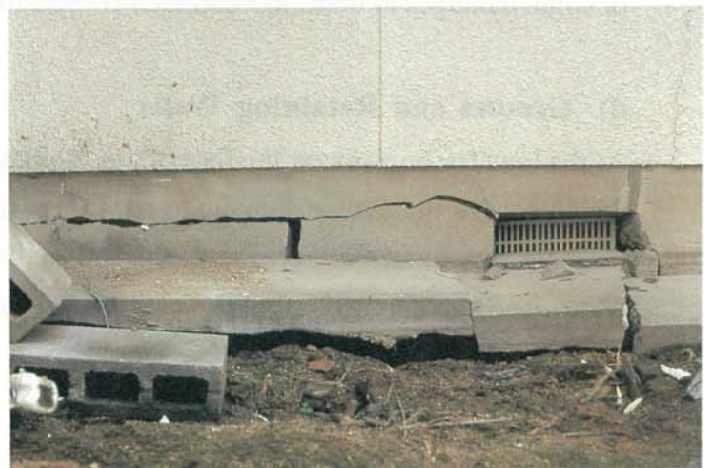
Photo 3.2.3.12 Damage of the foundation

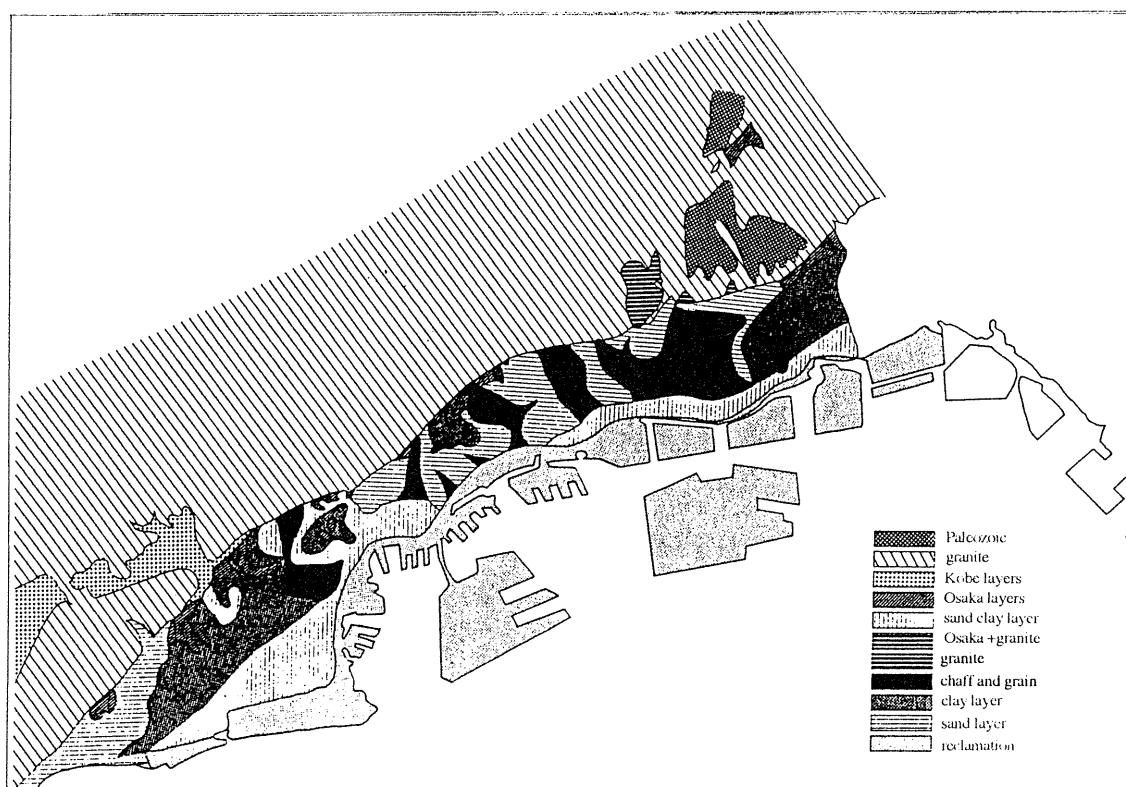
Fig. 3.2.4.1 Outlines of Surface Soil Condition
