Building damage by the 2011 off the Pacific coast of Tohoku earthquake and coping activities by NILIM and BRI collaborated with the administration

Isao Nishiyama¹, Izuru Okawa², Hiroshi Fukuyama³ and Yasuo Okuda³

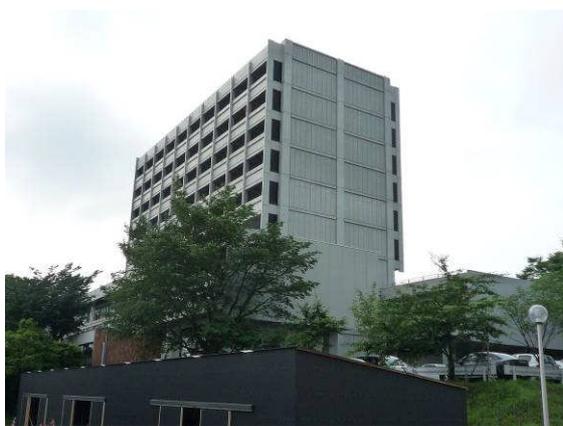
Photo 2.1 Appearance of the Building of the Human Environmental Course, Tohoku University

During the Tohoku earthquake, multi-story shear walls suffered flexural failure and other damage. The appearance of the building is shown in Photo 2.1, and strong motion records obtained during the main shock in Fig. 2.6. This figure shows (a) acceleration waveforms in the transverse direction, (b) acceleration waveforms in the longitudinal direction, (c) building displacement in the transverse direction (relative displacement to first floor of the 9-story building), (d) building displacement in the longitudinal direction, and (e) fundamental natural periods of the building that were calculated every 10 seconds [2.3].

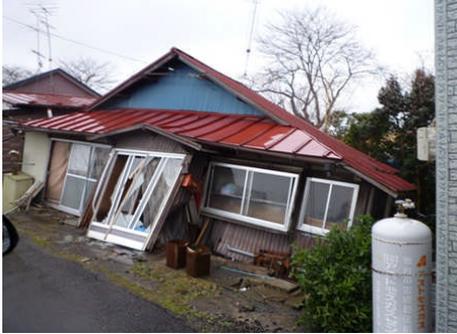
Photo 3.1 Damage of Houses caused by Ground Transformation

K-NET Tsukidate (MYG004 : Instrumental seismic intensity 6.6) is set up on the hillock about 3m higher than southern parking lot of Kurihara lyceum. There was a possibility of the amplification of earthquake motions. In Wakayanagi, the ground was bad and Sand eruption by liquefaction was observed. Damage of houses caused by ground transformation (Photo 3.1) and houses with store were also observed (Photo 3.2).

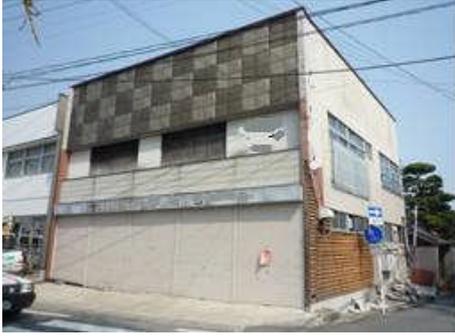
Photo 3.6 Store Combined House with Story Deformation

combined house) (Photo 3.6) with story shear deformation whose exterior mortar came off and wood lath under the mortar near the opening of the ventilation fan were deteriorated and attacked by termites. Such damage was confirmed in the other buildings. Most of these damage occurred along the small river, except for a few case, and it was considered that the soft ground near the river might amplify the earthquake ground motion.

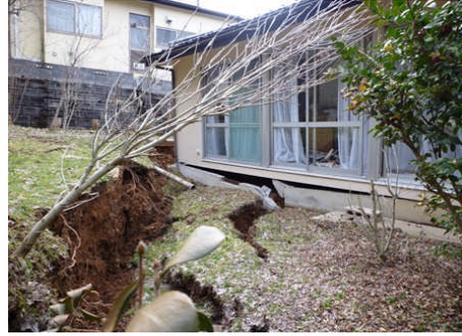
Photo 3.9 Damage of House

From the results of investigations on Oritate and Seikaen where the damage of the houses were serious, it was found that almost all of the damage of houses were caused by ground transformation. Moreover, ground transformation caused retaining wall collapse (Photos 3.8, 3.9), landslide and damage of houses (Photo 3.10). In Komatsujima, Aoba ward, drop off the mortar wall and damage of columns and by bio-deterioration and termite were observed in the house with shop (Photo 3.11).

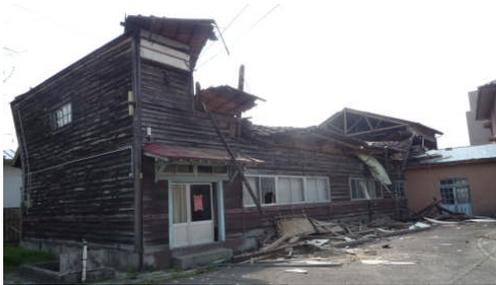
Photo 3.7 School Building whose 2nd Story Collapsed

The rare damage example (Photo 3.7) that only the 2nd story collapsed was observed.

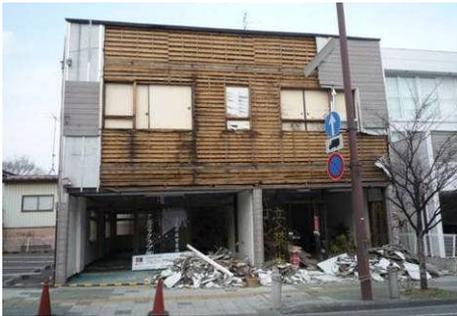
Photo 3.12 Fallen Mortar of Wall (Wood House with Shop)

A lot of damaged wood houses were found around the collapsed reinforced concrete building. For instance, they were the fallen mortar wall of the second floor of dwelling with shop (Photo 3.12), several decay and Japanese subterranean termite's damage on frame and wood sheathing of mortar wall (Photo 3.13).

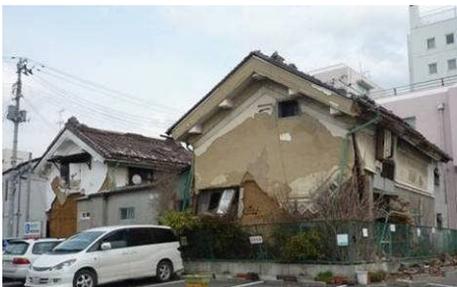
Photo 3.14 Dozo with Residual Deformation

The Dozo (Japanese traditional wood storehouse coated with clay and plaster finish) was greatly damaged around the hotel that the window glass

was broken, and it had residual deformation (Photo 3.14). The damage of roof's collapsing of the Dozo (Photo 3.15) was also found.

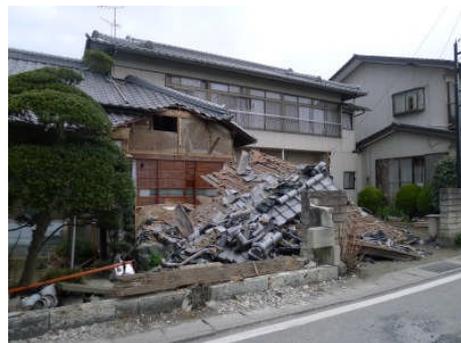
Photo 3.17 Breakage of Entrance Part

There were a lot of damaged fence made by the Ohyaishi stone. The collapsed farm type house was observed (Photos 3.16, 3.17).

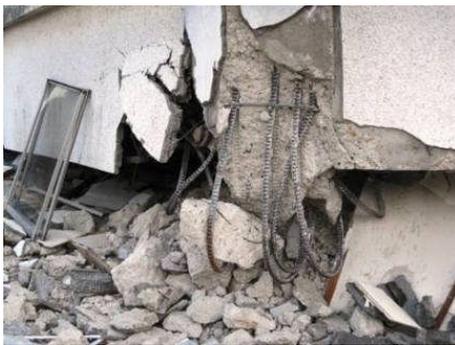
Photo 3.22 Close-up View of the Fallen Story

The 3-story RC building which was at the intersection in Sukagawa City, having a few walls on the facade on the first story and many walls on the back of the first story and the second story and higher, was severely damaged on the first story. The corner columns faced the intersection were significantly destroyed. The loss of axial load carrying capacity of the first-story columns caused the drop of the second and higher stories (Photos 3.21 and 3.22).

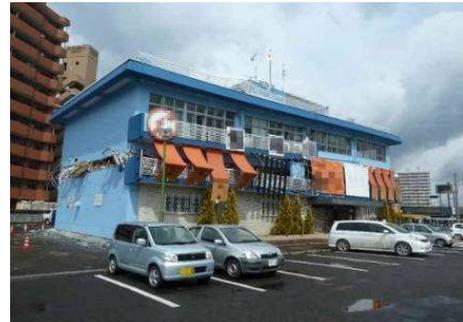
Photo 3.23 Mid-story Collapsed Building

The 3-story office building in Wakabayashi Ward, Sendai City partially collapsed on the second story and tilted (Photo 3.23). Only the second

story has openings on the wall at the gable side, as shown on the left wall of Photo 3.23. For this reason, it was assumed that the openings were intensively deformed and resulted in shear failure of the short columns formed by hanging and spandrel walls. Shear failure of the long columns on the third story was observed possibly due to the effect of the collapse of the second story. Damage of the columns and beams on the first story was not seen, while shear cracks were observed on the nonstructural walls.

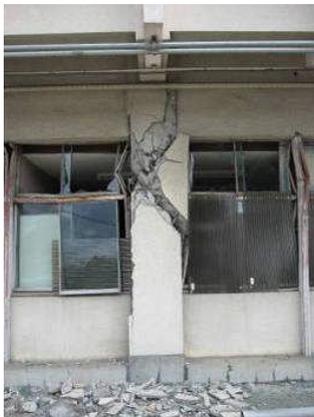
Photo 3.26 Shear Failure of Column

The 3-story RC building constructed in 1964 on a hill in Kasama City suffered also damage. Cracks in the ground were observed around the building. As seen in the photo, the RC structure on the first story was greatly damaged. Shear failure occurred on many exterior columns, which were made shorter in clear height by the hanging and spandrel walls without structural slit, as shown in Photo 3.26. In addition, the failures of the shear walls with openings were observed (Photo 3.27)

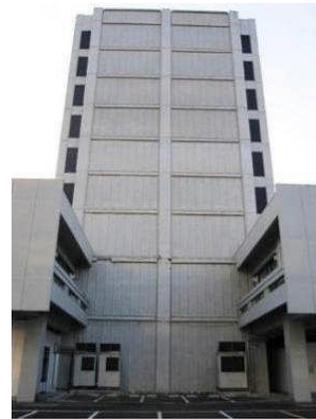
Photo 3.28 Appearance of Damaged Building

The building that consists of 9-story SRC and 2-story RC structures in Aoba Ward, Sendai City suffered from the earthquake (Photo 3.28). In the high-rise building, the multi-story shear wall on the gable side was subject to flexural failure at the third floor. Crushing of concrete and buckling of the longitudinal reinforcements were observed at the bottom of the boundary column of shear wall, as shown in Photo 3.29. This building was also damaged by the Miyagi-Ken-Oki earthquake in 1978 and had been retrofitted.

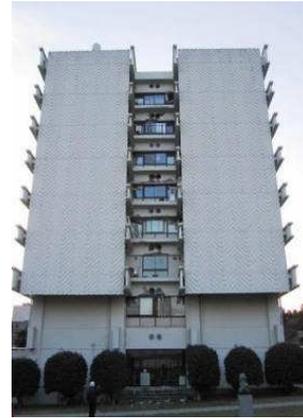
Photo 3.32 Appearance of Damaged Building

The shear failure or bond splitting failure occurred on the link beam connecting coupled shear walls from low-rise to high-rise stories on the 8-story RC building in Aoba Ward, Sendai City, as shown in Photo 3.32. The link beams has two openings at the center of them, and were damaged around these parts (Photo 3.33).

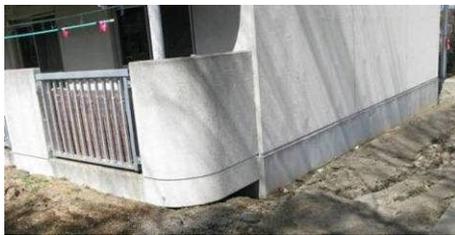
Photo 3.35 Sank Balcony

Photo 3.34 shows a residential building that sank and leaned in the longitudinal direction in Shirakawa City. The balcony, of which height above ground level was about 77cm, went down to ground surface in the gable side, as shown in Photo 3.35. Significant settlement was observed too on foot walk in surrounding area.

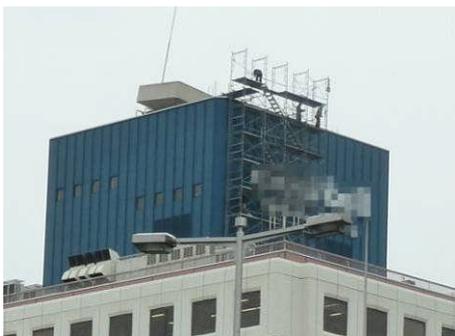
Photo 36 Damaged Penthouse

The damage on penthouses was observed everywhere, like tilting of it in Aoba Ward, Sendai City, as shown in Photo 3.36.

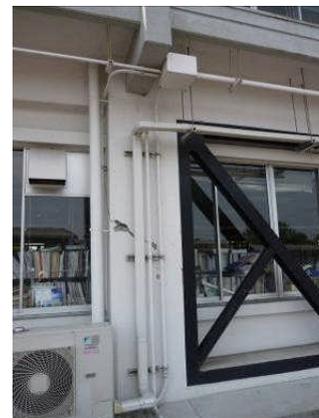
Photo 3.38 Shear Crack on Column with Framed Steel Braces

Shear cracks occurred on the columns with the framed steel braces at the earthquake, as shown in Photo 3.38, although the remarkable damage such as yield of steel were not seen on the braces.

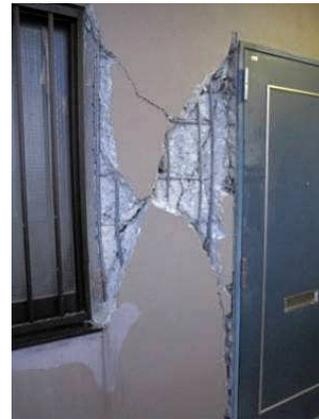
Photo 3.41 Shear Failure of Nonstructural Wall

The nonstructural walls around the front doors from low-rise to top floors were subject to shear failure, while the doors were deformed on the 10-story SRC residential building constructed in Aoba Ward, Sendai City in 1996, as shown in Photos 3.40 and 3.41. In addition, shear cracks were observed on the mullion walls on balconies in some of the low-rise floors.

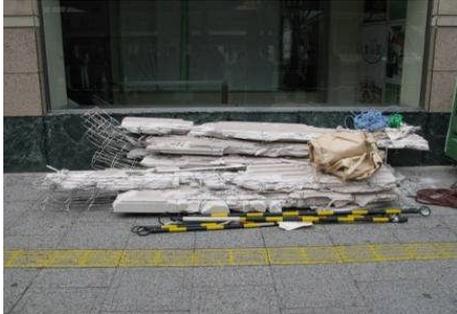
Photo 3.43 Dropped ALC Panels from 8 Story

Photos 3.43 show the case where the autoclaved lightweight aerated concrete (ALC) panel on the upper floor in the 8-story building fell away, and Photo 3.44 is the case where the tile on exterior wall was dropped, in Aoba Ward, Sendai City.

These kinds of damage relatively often occurred in buildings without structural damage, not limited to specific areas. Despite of the

construction period and the seismic design codes applied to, these damage are often seen in many buildings.

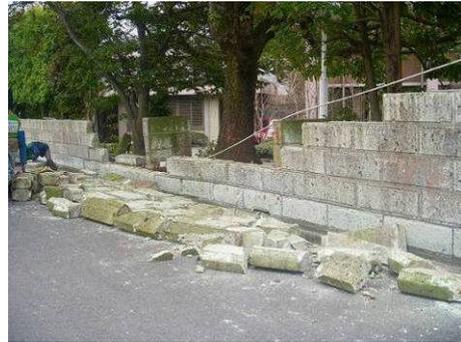
Photo 3.46 Collapse of Stone Masonry Wall

The collapse of concrete block wall and stone masonry wall are well known as earthquake damage caused by strong seismic motion. The damage of those was often observed in the field investigation, as shown in Photos 3.45 and 3.46.

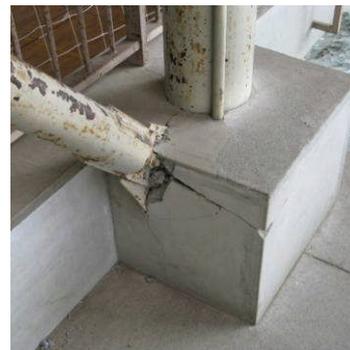
Photo 3.54 Cracking of Column Base Concrete

Damage of cracking of the column base concrete and mortar in the gallery of some gymnasiums was observed (Photo 3.54). Concrete and mortar of steel column base at a ground level was also cracked. However, almost all of these cracking are classified into minor or slight damage.

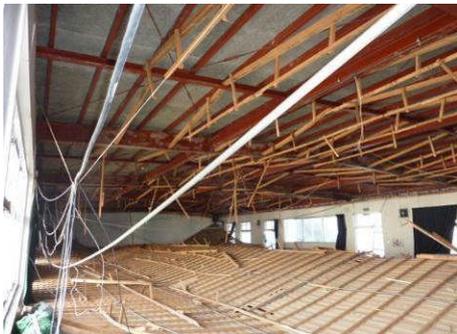
Photo 3.57 Dropping of Ceiling Materials

The types of nonstructural damage of gymnasiums include dropping of ceilings and lighting equipment (Photos 3.57 and 3.58), breakage of windows (Photo 3.59), dropping of exterior walls (Photo 3.60), dropping of interior walls and eave soffit. In particular, the severe damage such as dropping of extensive ceiling in the high school gymnasiums was observed than in the elementary and junior high school gymnasiums.

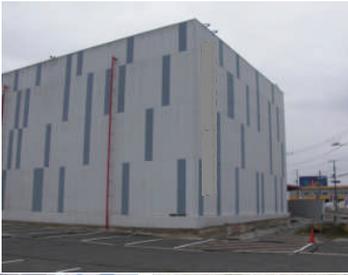
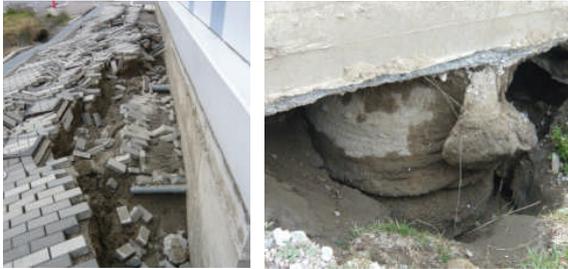
Photo 3.61 Situations around the Commercial Building and State of Pile Head

Finishes of the sidewalks around a large-scale commercial establishment along Route 11 of Prefectural Road were scattered. The subsidence of the surrounding ground was about 40 cm, and the settlement of the facility in itself was slight. The commercial building was tilted about 0.7/100 in the longitudinal direction. We visually observed a foundation type of the building from an opening between surrounding fissures. The type was confirmed to be a pile foundation (Photo 3.61).

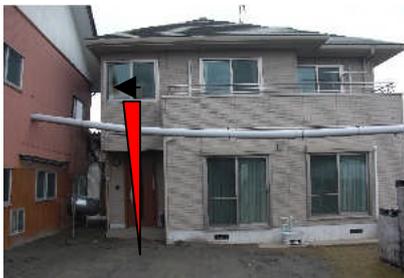
Photo 3.62 House Tilted 5.0/100

Sand boiling was seen everywhere on the roads or sites also in surrounding buildings lots. A house constructed on an embankment was tilted to an adjacent warehouse with sand boiling. An angle of tilting was 5.0/100 (Photo 3.62). It can be assumed that liquefaction occurred at the concentration of the loads of two adjacent buildings and the house was tilted to the direction.

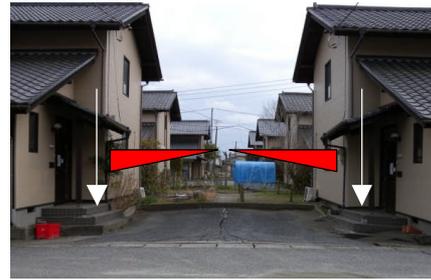
Photo 3.63 Subsidence of Two Houses enclosing Vacant Land

In Hinode, large-scale damage occurred in on corner within the zone of about 200 m four directions near Hitachi-tone River. Sand boiling, lift of buried structures, and subsidence or tilting of power poles, which were caused by liquefaction, were seen everywhere on the road and sites. Many buildings facing the road subsided 20 to 30 cm from the front sidewalk (Photo 3.63). For reference, foundation cracks or gaps were not observed in the investigated range.

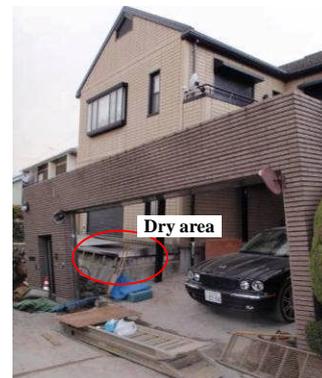
Photo 3.64 Tilted House

In Mihama, subsidence and tilting that was caused by liquefaction were observed in a house that has a dry area in a basement (Photo 3.64). An angle of tilting of the house was about 3 degrees. It is considered that the basement was lifted and another remaining parts of the house subsided. Around this house, a house's site was totally covered with boiled sand, and a fence's foundation was deformed. In addition, a carport in one building was ruptured by liquefaction and moved (Photo 3.65). A unit of the carport and the building was separated and moved about 50 cm probably due to the movement of the ground associated with liquefaction.

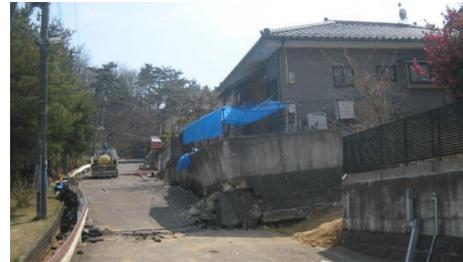
Photo 3.67 Damage of Retaining Wall and House Movement and Tilting by Sliding and Ground Transformation

In one corner of a large-scale housing area, where a slope in the N-NE direction had been developed, ground transformation by sliding of the housing site embankment to the slope direction, and damage to the retaining walls by ground transformation were often observed (Photo 3.67). Houses on the site were recognized to have different damage patterns, such as movement, subsidence and tilting without

structural damage, structural great deformation and fractured foundation.

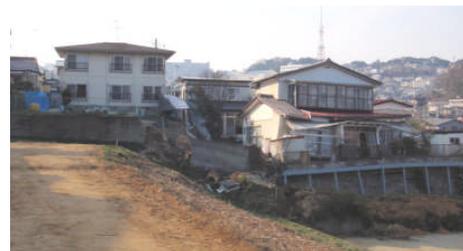
Photo 3.68 Group of Houses damaged by Sliding and Ground Transformation

This area is located at one corner of a large-scale housing area where a contoured hill was developed. Ground transformation by sliding of the housing site embankment to the slope direction, and damage to the retaining walls by ground transformation, were often observed. The damaged area at 4-chome, Midorigaoka under this earthquake was almost same as under the 1978 Miyagi-Ken-Oki earthquake. The land at 2-chome, Aoyama is wavier than at 4-chome, Midorigaoka. Near the zone of 2-chome, Aoyama, large-scale sliding of the embankment occurred (Photo 3.68). In this zone, large deformation and damage were seen on both of upper structures and foundations of houses on the housing area. In other places with embankment sliding, deformation and damage of upper structures of houses were observed, but it seemed that there was limited significant damage to foundations. Near 2-chome, Aoyama, a retaining wall for the housing area with a height of over 5 m was damaged.

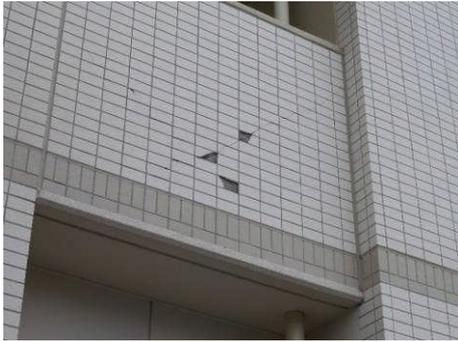
Photo 3.73 Drop of Ceramic Tiles

- a) According to the person in charge of the building, no furniture was turned over and no structural damage was observed inside of rooms. However, the damage to the expansion joint was observed.
- b) Drop of the ceramic tiles on outer wall (Photo 3.73) and shear crack on the wall in the first floor parking space (Photo 3.74) were observed. The subsidence of ground around 10 cm was observed near the building.
- c) No damage was found to NRBs by visual inspection (Photo 3.75), however, paint of U-shape dampers was peeled off (Photo 3.76) and many cracks were found on Lead dampers (Photo 3.77).

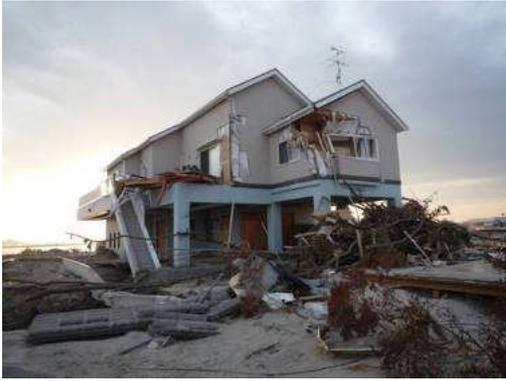
Photo 4.15 Remaining Mixed Building with Reinforced Concrete Piloti on First Floor

In addition to these cases, a tsunami wave force was reduced possibly due to many openings in the direction affected by tsunami, or a wooden house remained despite washed away of columns and external walls in the corner of the building. Several houses that have a reinforced concrete piloti on the first floor, or a mixture of wooden and reinforced concrete structures, remained (Photo 4.15).

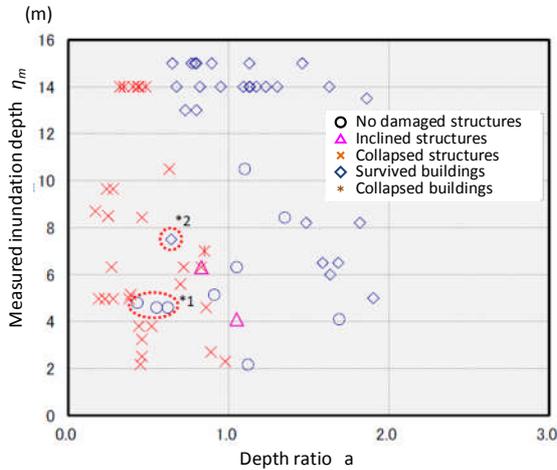
Fig. 4.2 Depth Ratio of Investigated Buildings with Some Obstacles for Tsunami Effect [4.3]

Fig. 4.2 plots damage situations of buildings and structures with some obstacles for tsunami effect for α and η_m . A boundary of damage situations of buildings and structures can be considered at the depth ratio $\alpha=1$ except *1 and *2 in Fig. 4.2 when the inundation depth was measured less than about 10m. Many buildings at the depth ratio α much less than 1 remain when the inundation depth was measured more than 10m.

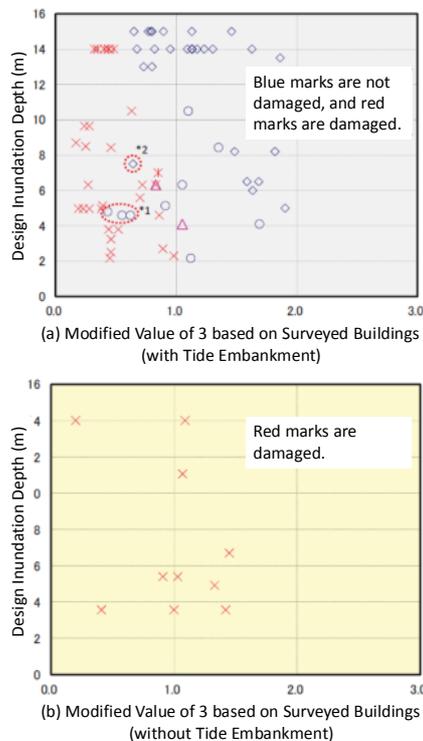
Fig.6.2 Comparison of the Measured Tsunami Inundation Depth and the Estimated Value

one side of the building whose inundation depth is 3 times the design tsunami inundation depth. Here, the value of 3 was determined from the laboratory test utilizing waterway, which was validated later by the field survey of tsunami damage by the 2004 Indian Ocean Tsunami Disaster [6.1]. However, the inundation depth of this time tsunami reaches about 15m or more which is far above the previous study and the topographical shape of rias coastline has not yet been verified. According to the interim report by the execution team, 44 examples of simple structures and 52 examples of buildings which subjected tsunami damage were collected and used for verification of the value. Fig. 6.2 shows the comparison of the measured tsunami inundation depth and the estimated value for simple structures and buildings with and/or without tide embankment etc. As seen from the figure, the value of 3 seems to be reduced drastically in case of with tide embankment, and the value becomes less than 1 in case of higher tsunami inundation depth such as over 10m. It is explained in the interim report that the load

effect by tsunami is the largest not at the highest inundation depth, so the effective tsunami inundation depth can be reduced in case of high depth.

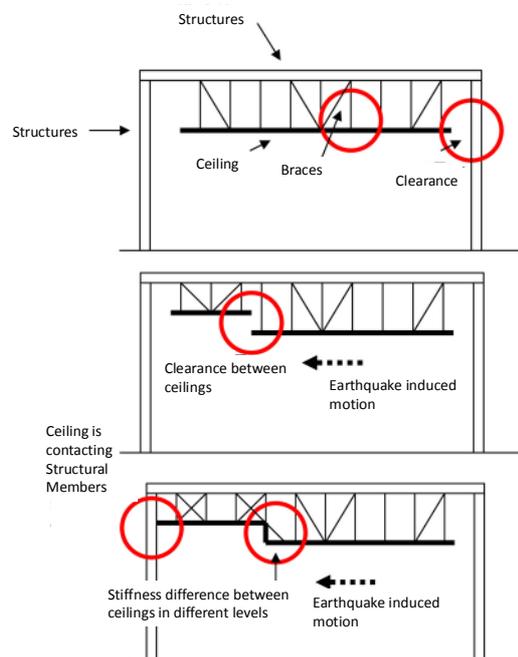
Fig.6.3 Schematic Explanation of Technical Advice on Details of Ceilings

After the 2001 Geiyo earthquake, in which many ceilings fell down in the large space gymnasiums stood in the urban park, the technical advice to keep appropriate clearance between ceiling and surrounding structure and to install braces on hanging bolts was send from MLIT to the special administrative agency⁷. An additional technical advice to keep clearance even between different

stiffness ceilings was send after the 2003 Tokachi-Oki earthquake, and an appropriate strengthening of clip members which connect ceilings to hanging bolts was indicated after the 2005 Miyagi earthquake. Fig. 6.3 shows schematically these technical advices. In the figure, red circle portions should be taken care in the design of ceilings. From the fiscal year of 2008, vibration measurement, time history analysis, and vibration test using shaker on gymnasiums were performed in order to prepare concrete design manuals for ceilings against falling down.

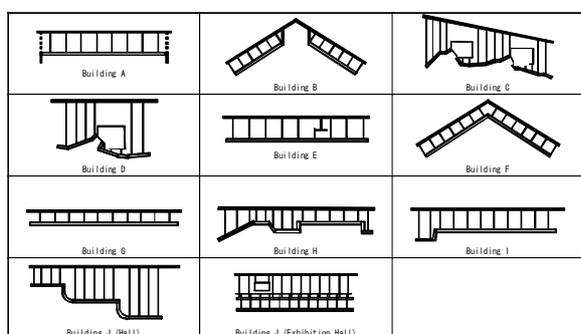
Fig.6.4 Patterns of Ceilings Surveyed

In the Tohoku earthquake, building collapse was rarely observed but many ceilings falling down was reported at the places with not large earthquake motions and even death due to falling down of ceilings was occurred for example in the Imperial Crown Style building in Chiyoda Ward, Tokyo.

investigation on establishing building structural codes for non-structural elements based on the earthquake damage was initiated by the execution team of Building Performance Standardization Association. The study items are 1) collection and classification of ceiling damages in the Tohoku earthquake, and 2) building structural codes, which should be, for non-structural elements especially for ceilings. In the interim report, 151 examples of ceilings falling down are collected through the questionnaire to the special administrative agency and field survey was made on the selected 10 examples. Fig. 6.4 summarizes the shape of the damaged ceilings in these buildings.

During the next six months after the interim report, concrete countermeasure methods for existing ceilings and safety calculation methods for new ceilings will be considered.
